CatchmentCARE River Restoration Works Report

MARCH 2023

Community Actions for Resilient Ecosystems

A project supported by the European Union's INTERREG VA Programme, managed by the Special EU Programmes Body (SEUPB).

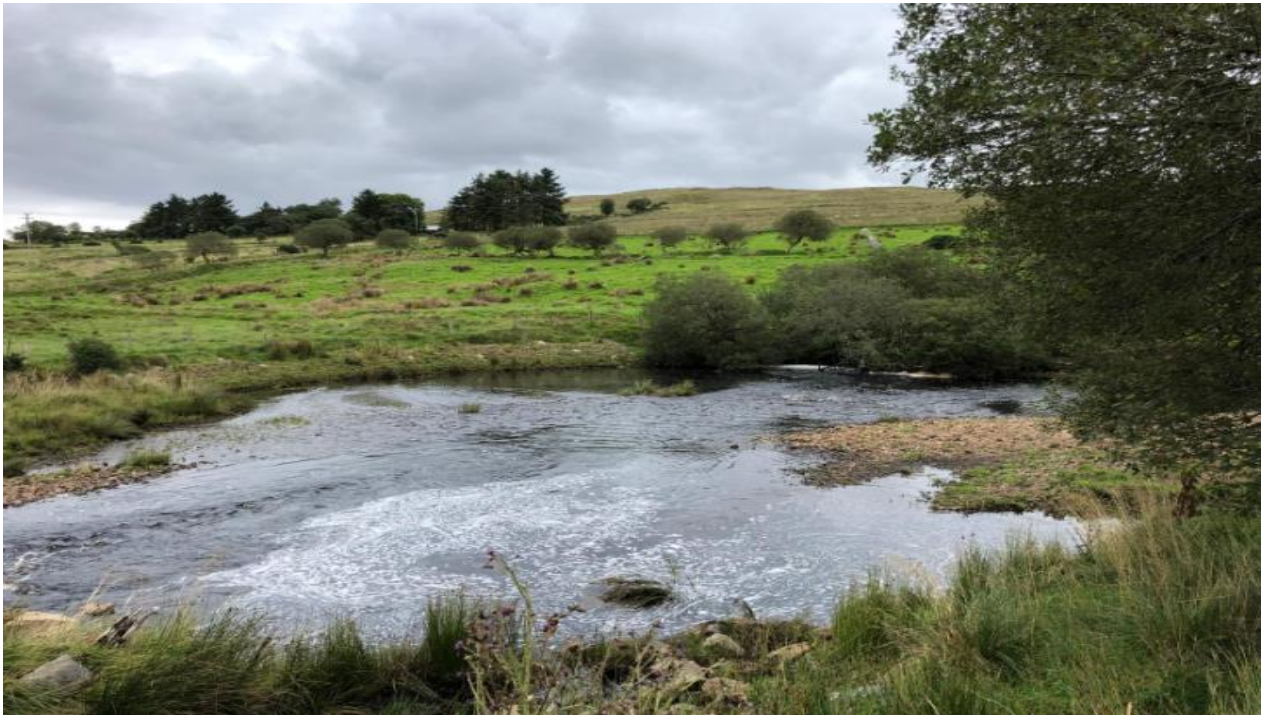
The Cummirk River suffered from erosion on both banks along its length, with evidence of significant livestock poaching at numerous points along the river. The effects of erosion have had particular impact on the northern bank of the river, with formation of a deep pool and the deposition of gravel on the opposite bank causing loss of valuable land. Fencing is also inadequate and intermittent along the stretch of river, with only a small pre-existing riparian margin of ~1 m.

Figure 4: Deep pool had been created by erosion with large amounts of high and dry gravel deposits.

“High and dry” gravel (under normal flow conditions) adjacent to the soft engineering was also regraded to provide appropriate spawning habitats for salmonids, in the hopes of increasing survivability of salmonids in the locality.

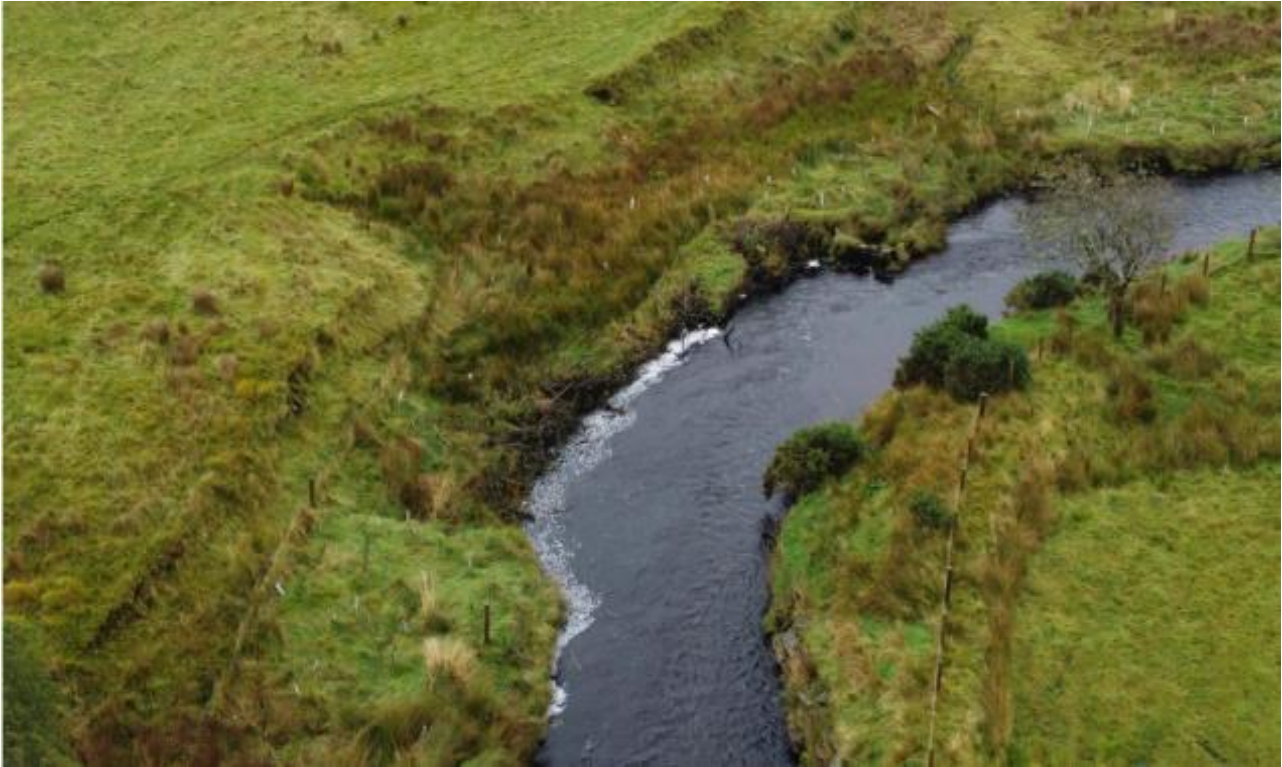
Figure 7: Cummirk Restoration works in 2022. Banks have successfully naturalised and gravel is available for spawning habitat.

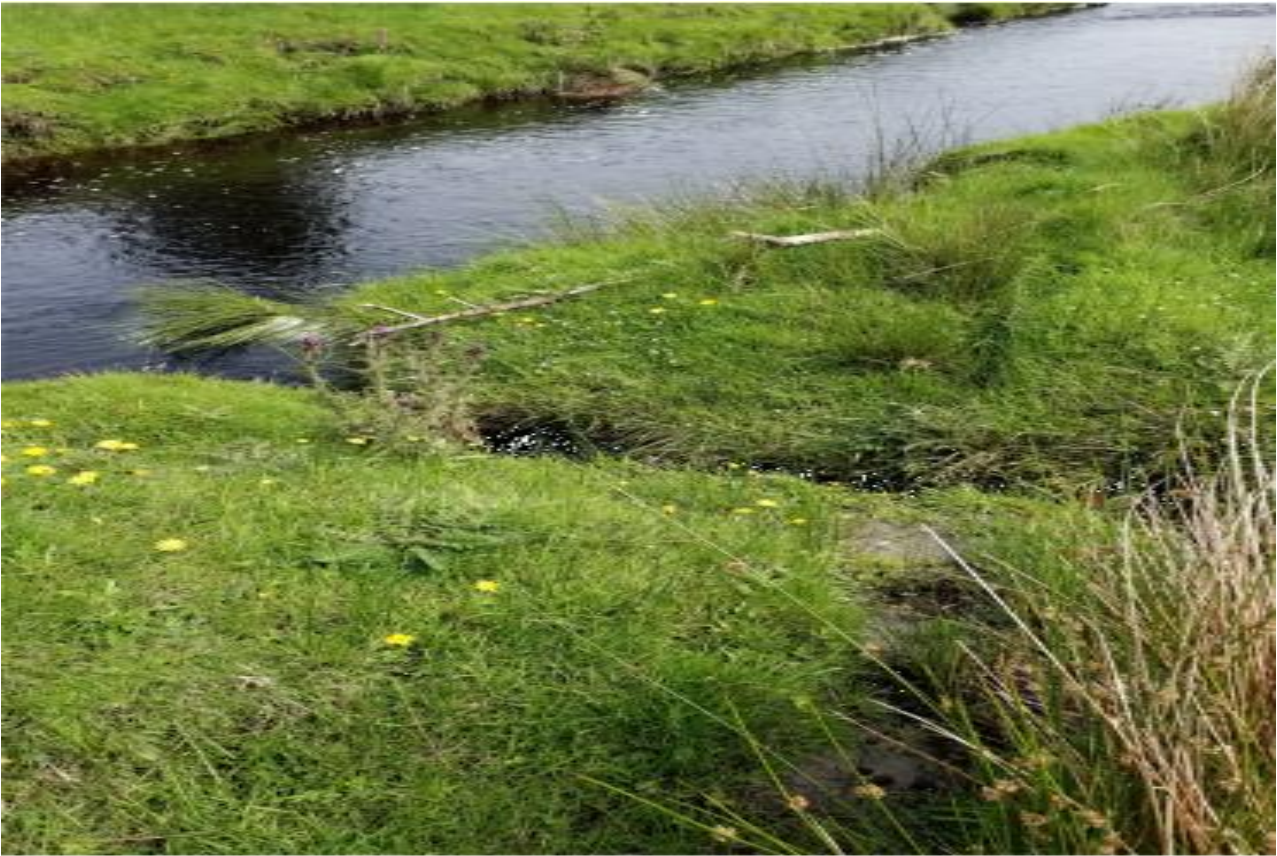
Areas along the Elatagh River have an inadequately fenced riparian margin, allowing direct livestock access into the river and subsequent poaching of river banks and riverbeds. Areas of banks have also been subject to erosion and collapse as a result of natural instream processes.

Figure 9: Evidence of poaching from livestock into the river.

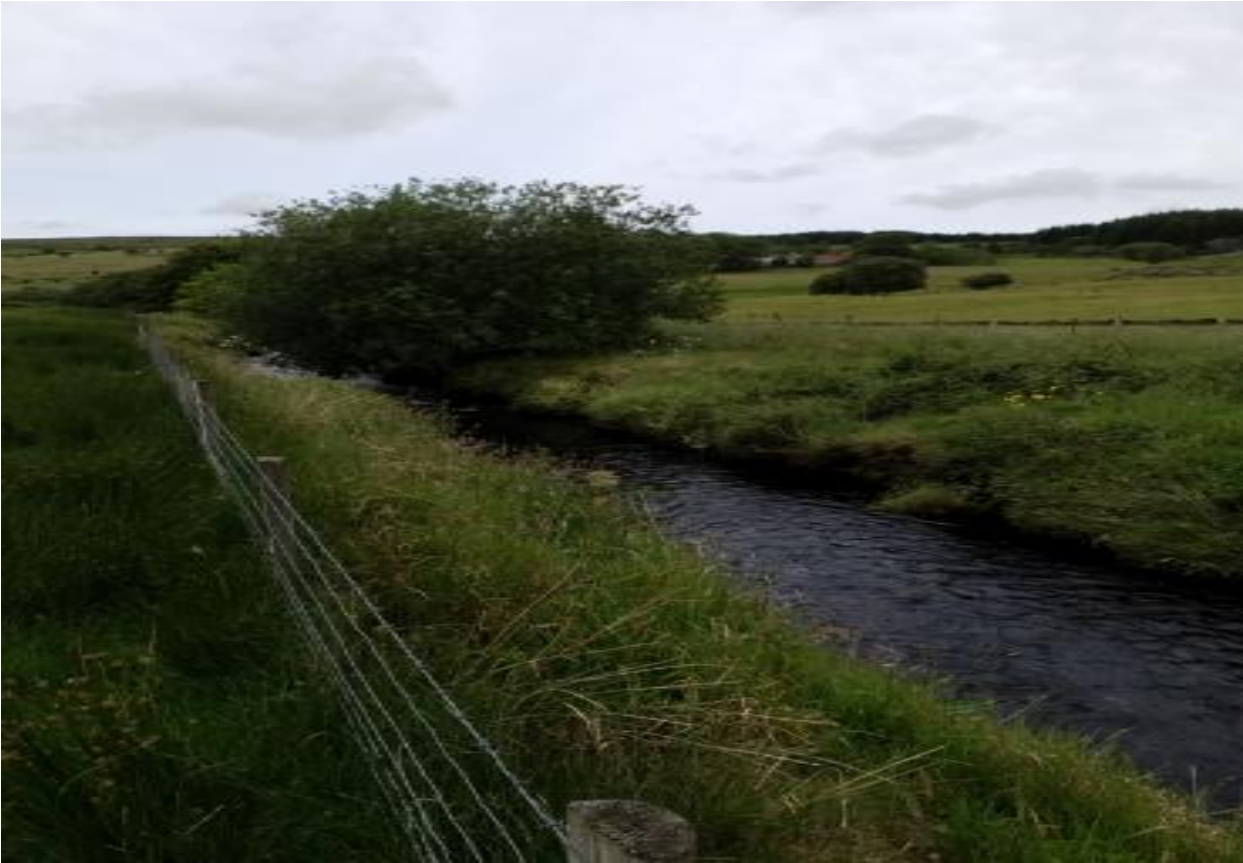
Small, poorly planted riparian margins fail to provide sufficient surface area for absorption/degradation of agricultural, waste water, domestic and forestry chemical export, and vegetation uniformity has also resulted in reduced habitat diversity along the length of the Elatagh. Several areas also had significant stands of overhanging trees which effectively blocked all sunlight from the river.

Figure 10: Banks had been fenced off in areas and had lacked appropriate riparian margins.

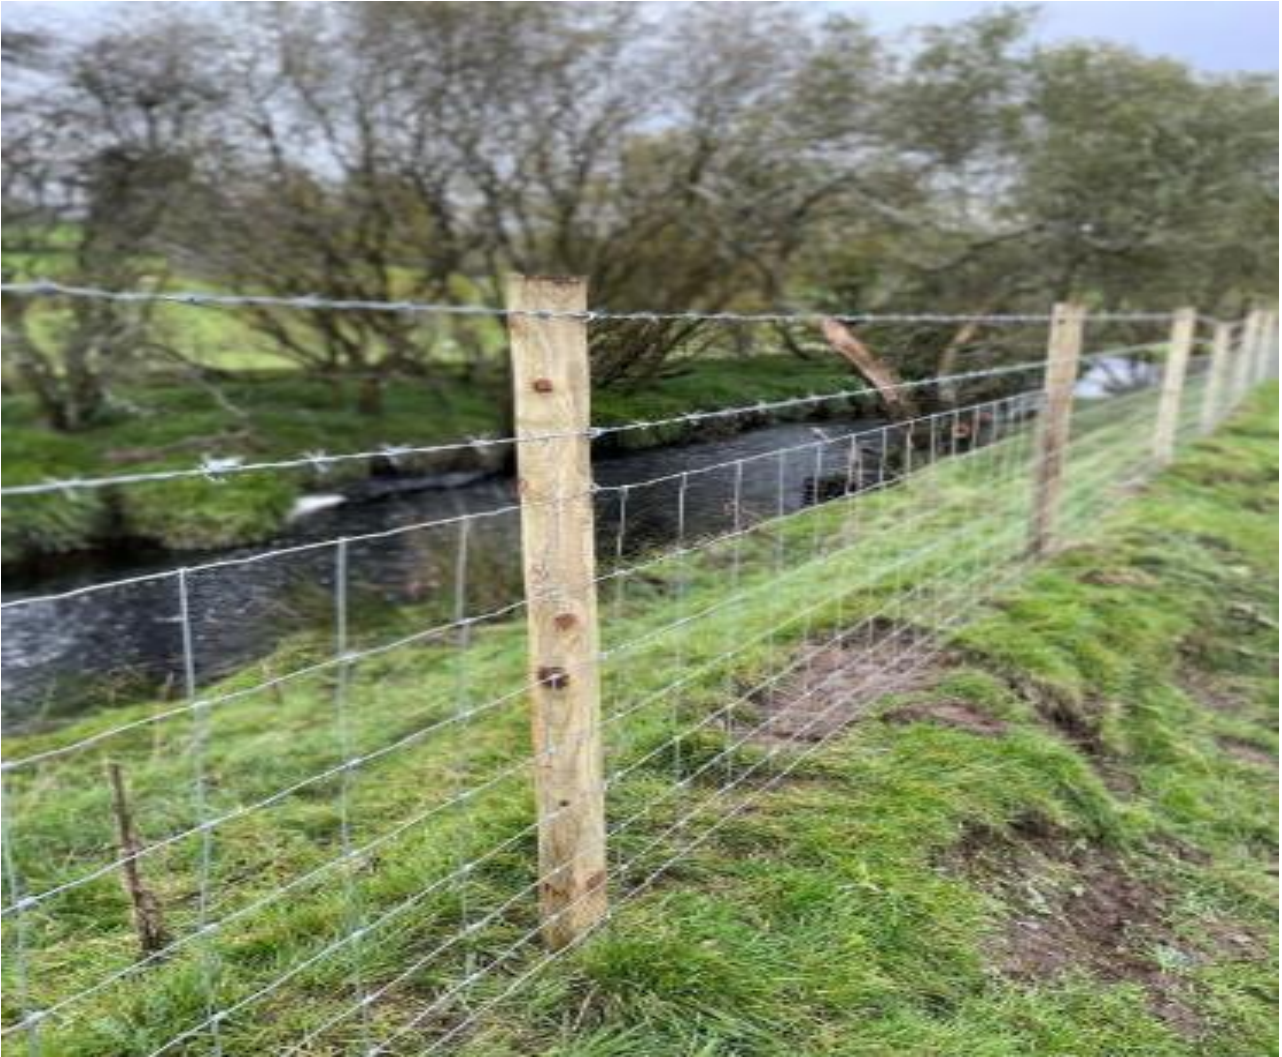
Figure 12: Riparian fencing installed along the Elatagh.

Riparian works along the Elatagh involved the installation of 3,360 m of fencing to create a riparian margin of varying distances from the river bank (2-20 m), with 28 single wooden unigates and 24 stiles for ease of access to the riparian margin. Approximately half of the area targeted had existing fencing, although much of this was in poor repair and was therefore replaced. In lieu of direct livestock access to the river, 22 x 80 gallon twin reservoir plastic drinking troughs connected to solar powered pump systems were provided to landowners as an offline drinking water source for livestock.

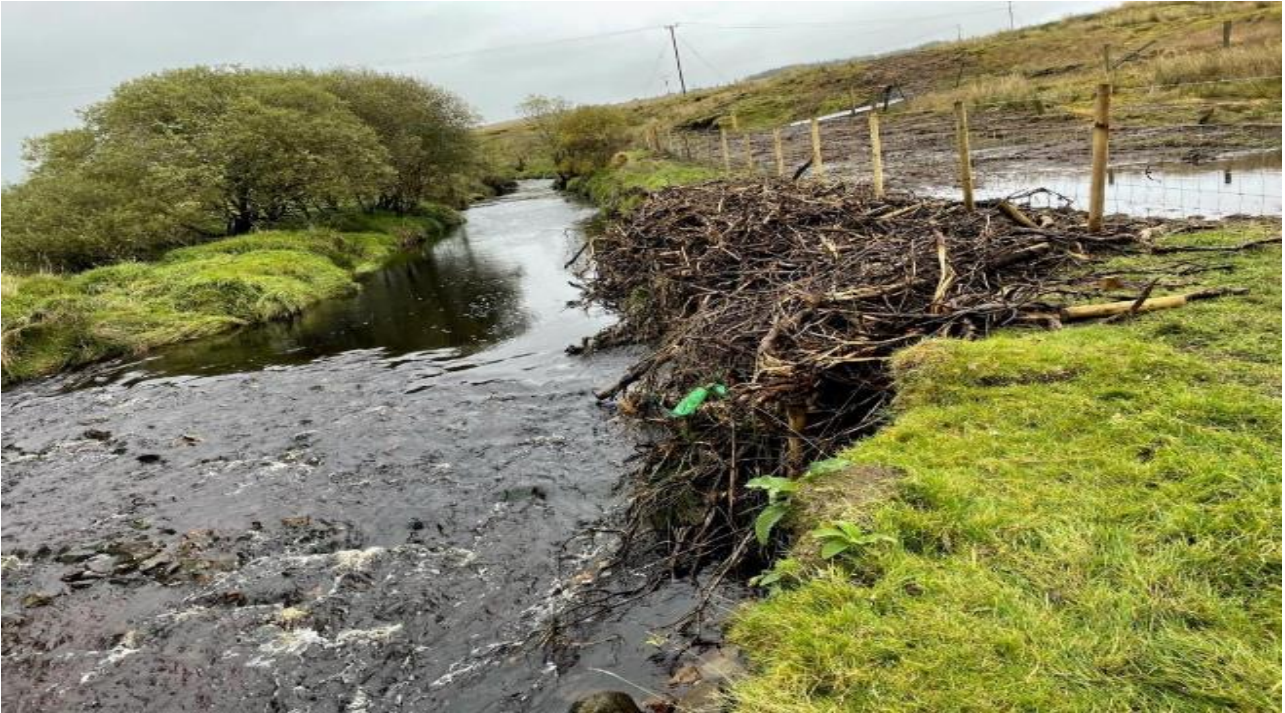
Figure 15: Area of Pinned woody Material installed with the Elatagh Restoration Works.

Pinning of woody material at six locations was required to protect the river banks from erosion, while also providing aquatic refugia for fish and a source of food and habitation for macroinvertebrates.

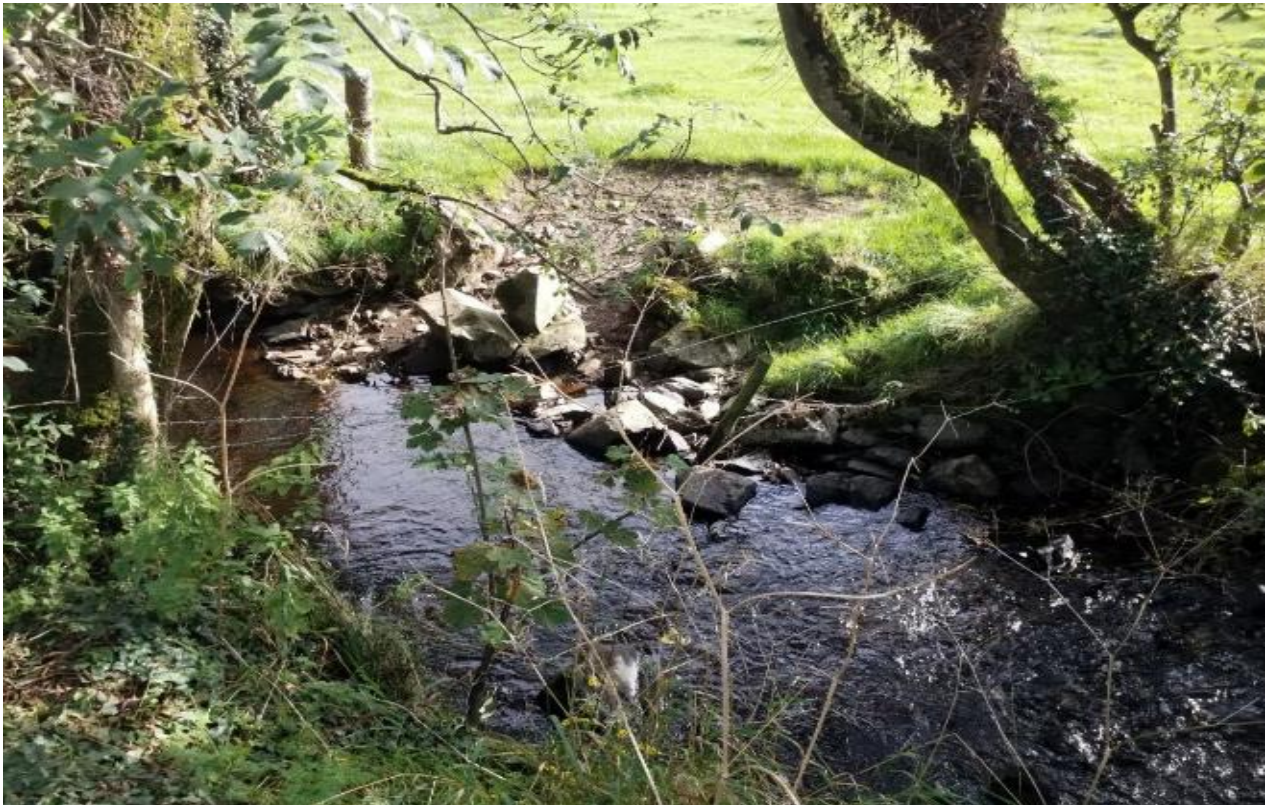
Site walkovers undertaken by CatchmentCARE in the prioritisation elements of the project highlighted evidence of livestock poaching the river at numerous points, leading to increased sedimentation from bank erosion. Introduction of elevated levels of sediment into the channel was particularly evident toward the Dresnagh river’s confluence with the main stem of the Finn River, where significant build-up of silt had severely reduced the connectivity of the tributary to the main river.

Figure 18: Bank erosion on the Dresnagh from livestock poaching.

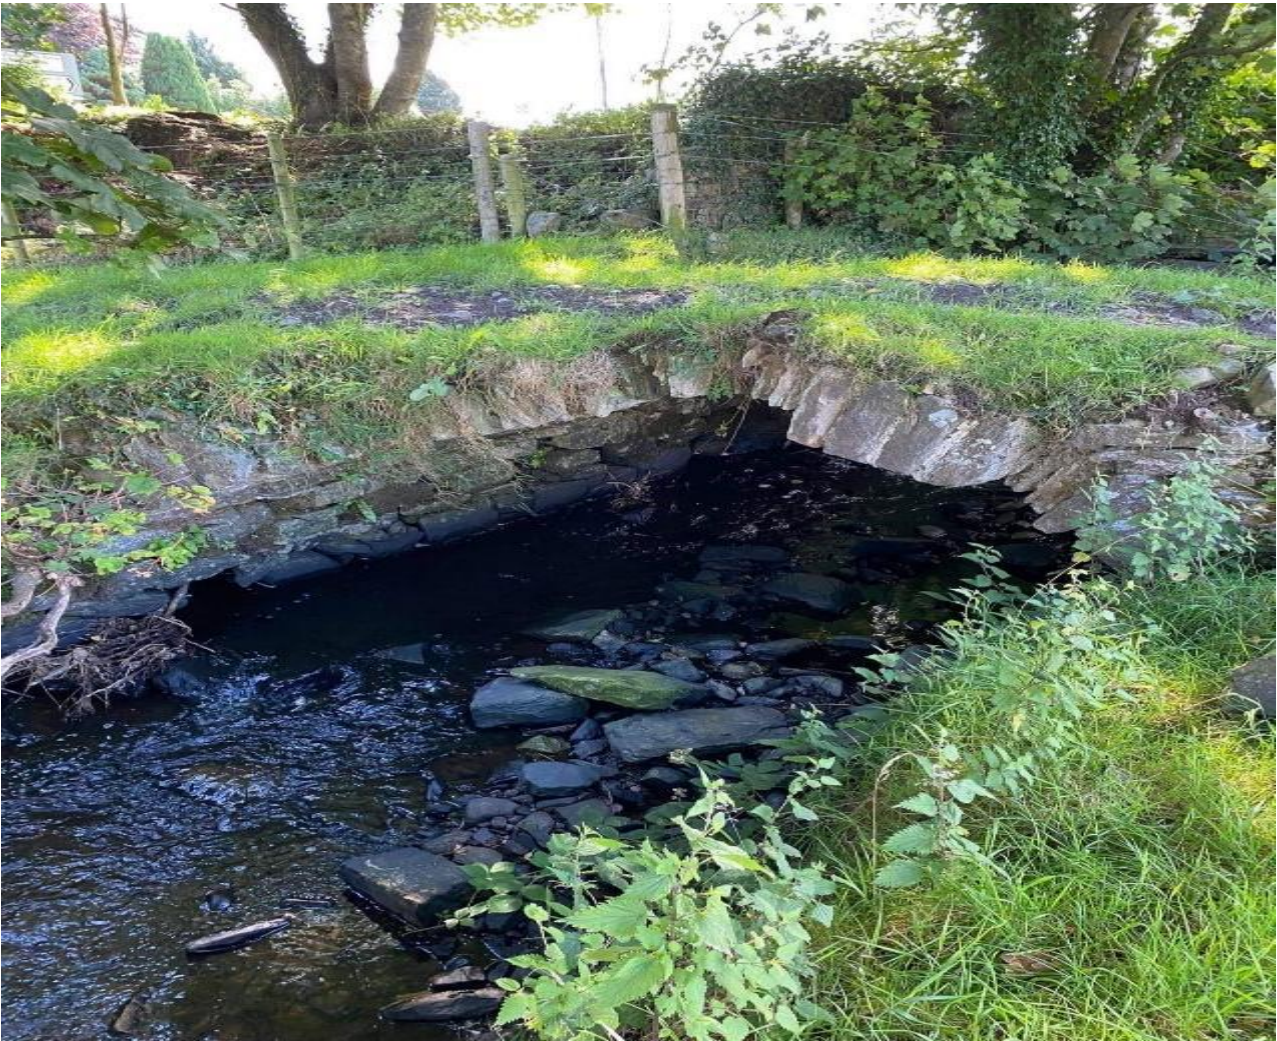
A small arched bridge with missing keystones was also identified. If this bridge was left in a state of disrepair there was a risk of it collapsing into the river and forming a complete barrier to upstream fish migration. Additionally, there was a risk of the river forming secondary channels during flood conditions if the bridge were to collapse.

Figure 19: Bridge at risk of collapsing into river, causing a potential barrier to fish migration.

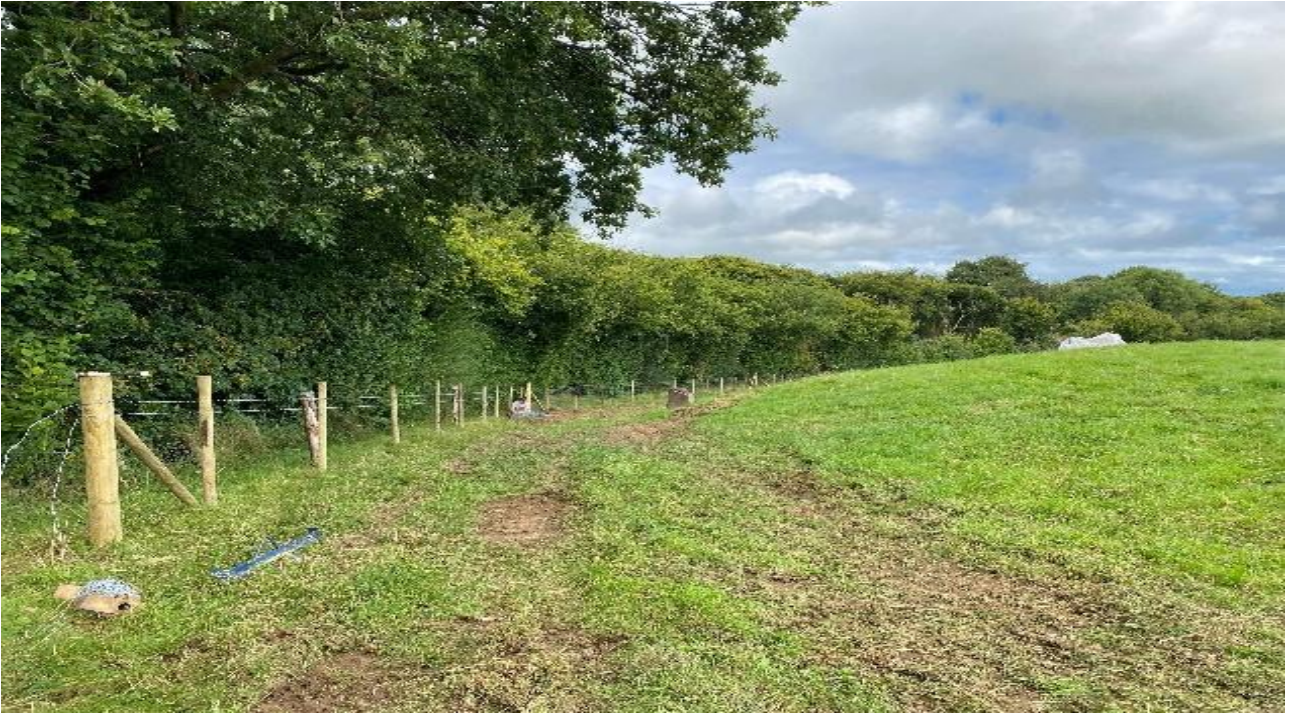
Figure 20: Fencing along the banks of the Dresnagh River.

A combination of new and replacement fencing, posts, splitters and strainers were installed along both banks of the Dresnagh river to a total length of 5,144 m. The majority of fencing was sheep wire.

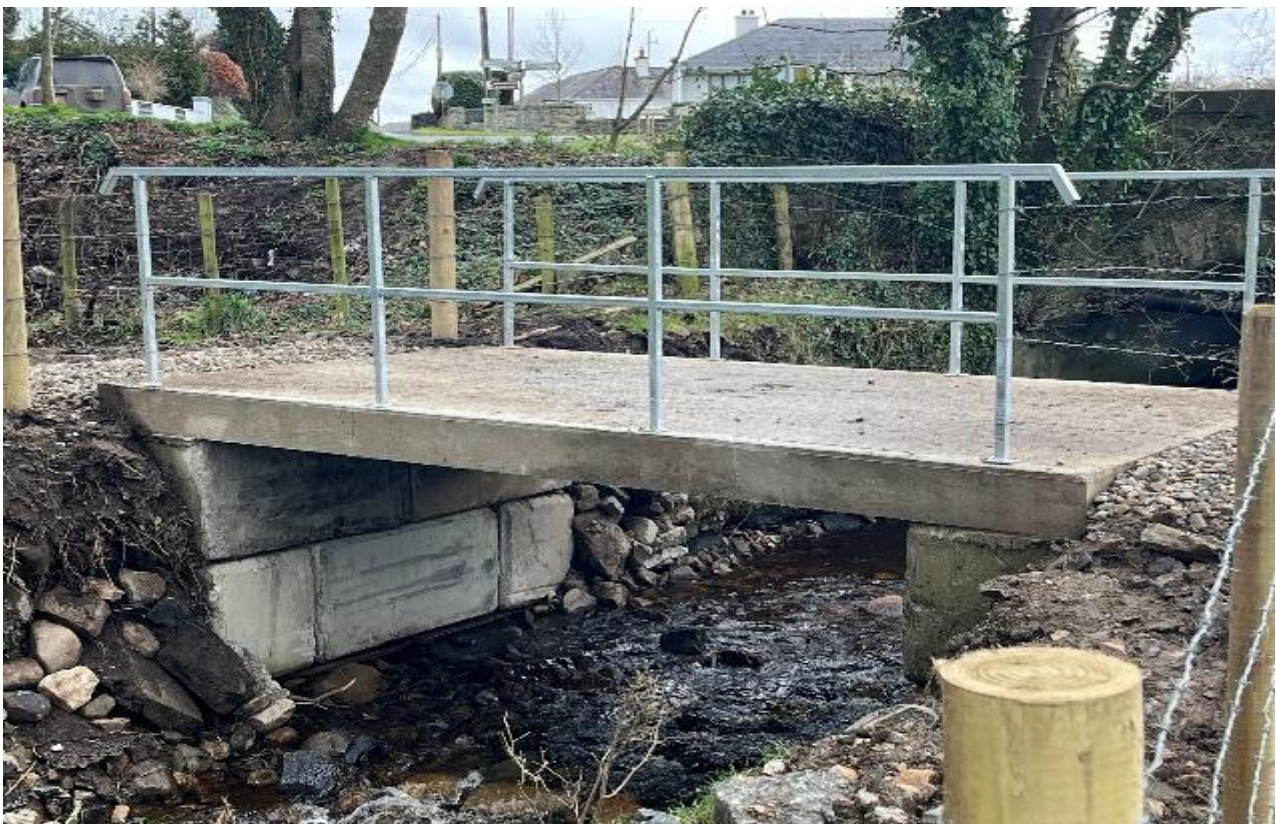
A small arched bridge with missing keystones threatened to collapse and form a complete barrier to upstream fish migration and would have forced the river to form secondary channels during flood conditions. Removal of this potential barrier was carried out and it was replaced with a clear span structure, strong enough to support tractor and trailer access while preserving the natural river bed below.

Figure 25: Clear span bridge replaced the potential barrier for landowner to access both fields on either side of river.

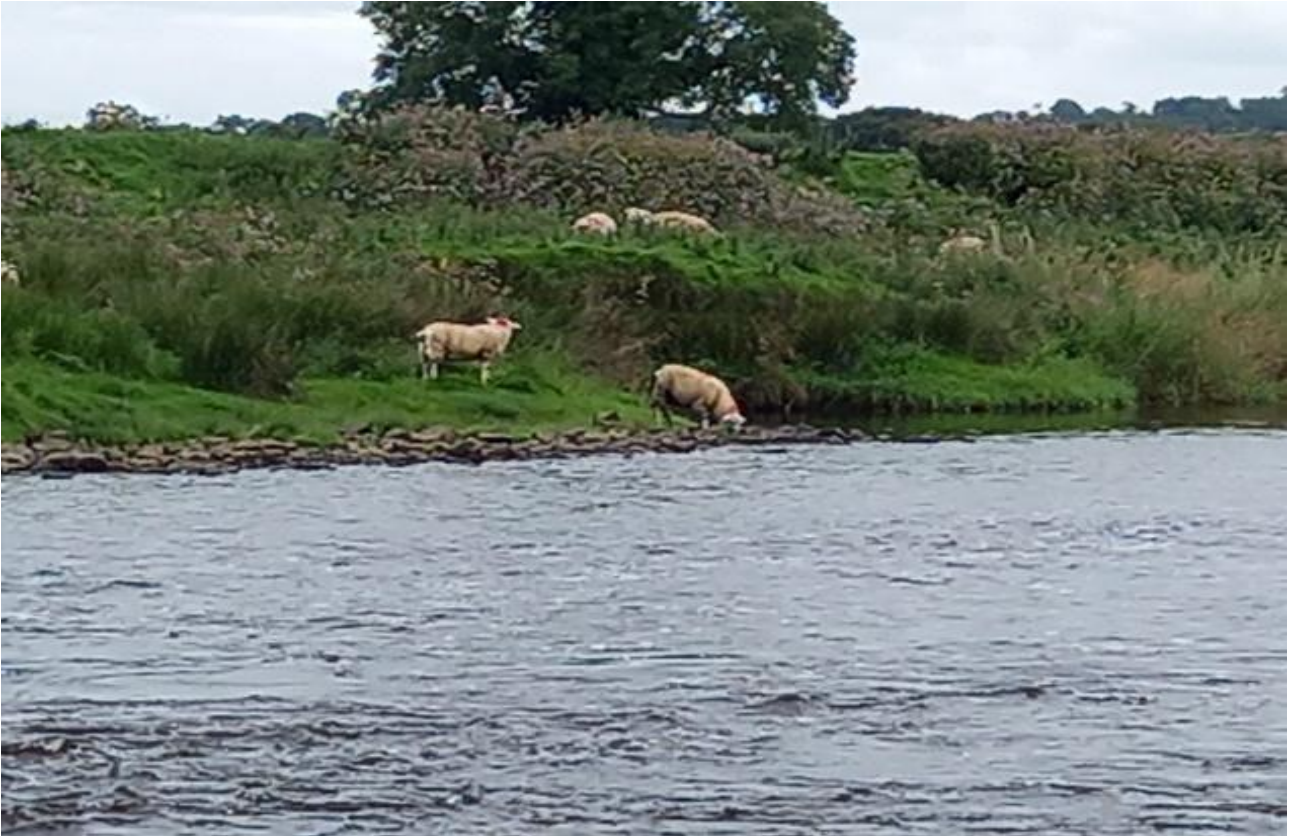
The stretch of river identified for works lacked a consistent riparian margin, with an absence of appropriate fencing and riparian margin between agricultural land and the River Finn. Domestic waste water, agricultural and forestry pressures within the Finn catchment mean that a riparian margin with appropriate surface area is essential for the absorption and degradation of chemical export run-off.

Figure 27: example of the inconsistent riparian margins, lack of fencing in areas allowing livestock to encroach the banks of the River Finn.

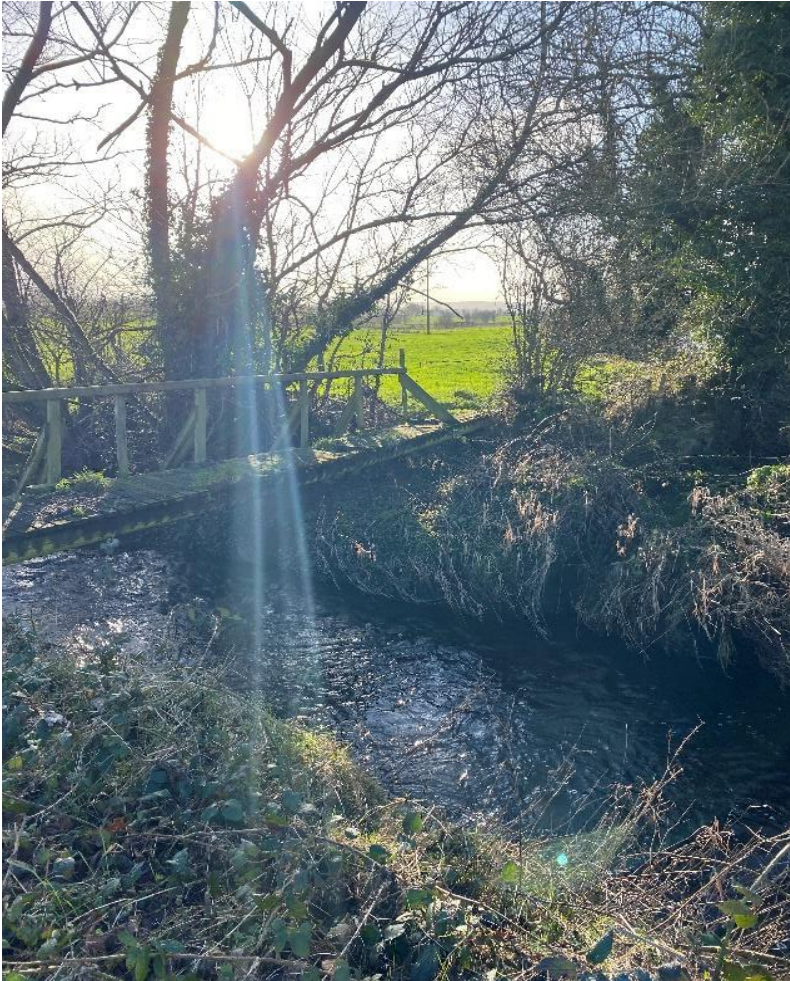
Issues were further compounded by the fact that the stretch of land running along the Finn 003 was owned by several landowners, adding an element of logistical difficulty in achieving landowner contact and buy-in. The cost of instream and riparian works was also dependent on the level of landowner buy-in and therefore length of the area targeted, which includes installation of fencing, stiles, unigates, water troughs and a footbridge in significant disrepair for farmers involved.

Figure 29: Footbridge degraded over time due to usage and weather.

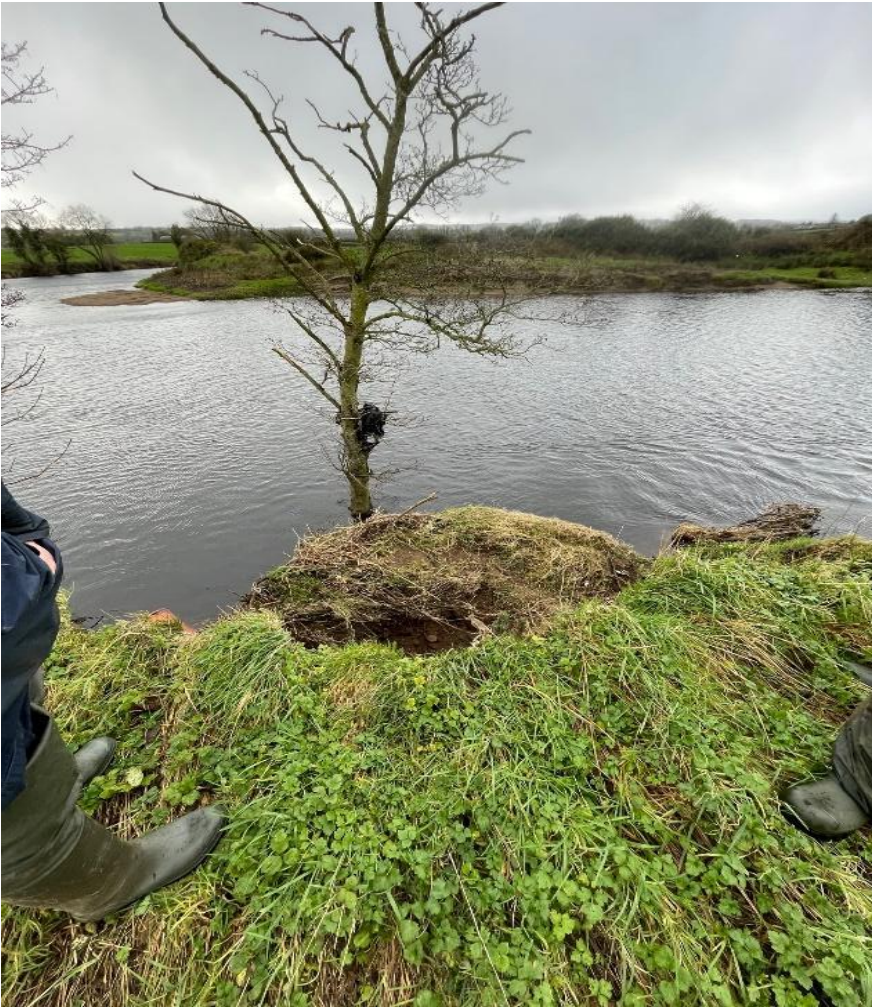
The main stem of the River Finn is subject to strong currents, which has resulted in heavily eroded river banks and loss of land along the Finn 003 stretch. In combination with this, low lying river banks mean that many areas are at high risk of flooding.

Figure 30: example of land loss landowners along the Finn 003 stretch were experiencing.

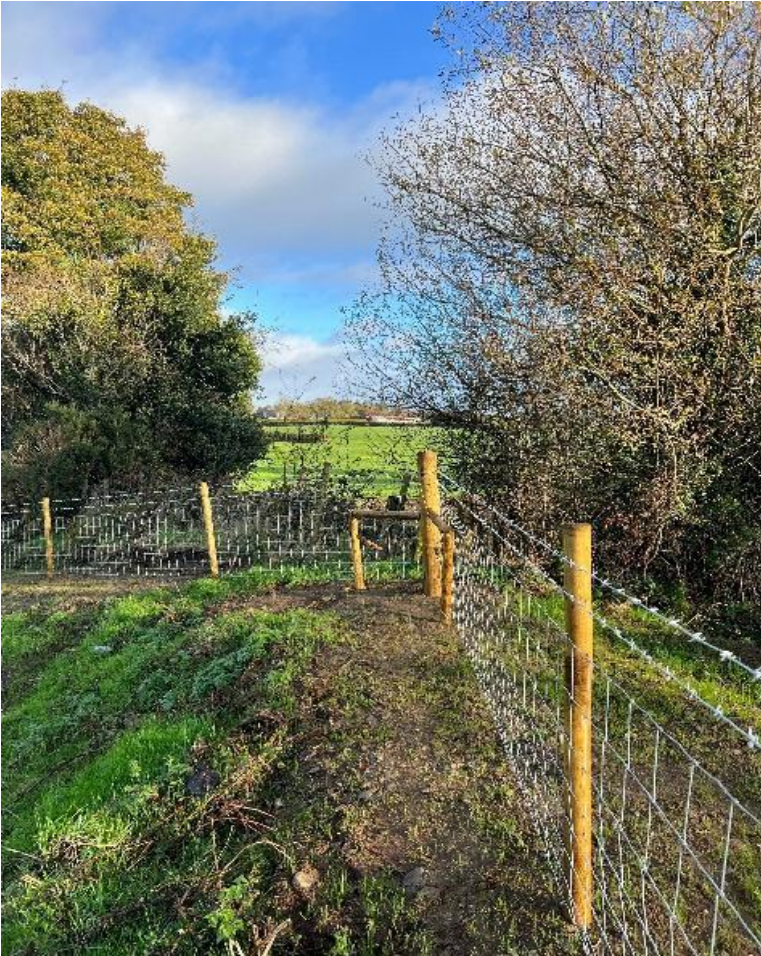
Figure 31: Fencing installed along the Finn 003 stretch.

In total 6,564 m of fencing, including 18 stiles, two 12ft galvanised sheep gates and one kissing gate for ease of access, posts, splitters and strainers was installed along the Finn 003 works, with removal of old fencing and provision made for disposal or return of old fencing to landowners if desired.

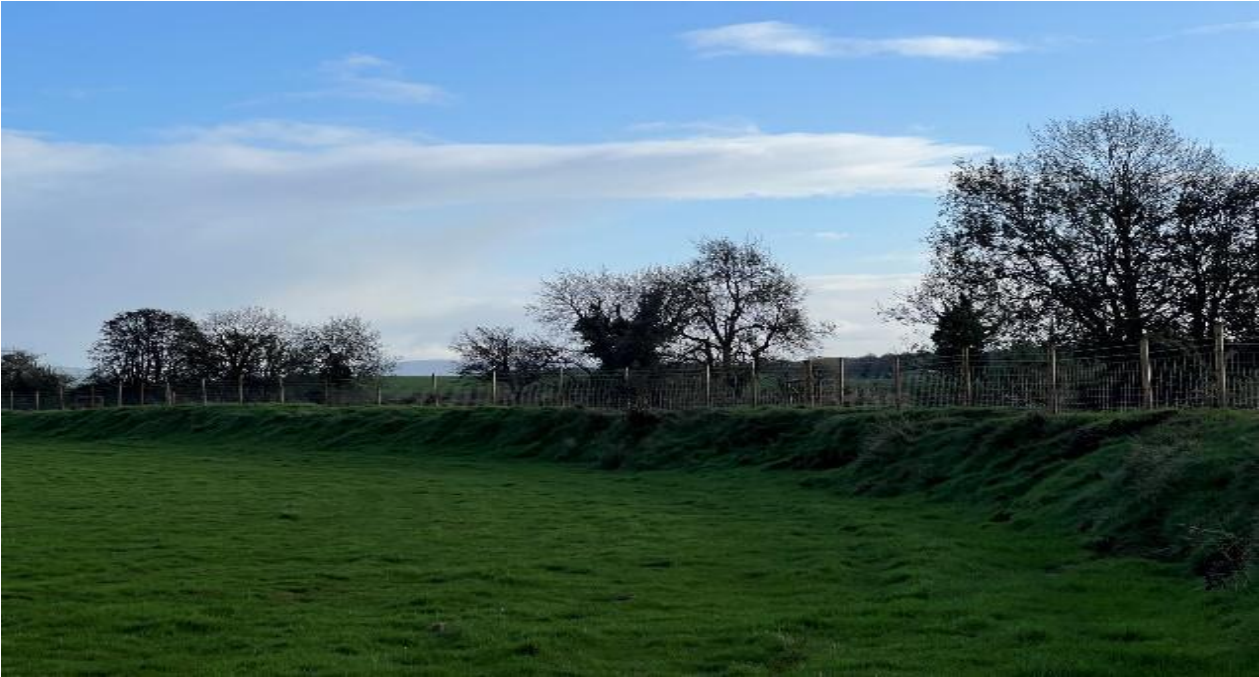
Figure 33: bank build up implemented along the Finn 003 stretch.

Riparian improvements along the Finn 003 stretch also involved the repair of low lying and eroded river banks. A 221 m² area of artificial embankment (berm) was repaired on the south bank of the river between the coordinates 54.789145N -7.679260W and 54.788275N -7.677887W.

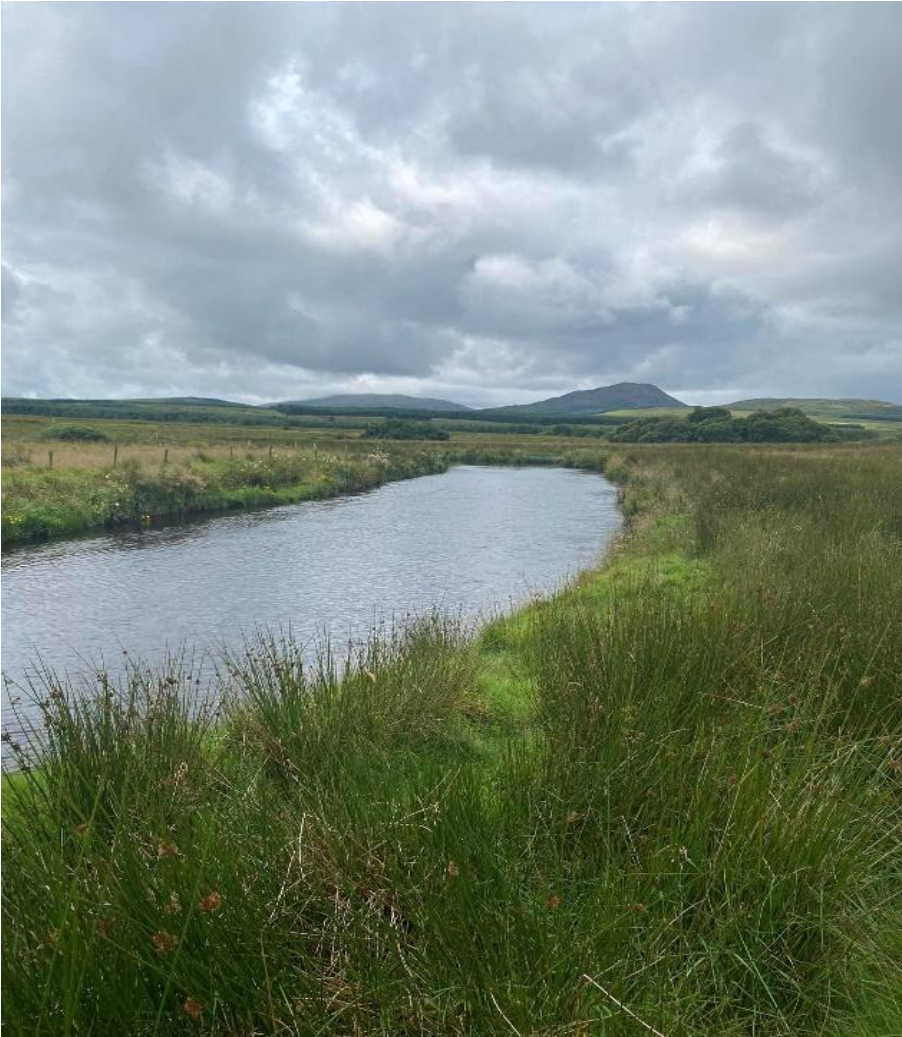
The riparian margin along the Finn 001 stretch, where present, is inadequate at 1 m or less, with inadequate or no fencing on both sides of the river. A lack of native deciduous trees present also means livestock can directly access the river, causing poaching on both banks.

Figure 37: Along the Finn 001 Stretch there was a severe lack of riparian margins and fencing.

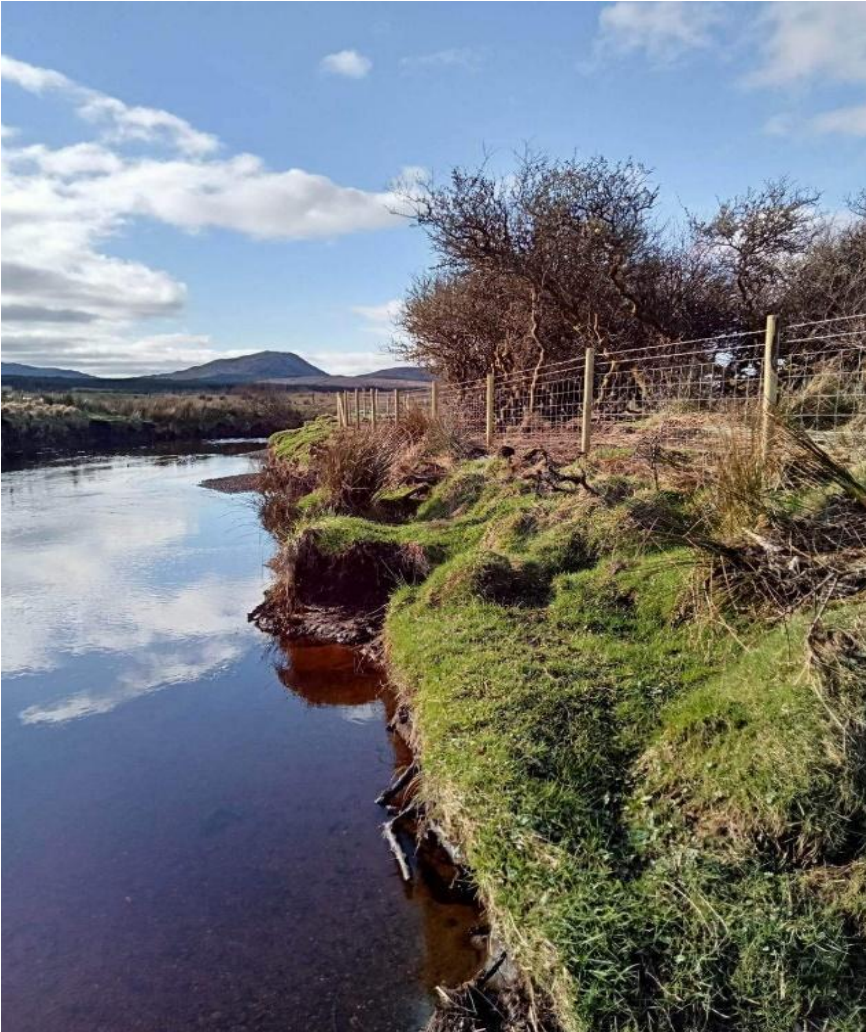
Figure 38: Fencing installed along the Finn 001 stretch to prevent livestock poaching.

A total of 1,200 m of fencing, including posts, splitters and strainers where appropriate was installed, creating a riparian margin along the Finn 001 stretch at distances varying from 2–5 m from the river bank. As approximately half of the targeted area had existing fencing, fencing works included installation of new fencing, as well replacement of old fencing no longer fit for purpose.

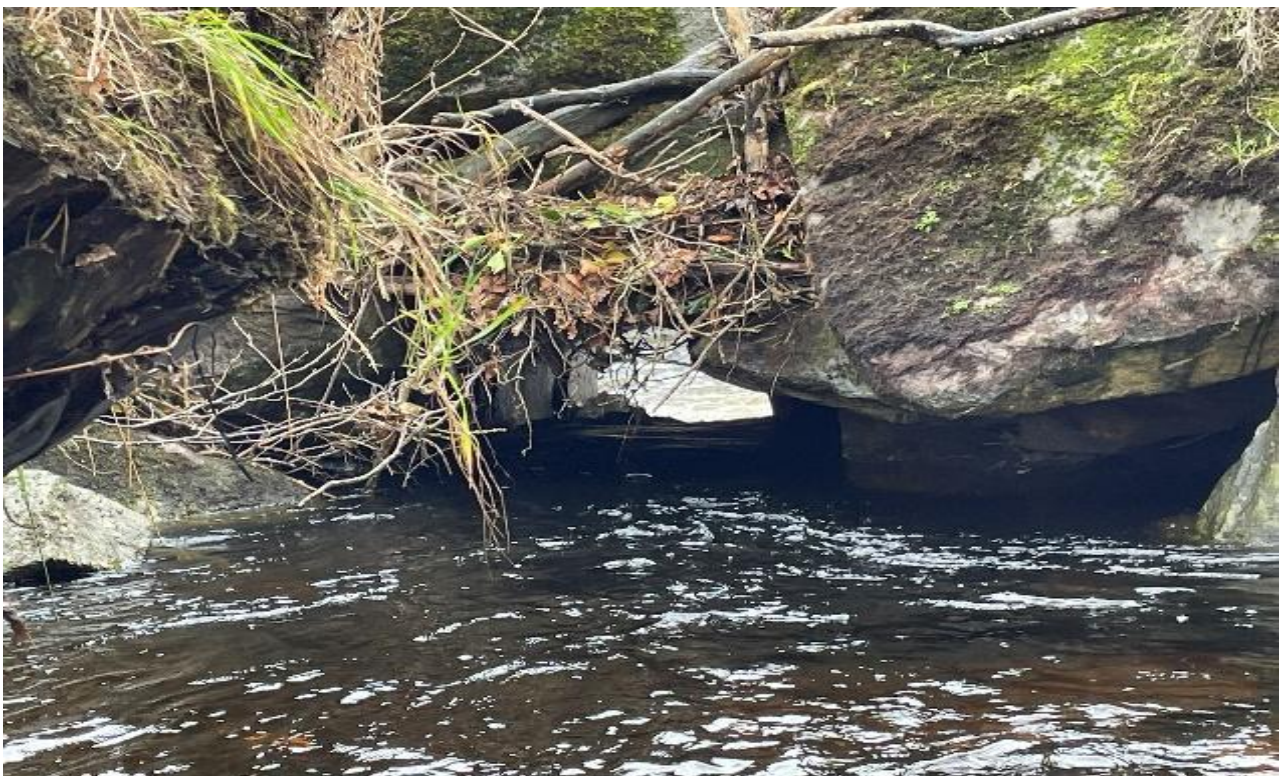
A concrete pipe culvert overlain with crushed boulder and rubble used for agricultural purposes posed a potential barrier to fish migration. The weight of overlying rock was gradually crushing the pipe culvert and would have eventually collapsed and blocked the river entirely. The pipe culvert itself was 1 m in diameter; a fraction of the river's natural 7 m width, meaning the river could not flow freely during times of high flow. This led to the creation of secondary channels around the existing barrier structure into the adjacent field, with silt build-up accumulating upstream of the barrier and compacting spawning gravel.

Figure 40: downstream view of the Rough Burn Barrier to fish migration.

Instream improvement works involved the removal of the pipe culvert and overlain crushed boulder which acted as a potential barrier to fish migration. This structure was replaced with a more suitable clear span bridge, allowing landowner access with machinery and livestock, while preventing the river from cutting secondary channels into the river banks.

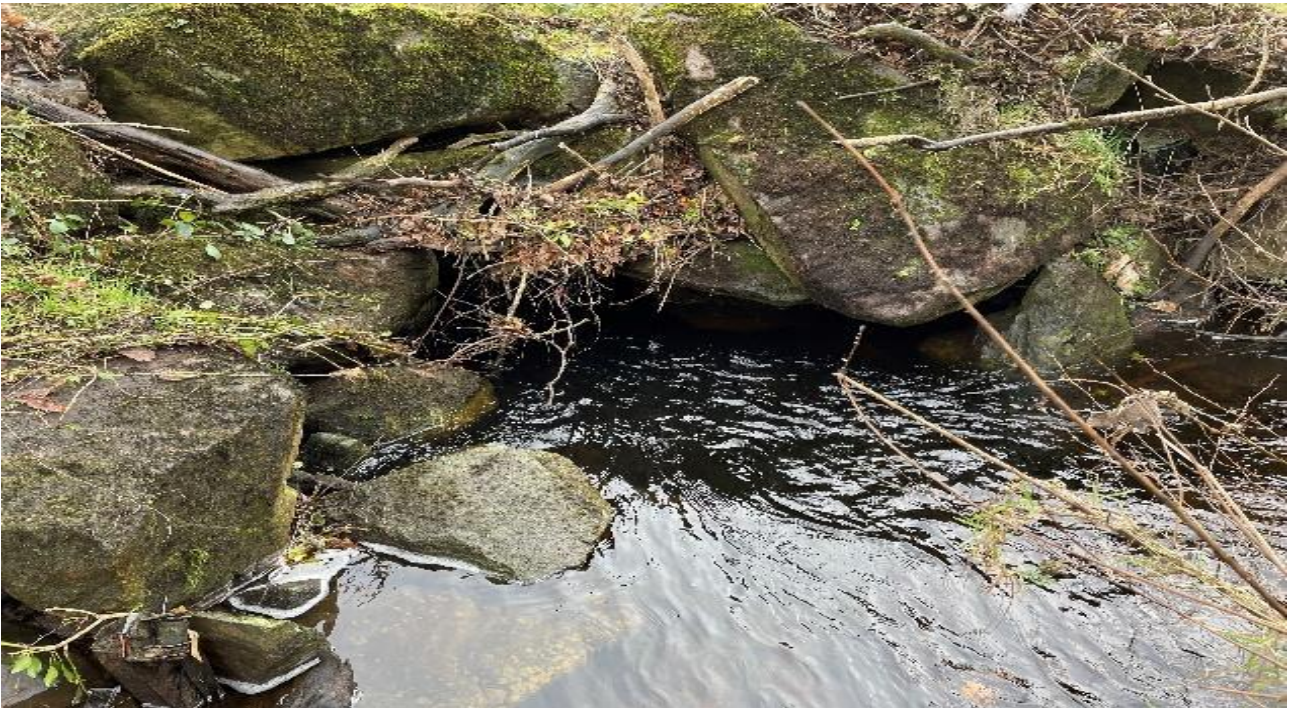
Figure 41: upstream view of the Rough Burn Barrier to fish migration.

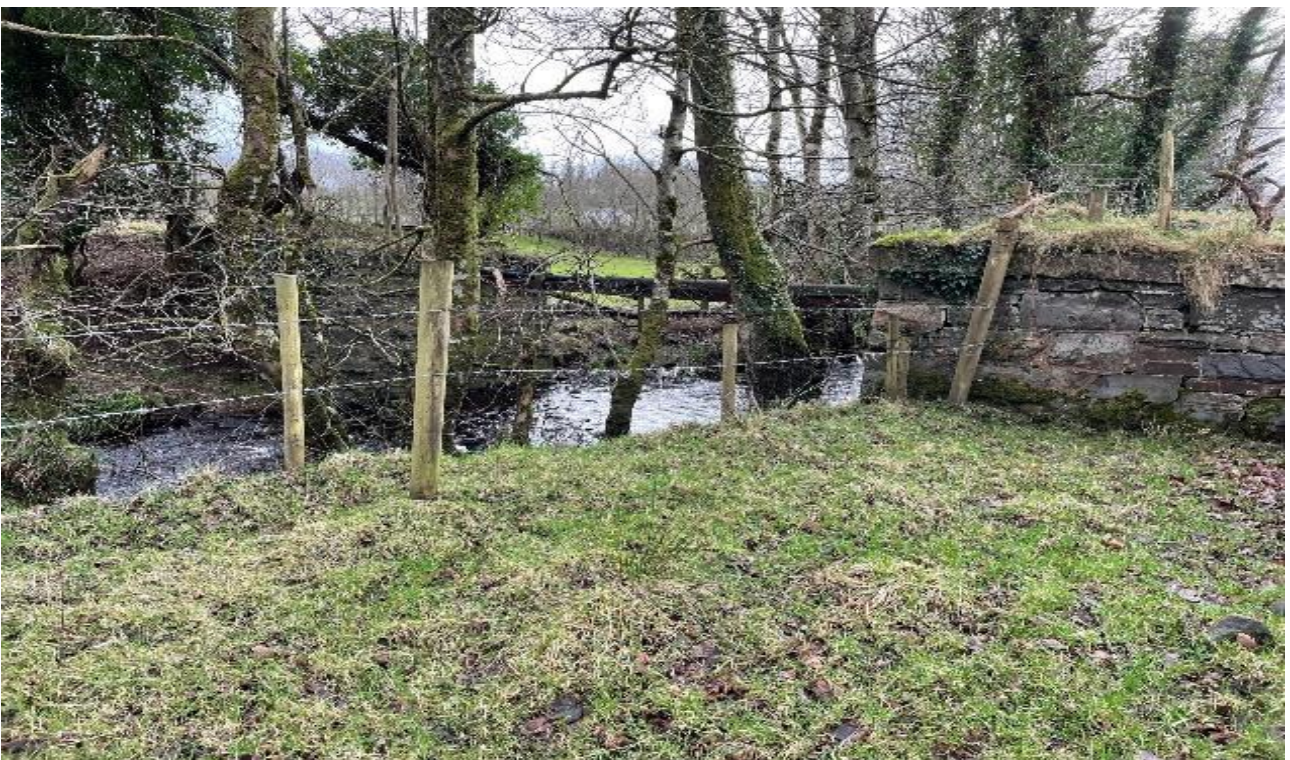
Another issue this site faced was intermittent/poor fencing along its length with small or non-existent riparian margins in areas. Site walkovers undertaken by CatchmentCARE in the prioritisation element of the project highlighted evidence of livestock entering the river at numerous points and significant poaching of the stream banks.

Figure 42: example of the poor fencing along the Rough burn
