CatchmentCARE River Restoration Works Report

MARCH 2023

Community Actions for Resilient Ecosystems

A project supported by the European Union's INTERREG VA Programme, managed by the Special EU Programmes Body (SEUPB).

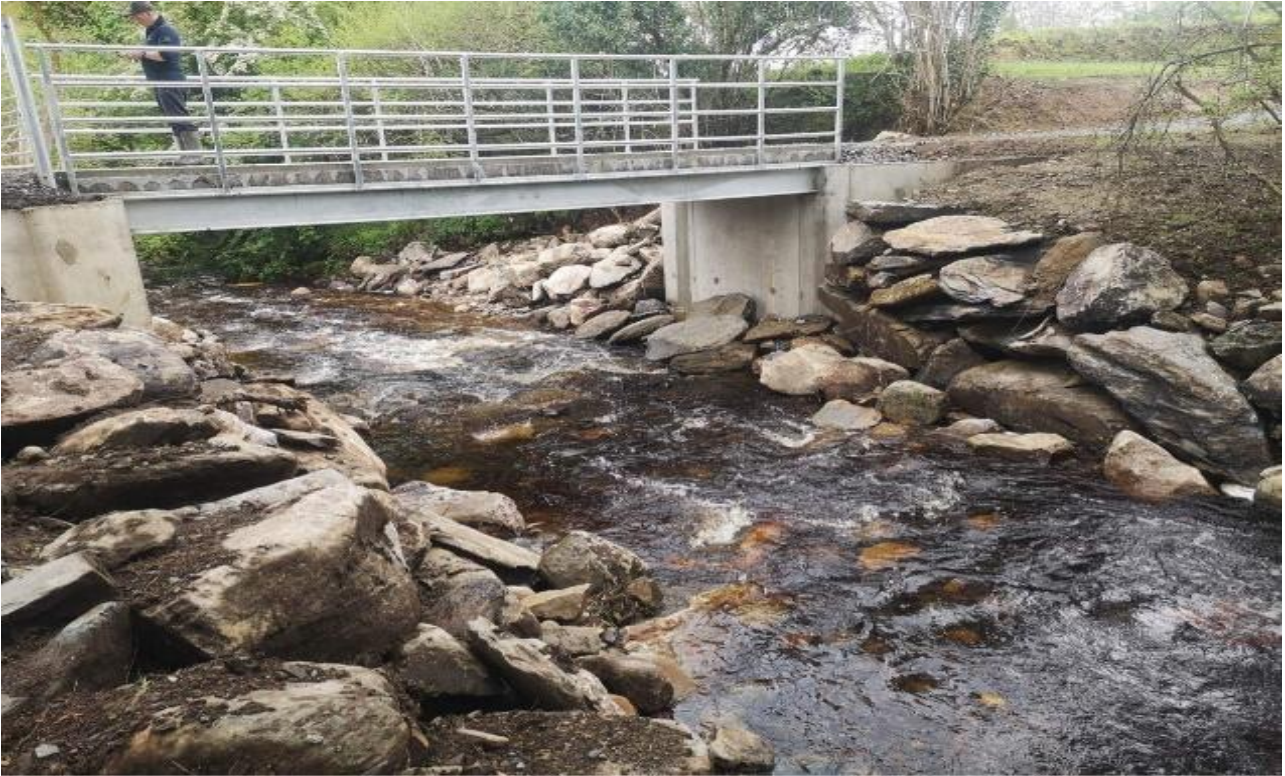
Figure 46: Clear span bridge replaced the prior crossing which was a barrier to fish migration.

Instream improvement works involved the removal of the pipe culvert and overlain crushed boulder which acted as a potential barrier to fish migration. This structure was replaced with a more suitable clear span bridge, allowing landowner access with machinery and livestock, while preventing the river from cutting secondary channels into the river banks.

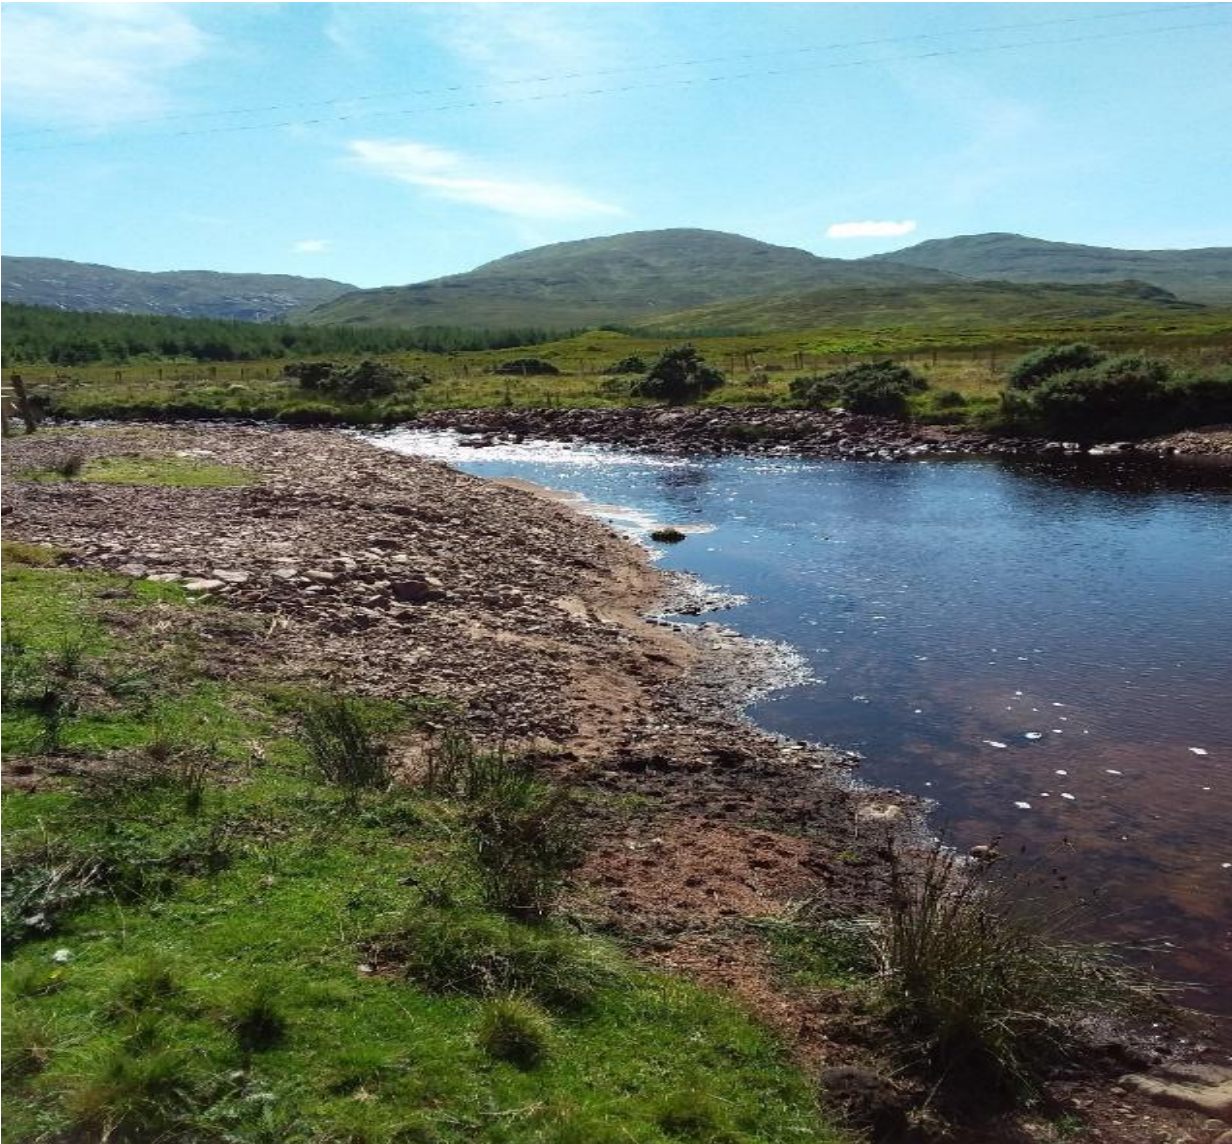
Figure 52: a large bank of high and dry gravel had been regraded into the river to provide spawning habitat for salmonids.

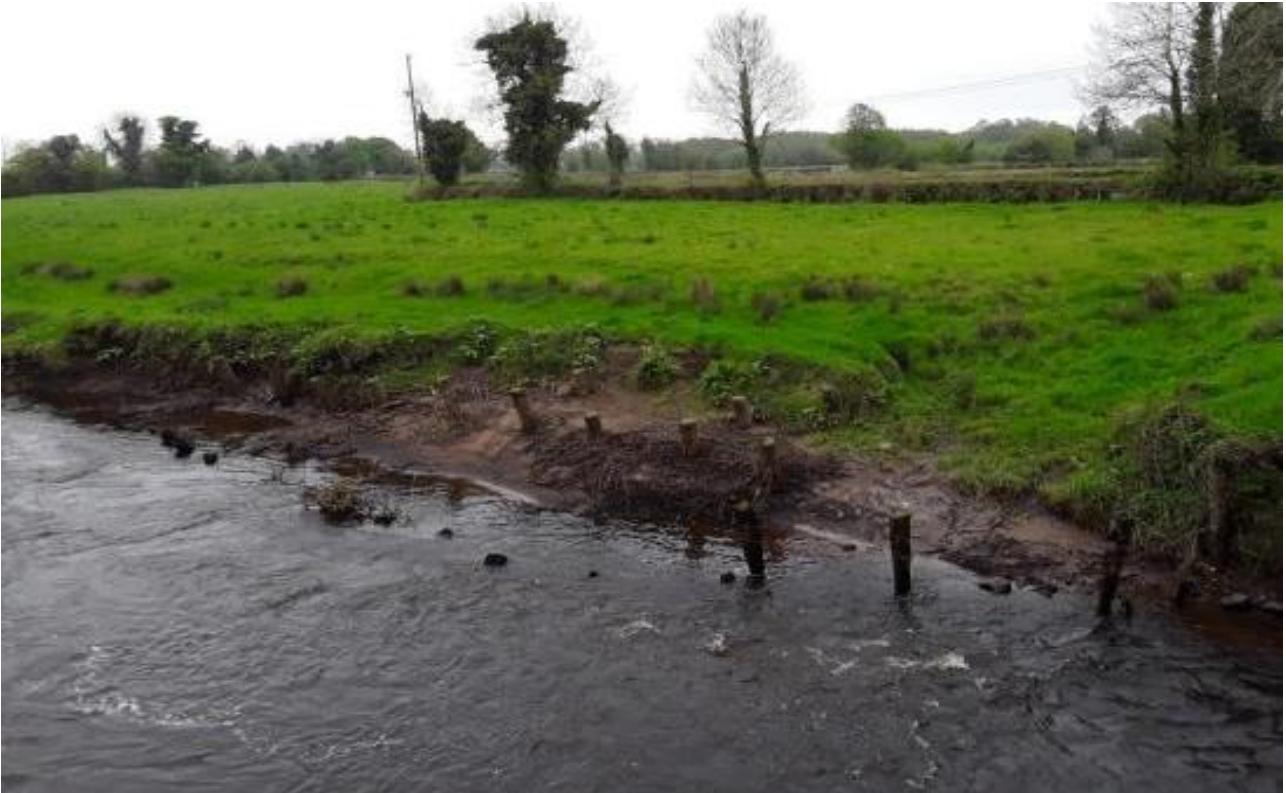
Figure 54: Cattle poaching site due to no riparian fencing or buffer zone.

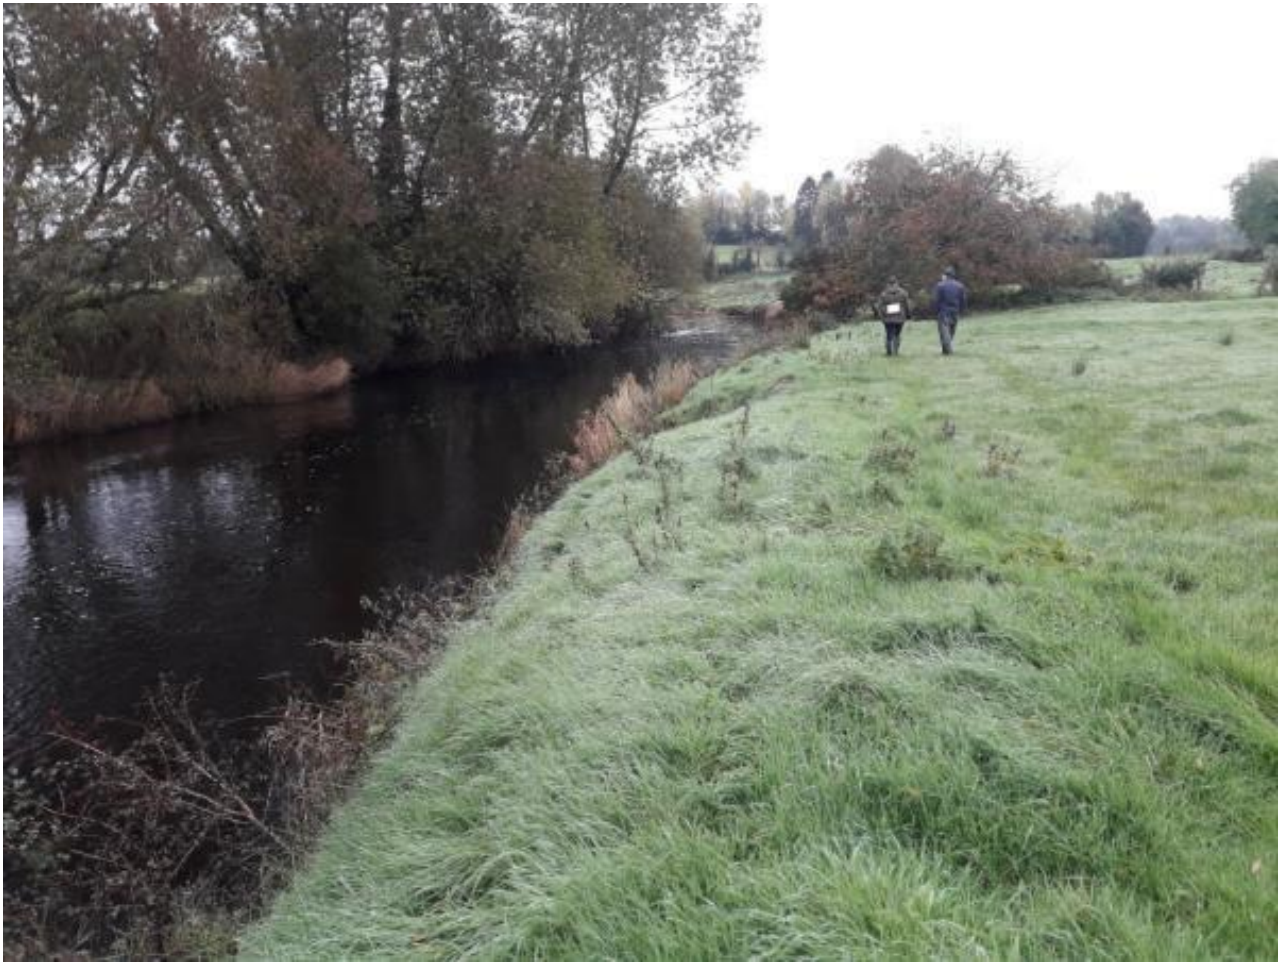
Figure 58: Lack of Riparian buffer zone and diversity of vegetation.

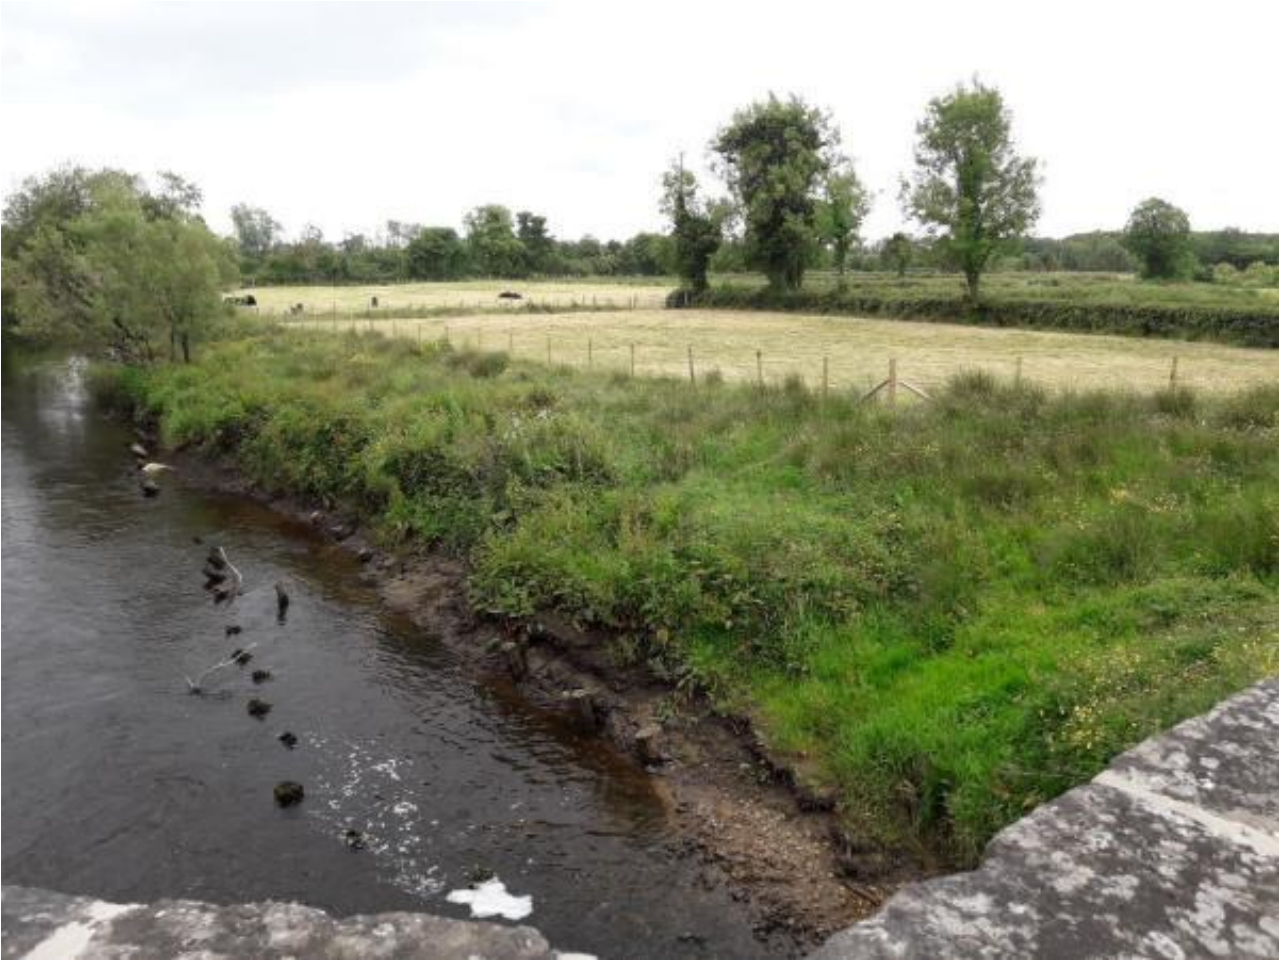
Figure 64: Two years after fencing has been installed. Riparian vegetation growth in the buffer zone is now evident, helping to stabilise the river bank and reduce excess sediment input.

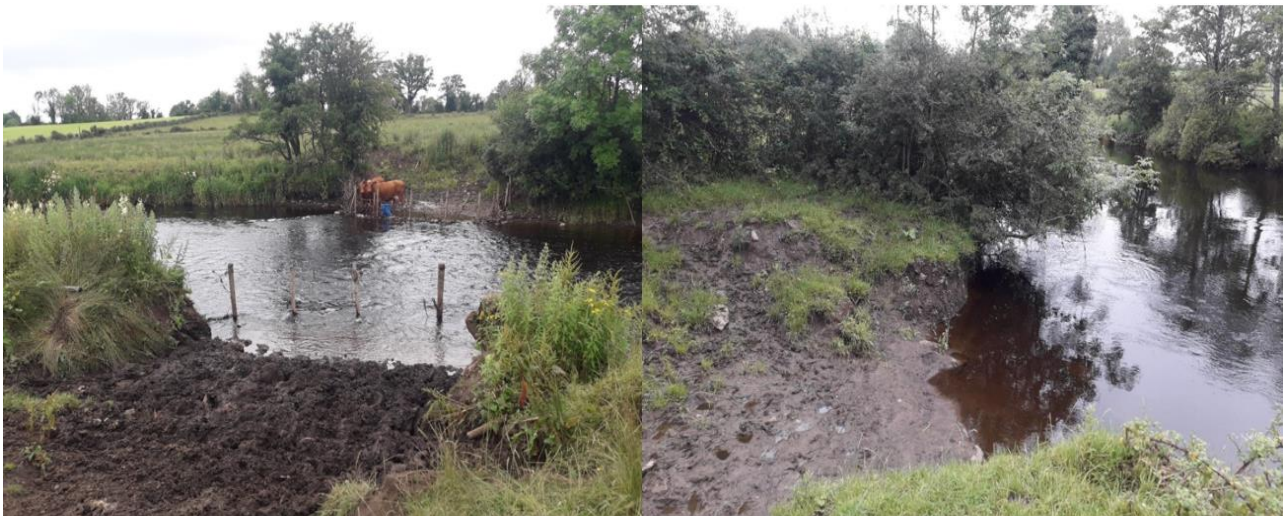
Figure 67: Cattle poaching area with large inputs of sediment, lack of riparian buffer and lack of diversity of riparian vegetation.

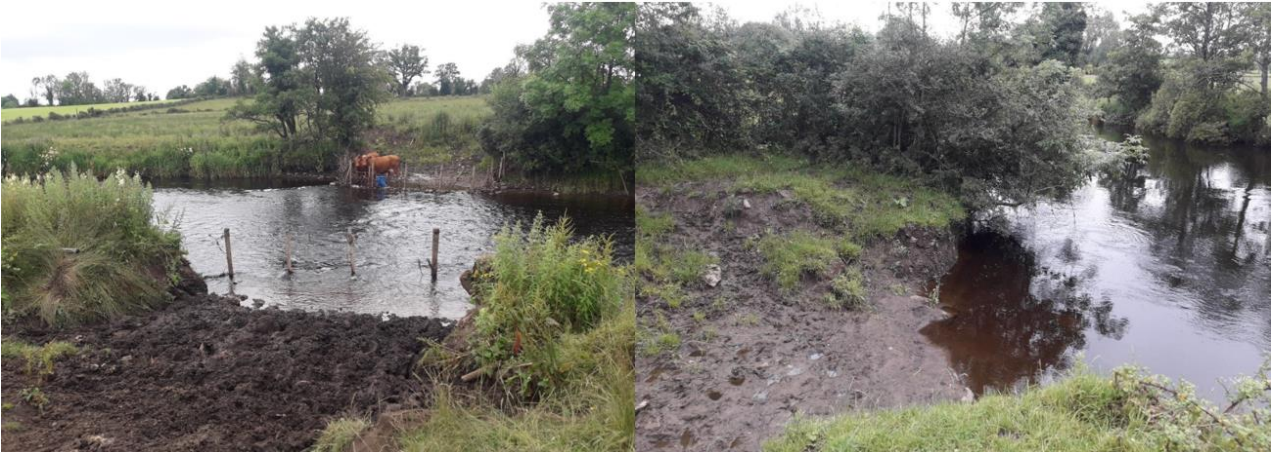
Figure 76: Cattle poaching area with large inputs of sediment, lack of riparian buffer and lack of diversity of riparian vegetation.

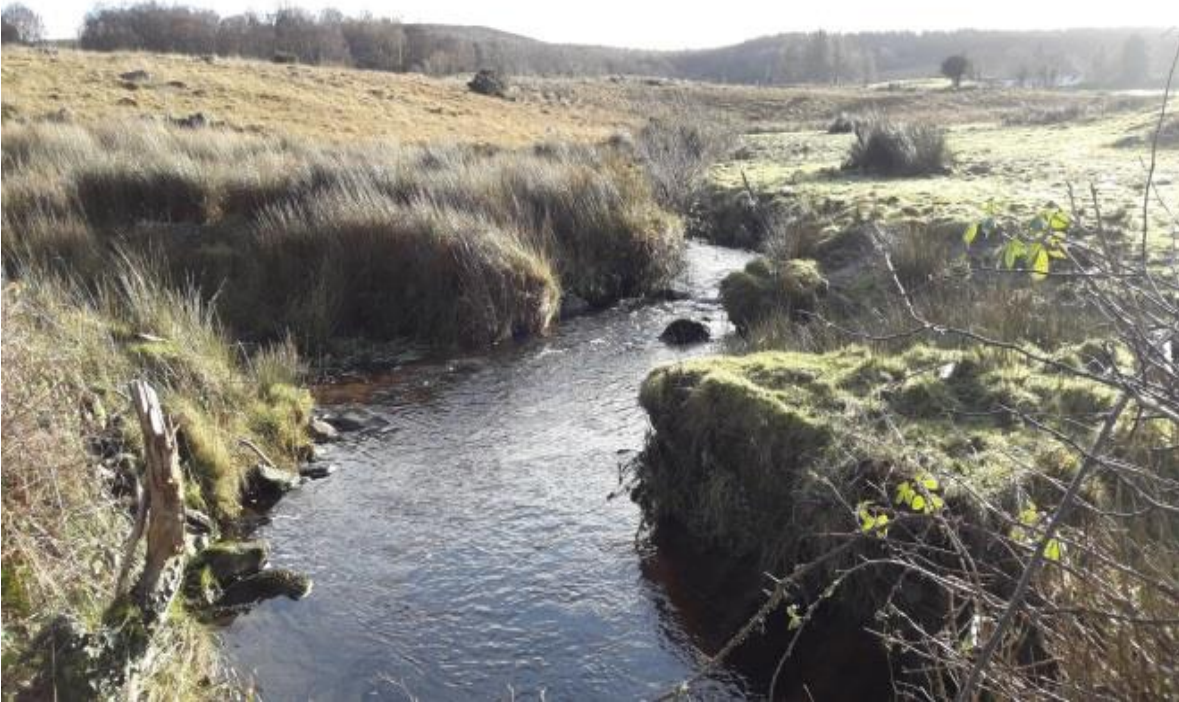
Figure 85. Before. Lack of riparian vegetation and livestock ingress to channel.

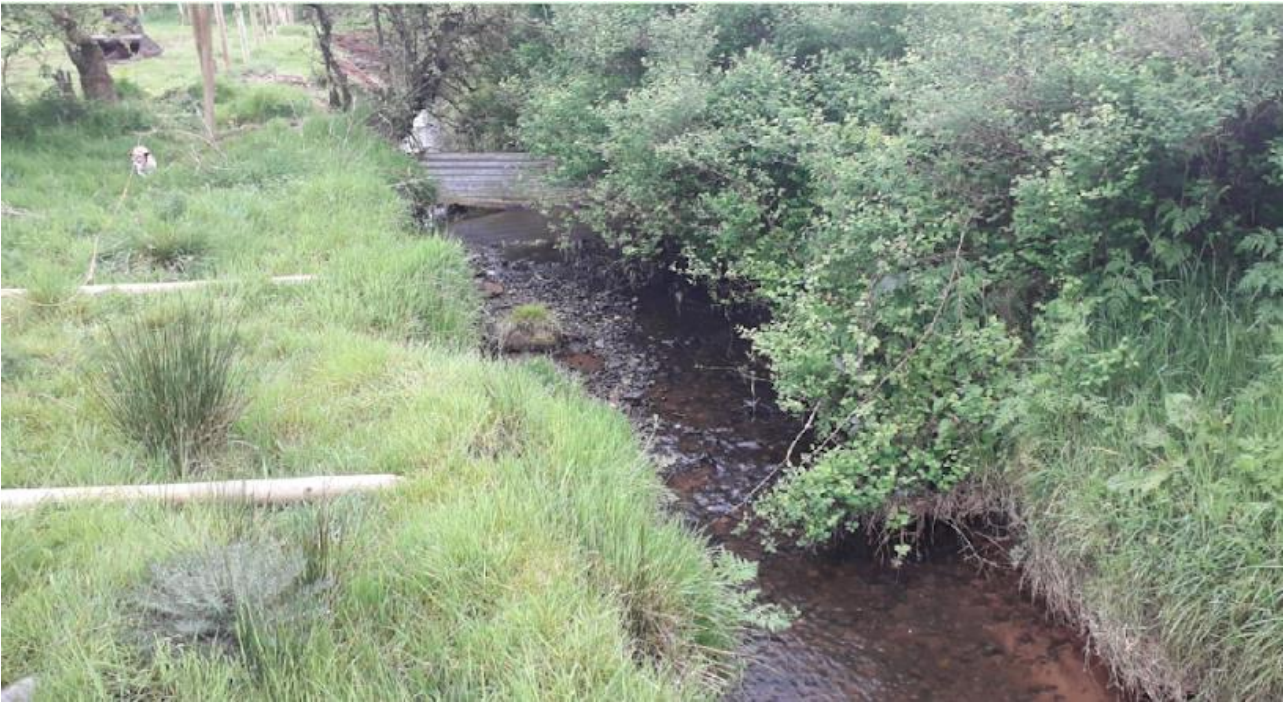
Figure 138: Lack of riparian margin along stretch

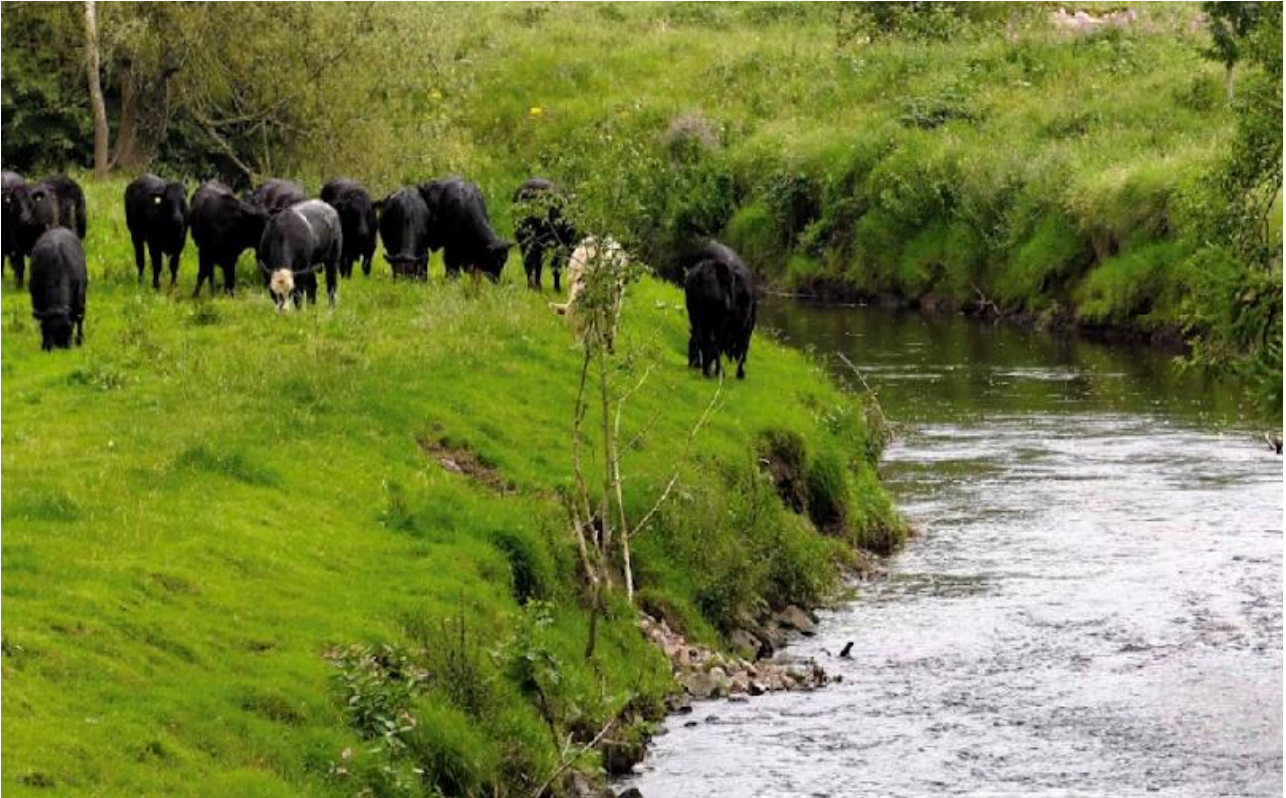
Figure 141: Lack of fencing allowing cattle to poach banks

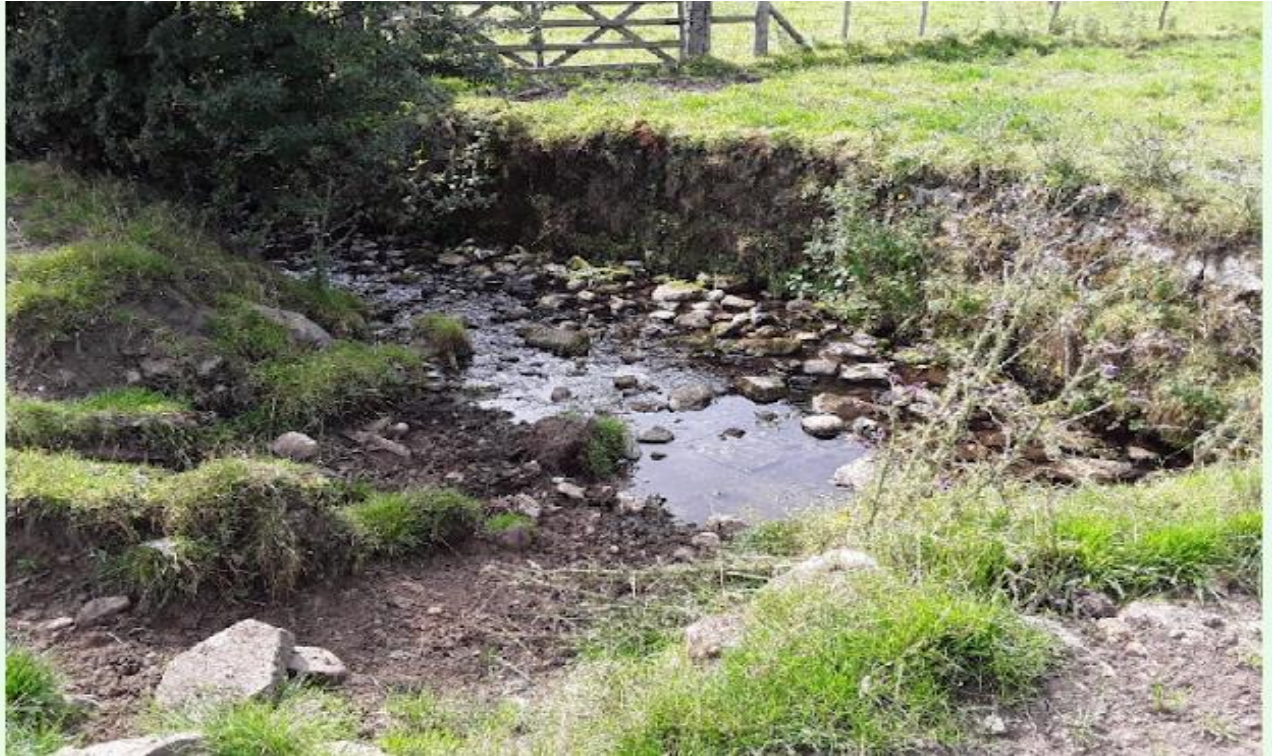
Figure 143: eroded river bank caused by cattle poaching

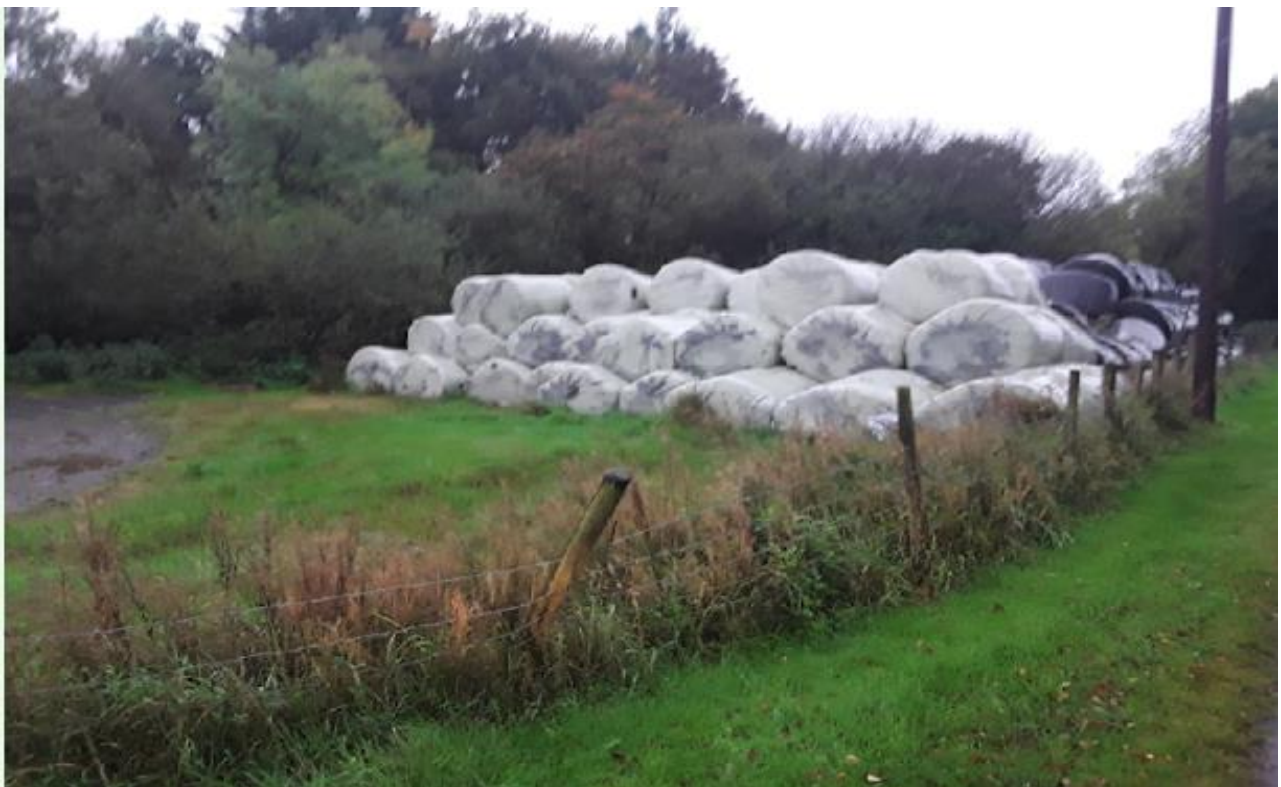
Figure 144: Silage bales stored at waters edge leaching in to watercourse
