CatchmentCARE River Restoration Works Report

MARCH 2023

Community Actions for Resilient Ecosystems

A project supported by the European Union's INTERREG VA Programme, managed by the Special EU Programmes Body (SEUPB).

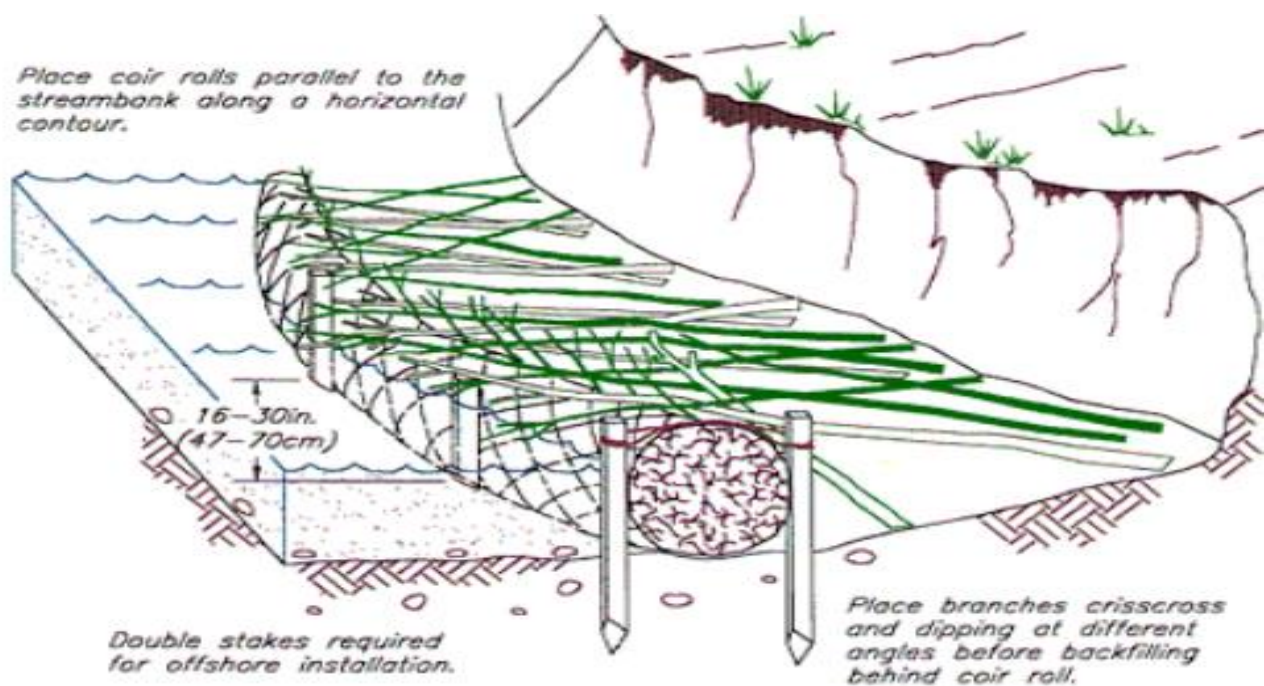
Two locations along the northern banks of the Cummirk River were identified as needing soft engineering measures to mitigate erosion. Coir mats and rock rolls were installed to a height of 1 m at the toe of the eroding eastern/north eastern bank face to alleviate erosion pressures and prevent undercutting.

Figure 5: Schematic of soft engineering implemented with coir roll toe emplacement.

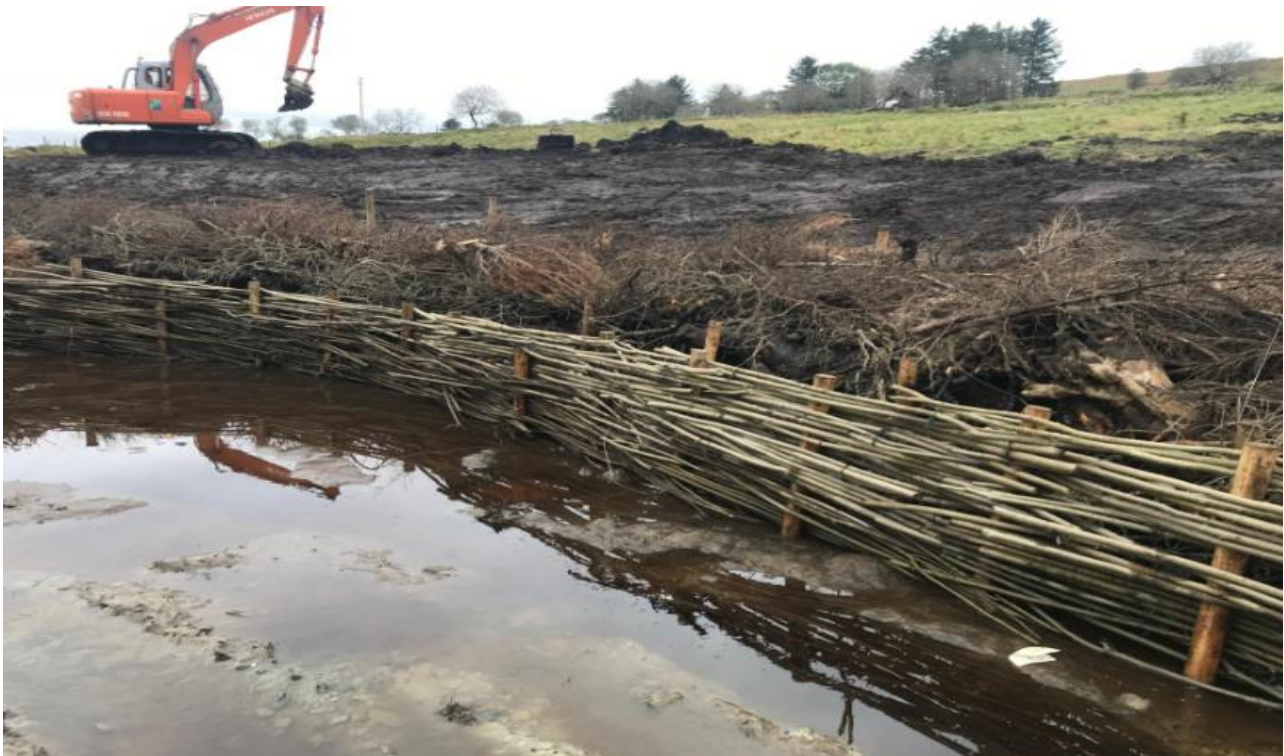
Above and in front of the coir matting, pinned woody material was installed using onsite felled tree material, packed brushwood fascine and brash material (weathered Christmas trees). Brash and brushwood fascine material was densely packed to deflect the rivers flow, and the weaving of live willow cuttings onto the face of the soft engineering measures ensured its binding to the bank face soil, preventing further erosion.

Figure 6: Live Willow weave wall with brash material packed behind.

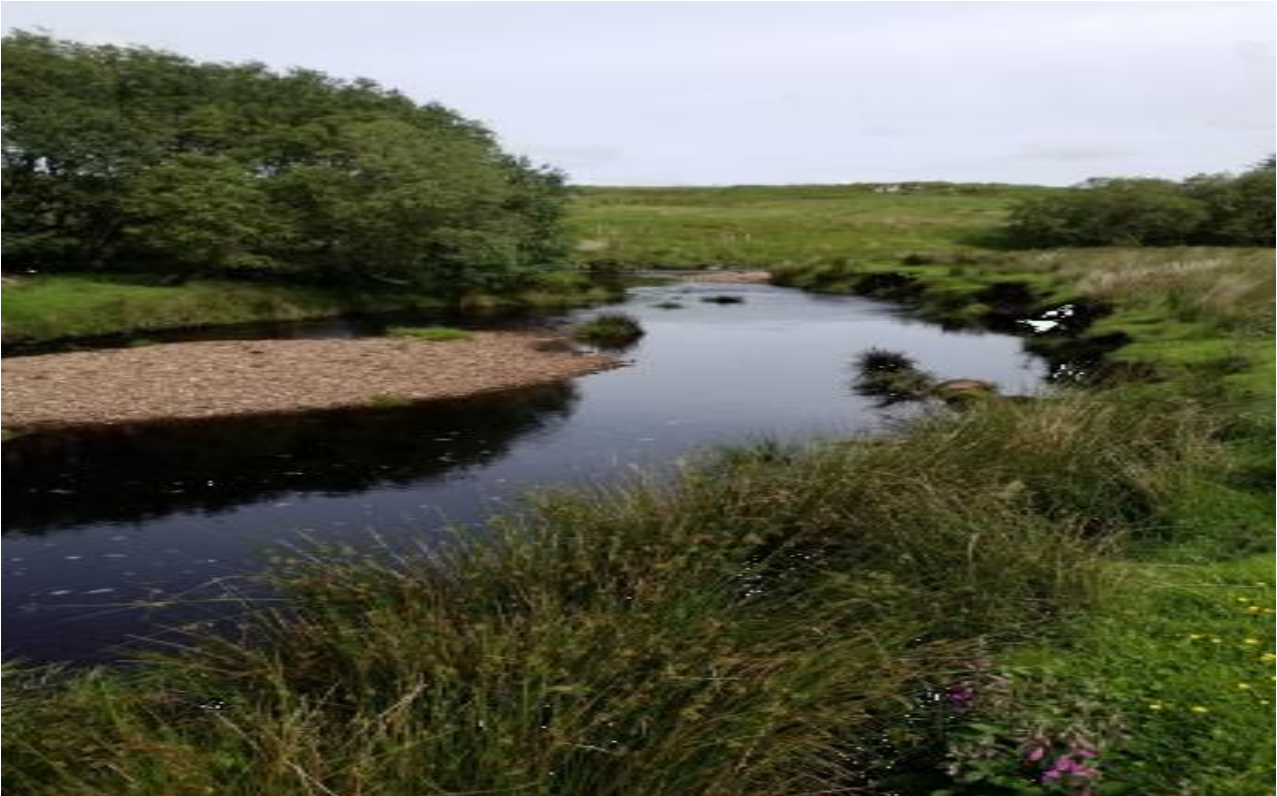
Within the river channel there was an absence of habitat variability, with a lack of pool-riffle-glide sequences and channel straightening at two locations. Significant amounts of “high and dry” gravel otherwise suitable for salmonid spawning was also compacted with silt.

Figure 11: High and Dry gravel within the river which is unsuitable for spawning habitat.

Regrading and local redistribution of “high and dry” gravel deposits increased available spawning habitat for salmonids, suitable even in low flow conditions. Additionally, several areas where gravel was compacted by sediment were regraded and cleaned of excess sediment to better allow its use by salmonids.

Gravel was regraded in such a way that the integrity of the river bank was not compromised or exposed to elevated levels of erosion. Gravel regrading has since supported increased redd counts along the Elatagh river.

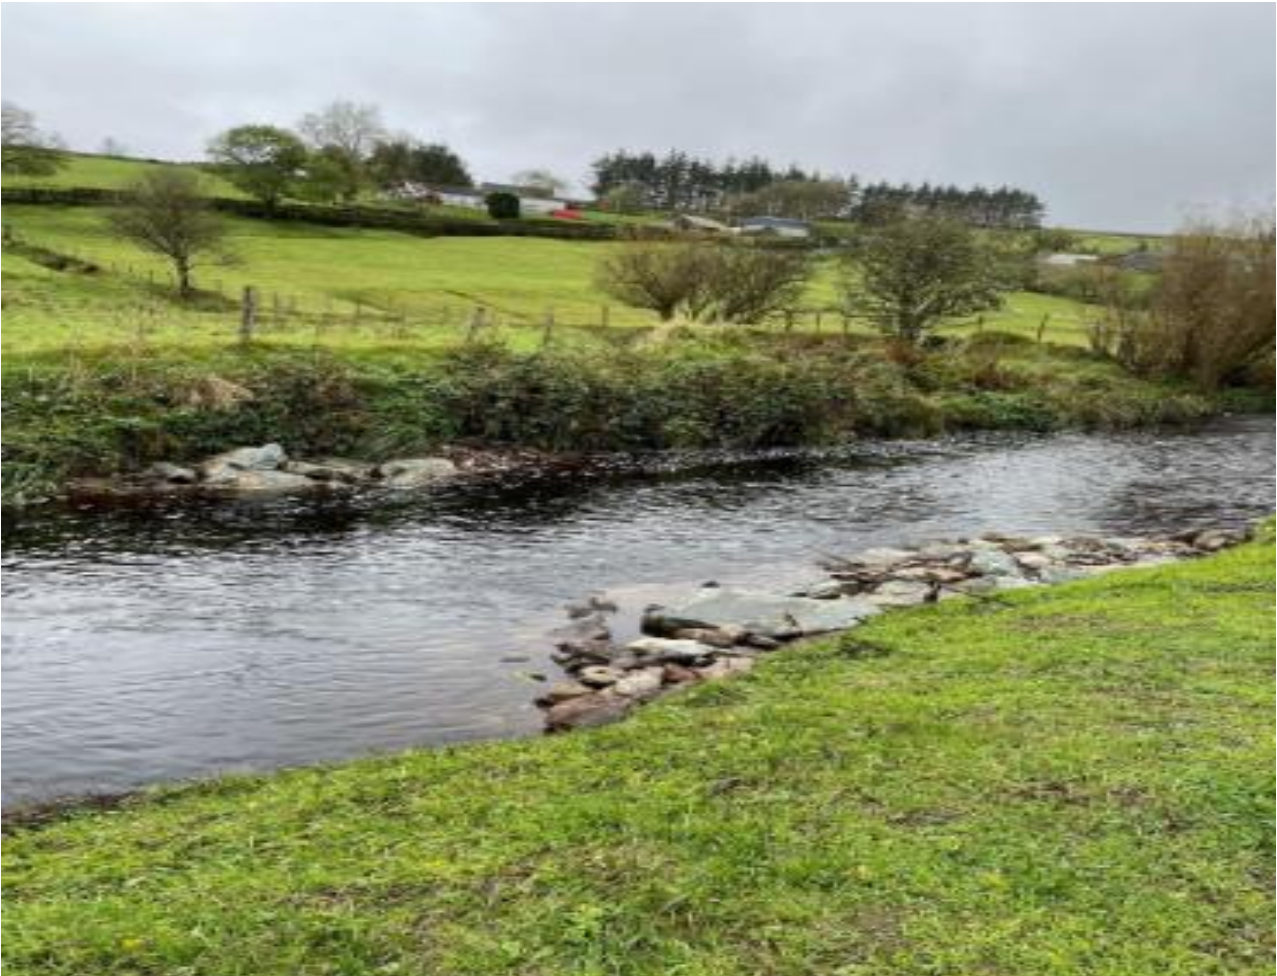
As several areas of the Elatagh exhibited habitat uniformity, artificial meander complexes were introduced at two locations using limestone deflectors to address impacts of historical channel straightening. The installation of rubble mats at 11 locations helped recreate the naturally occurring riffle habitat, providing shelter for fish as well as small scale turbulent mixing of water to increase

Figure 13: Artificial Meanders complexes installed

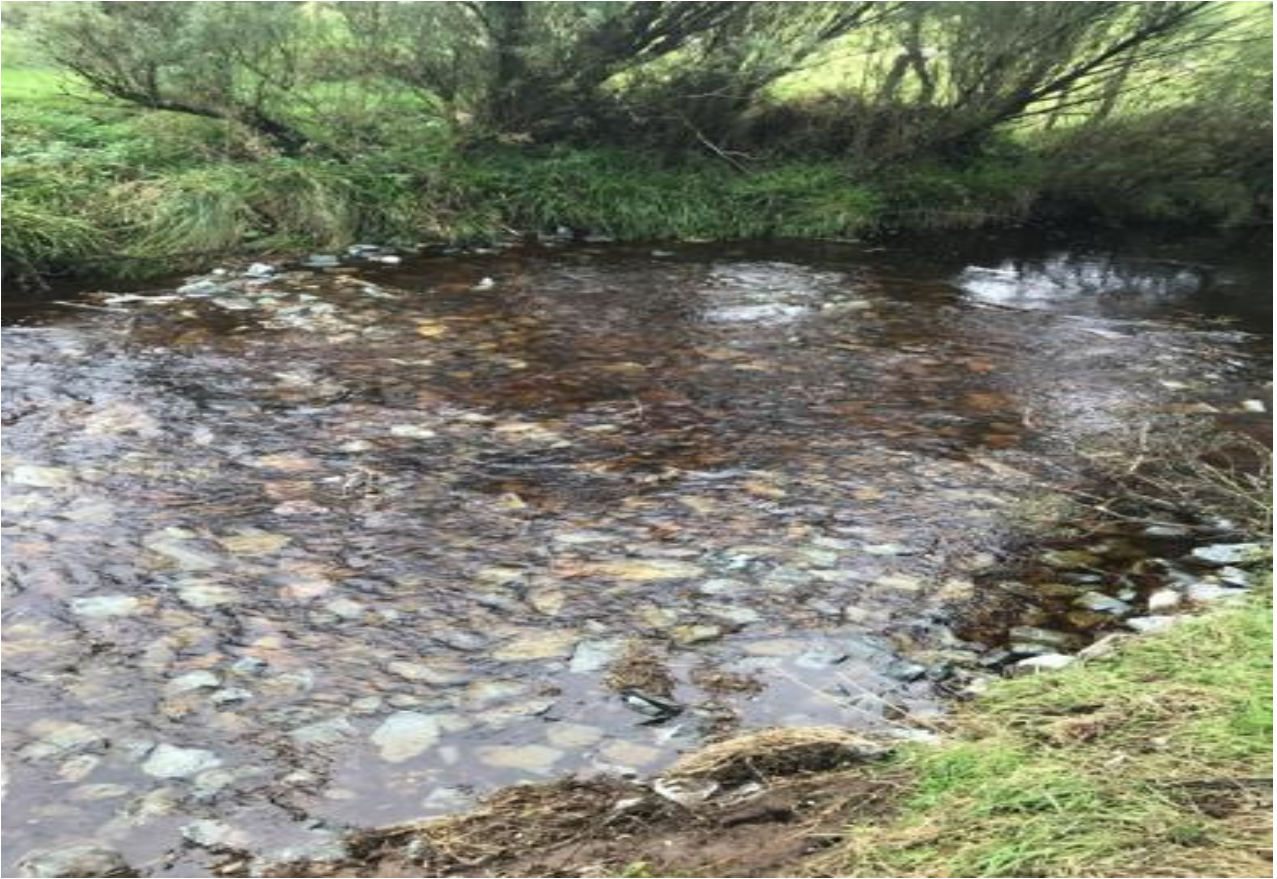
oxygen levels. Installation of artificial pools in tandem with the strategically placed stones helped to replicate the pool/riffle sequence seen in healthy rivers, providing variability and heterogeneity in the river bed.

Figure 14: Rubble Mats installed within the Elatagh River.

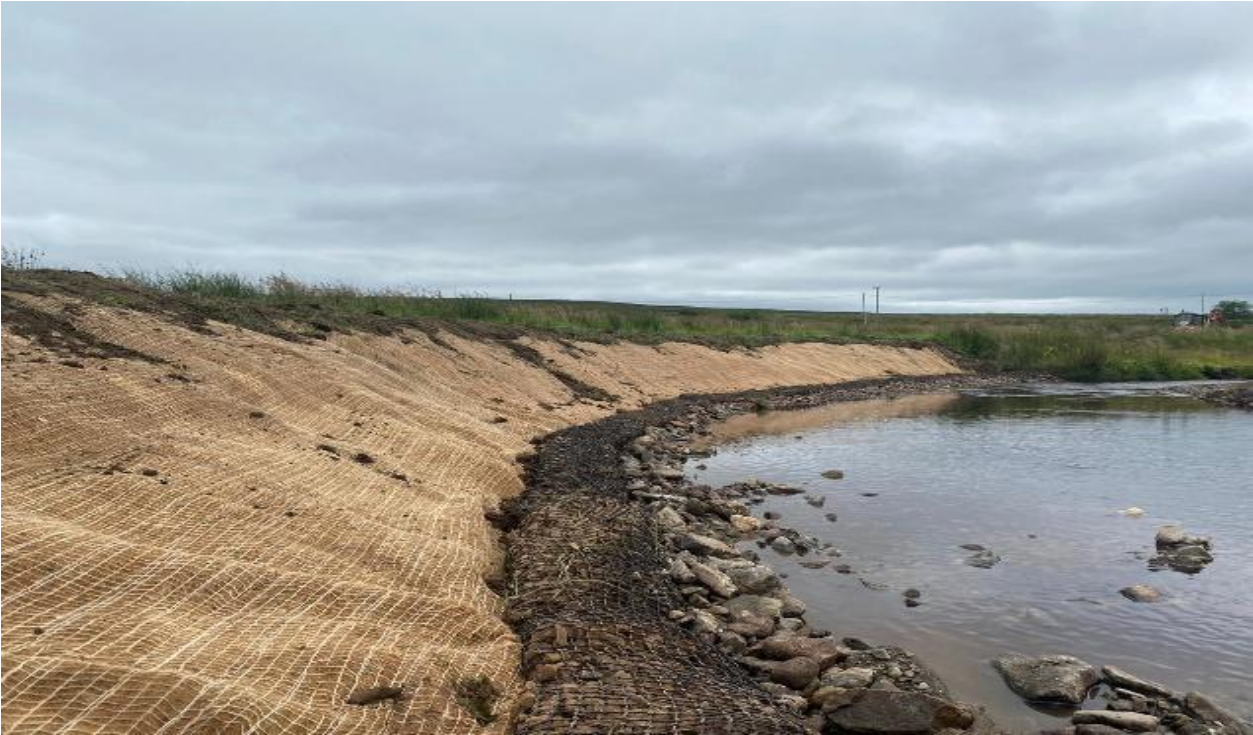
A follow-up site visit identified the advancement of an area of natural erosion along a meander within the habitat improvement works. In order to protect the areas of gravel regrading adjacent to the meander, additional green engineering measures were implemented. These included reprofiling of the undercut and eroded bank, with installation of coir matting and rock rolls at the toes of areas uniquely vulnerable to heavy erosive forces.

Figure 16: Additional Works implemented on the Elatagh included bank reprofiling of eroded and undercut banks.

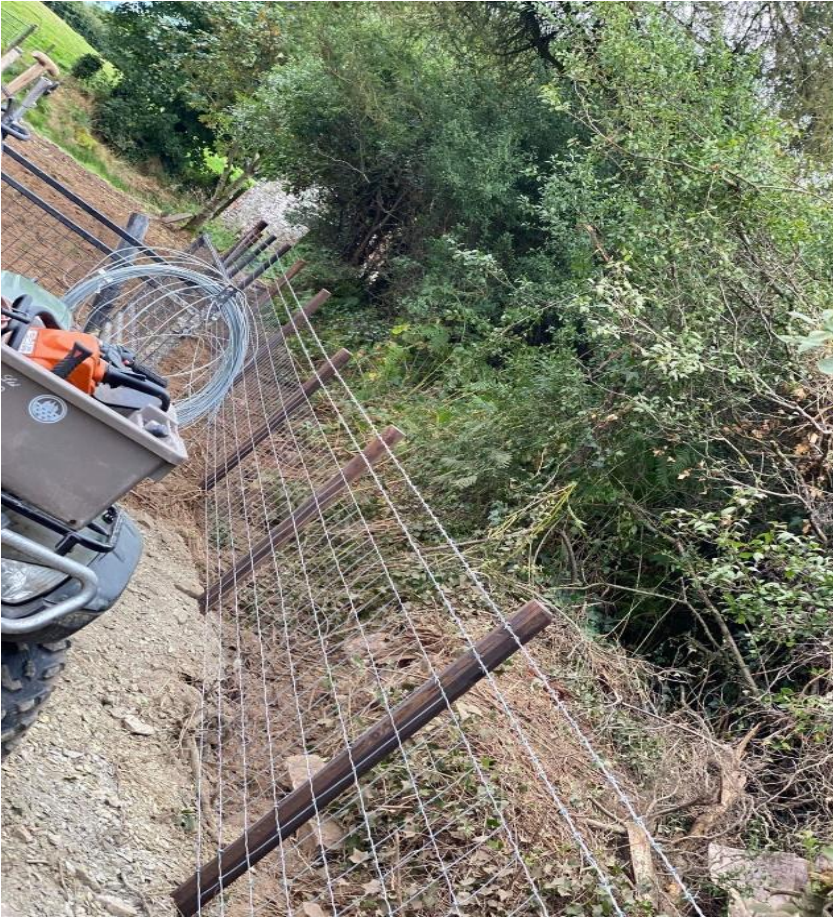
Figure 21: fencing erected along the recreational walkway of the Dresnagh River.

Along a 530 m stretch through a recreational walk, replacement posts were creosote treated to meet the aesthetic of the area.

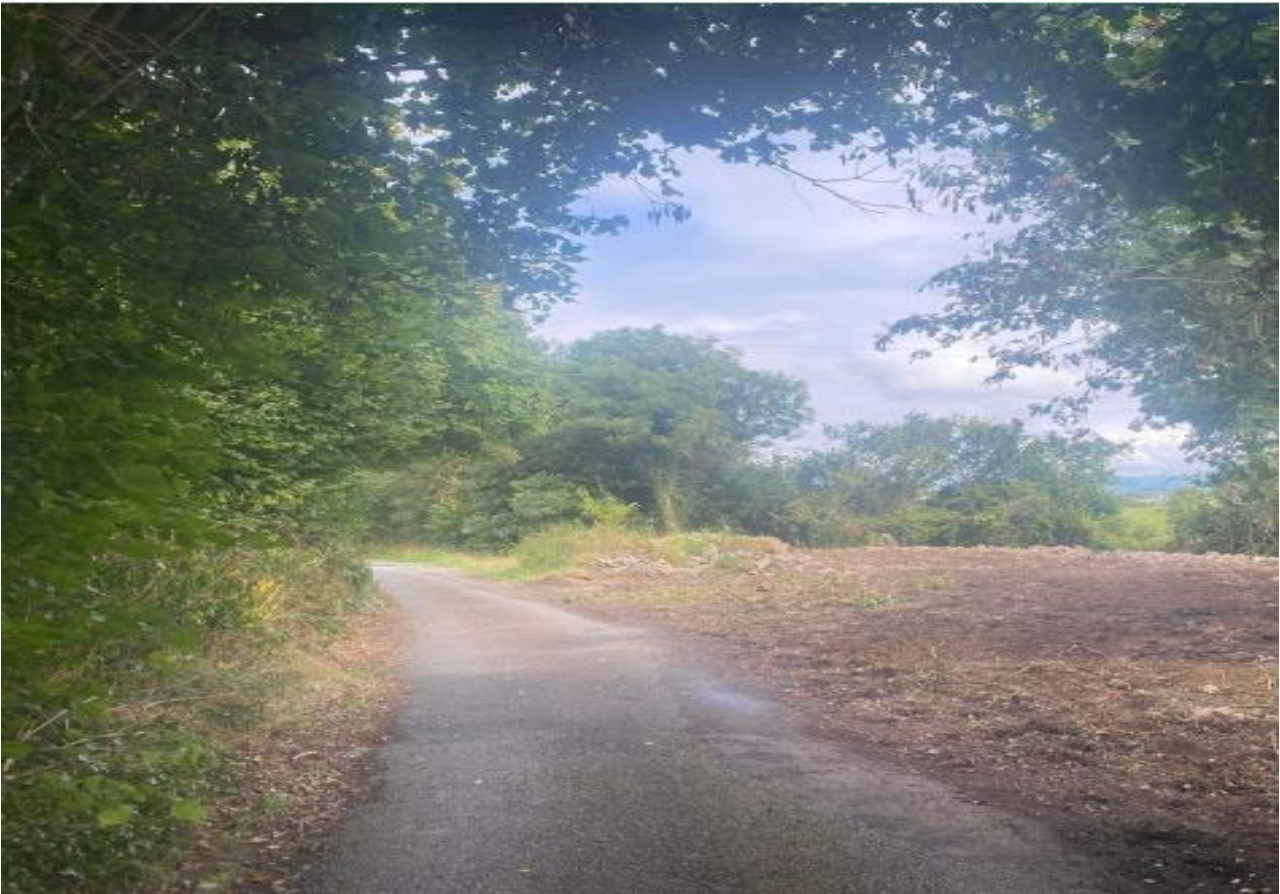
Figure 22: area of land cleared and levelled for recreational walkway for the Community around the Dresnagh River.

The area of land cleared for a recreational walkway will help the local community connect with the river. A total of 626 m of fencing comprising two strands of high tensile electrified fence fitted with appropriate batteries fitted with solar powered recharging units was installed. In order to allow access to the riparian margins 35 unigates, one single wooden gate, two double wooden gates, four 14 ft galvanised steel gates and 19 stiles were also installed.

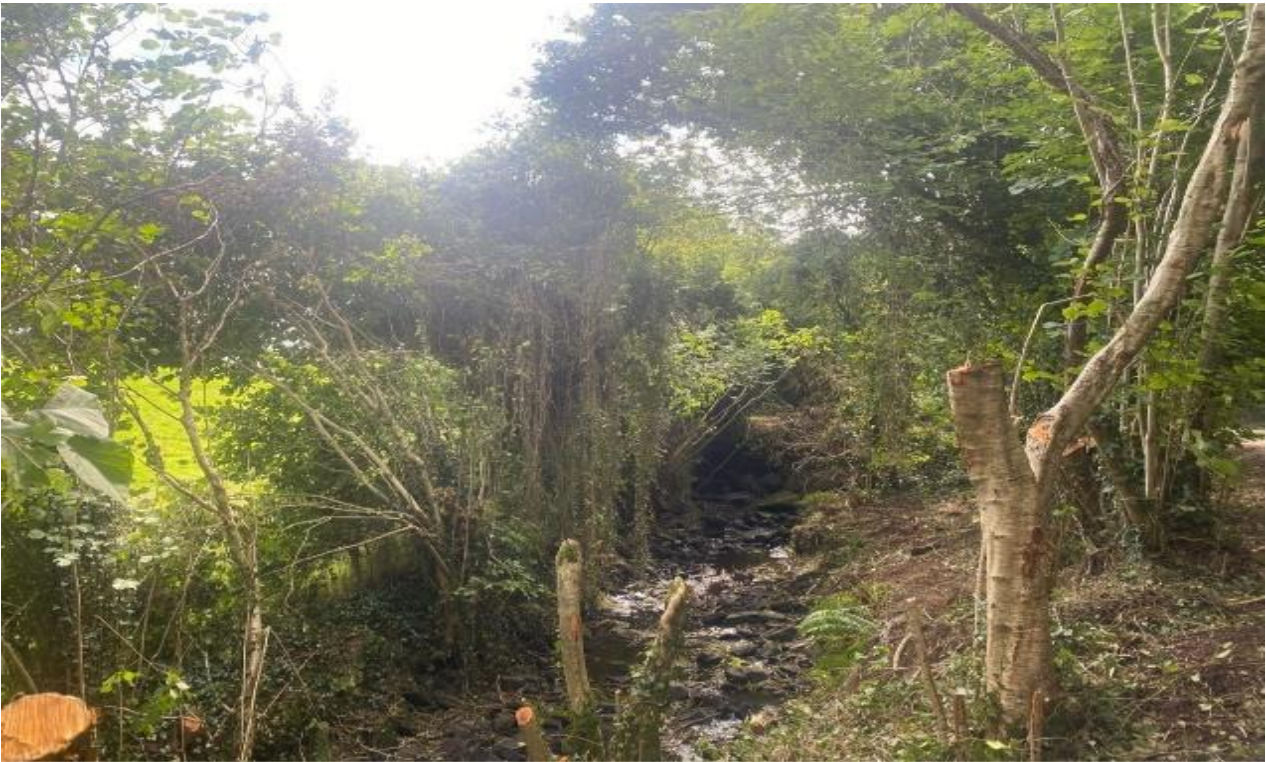
To provide increased light penetration to the river's surface, overgrown tree canopy was trimmed over a 2,152 m stretch of the works.

Figure 23: one of the areas of implemented bush trimming to increase light penetration.

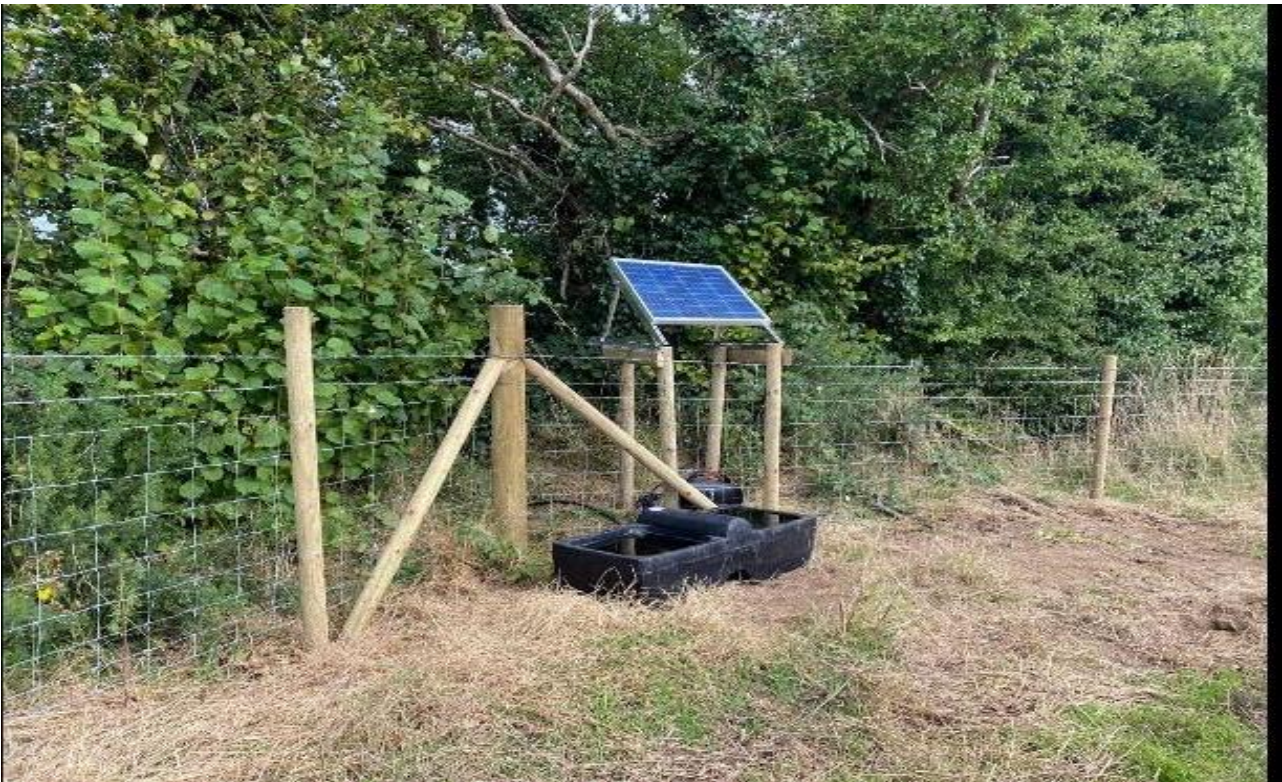
In lieu of direct livestock access to the river, 24 low spec and 4 high spec solar powered pumps with associated screens, filters, pipes and 73 x 80 gallon twin reservoir drinking troughs were installed for landowners.

Figure 24: Solar powered pump and trough installed within the Dresnagh River Restoration works in lieu of preventing livestock access to the river.

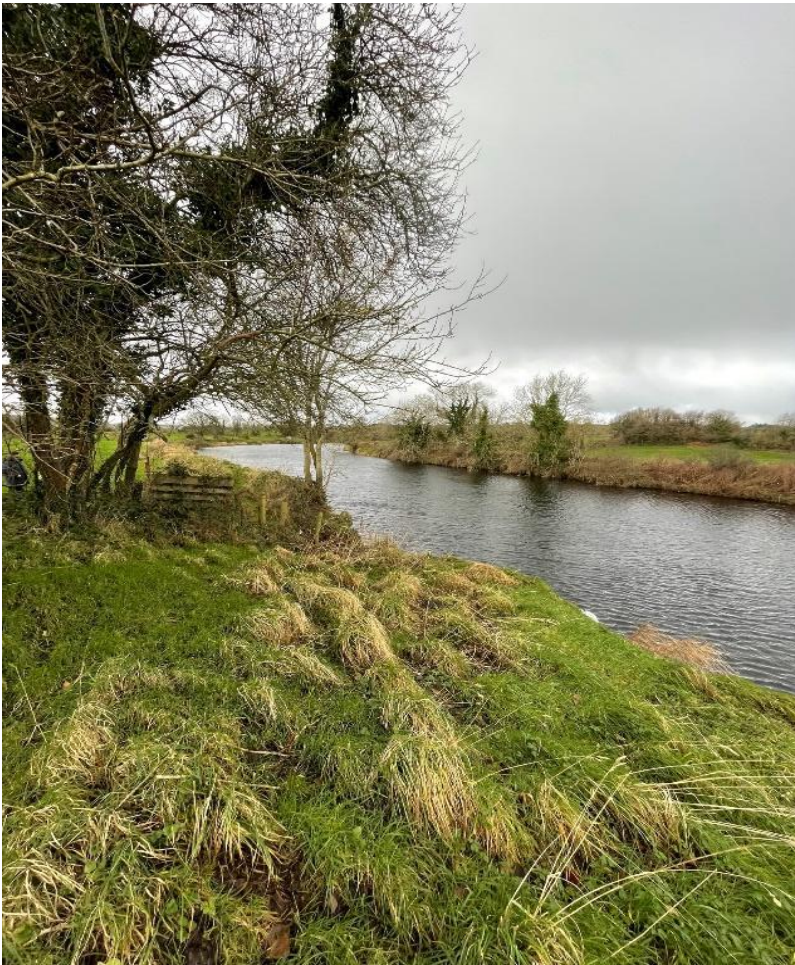
Pre-existing riparian margins were inconsistent in width, varying from 1–14 m from the river bank. However, less than half of these margins were planted with trees. The pre-existing margins were mostly colonised by a mixture of grasses and scrub.

Figure 28: lack of riparian margin between agricultural use and the River Finn.

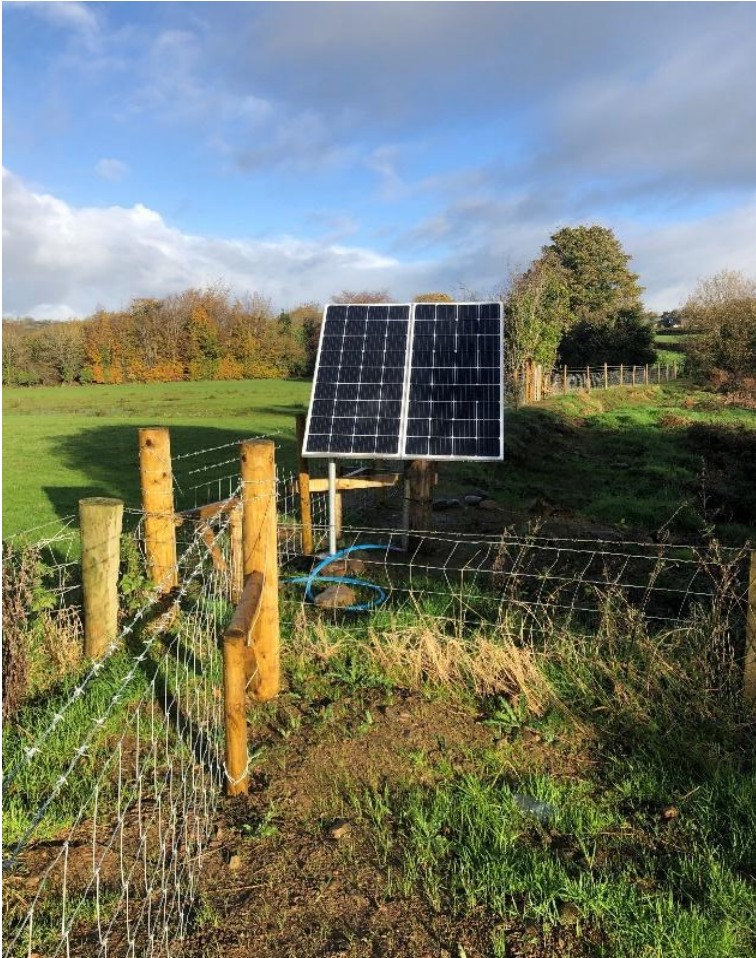
Upon fencing of the riparian margin, direct livestock access to the river was no longer possible. In lieu of this, 7 lower spec solar powered pumps and associated screens, filters and pipes capable of pumping water 10 m vertically and 30 m horizontally, and 14 higher spec solar powered pumps capable of pumping 1,200 L of water per hour to higher elevations and over longer distances were installed at various locations throughout the works. As a result of the works, 39 80-gallon twin reservoir drinking troughs filled by the solar powered pump systems now provide offline drinking water for livestock. In addition, 60 m of perforated twin wall pipe was installed and covered with appropriately sized stones for efficient land drainage at one location.

Figure 32: solar powered pump installed for livestock welfare.

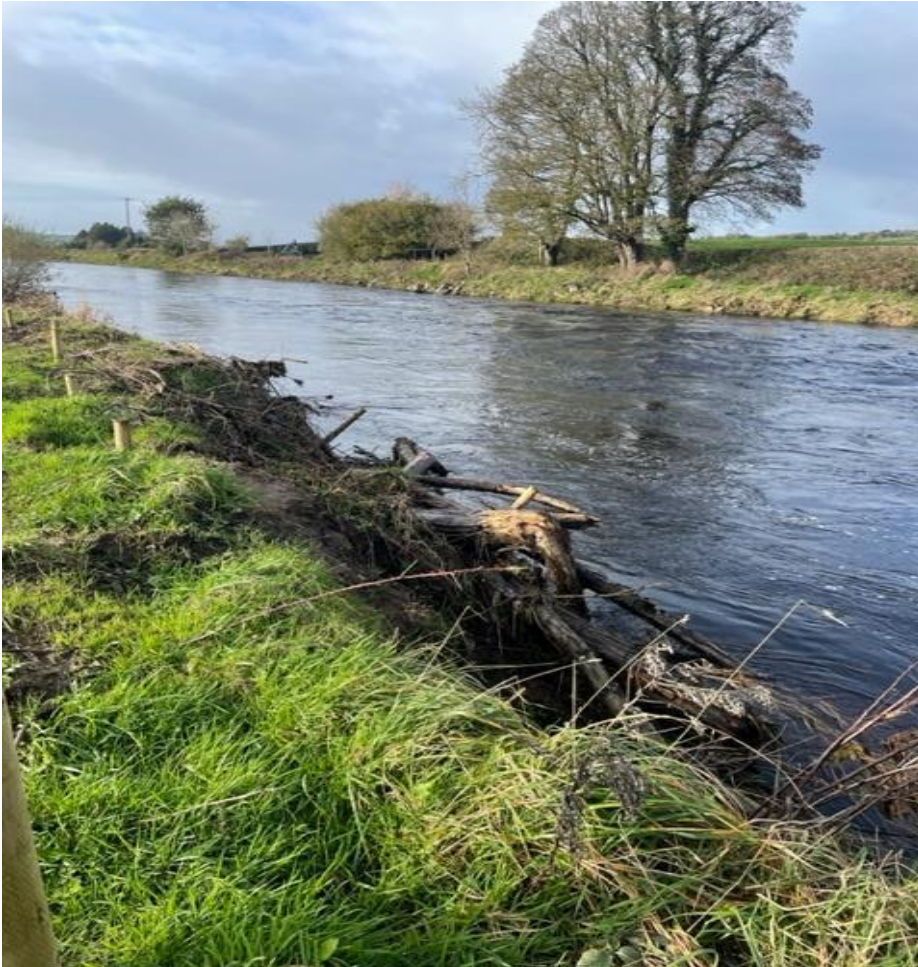
Woody material was pinned at six locations along the stretch of river, with tree trunks and tree limbs sourced from established trees within the work area, in agreement with the landowner. Material was pinned using posts and anchors, with the amount and placement of material designed specific to the site, so as not to block the main river flow or collect significant debris.

Figure 34: pinned woody material implemented at 6 locations of the Finn 003 stretch.

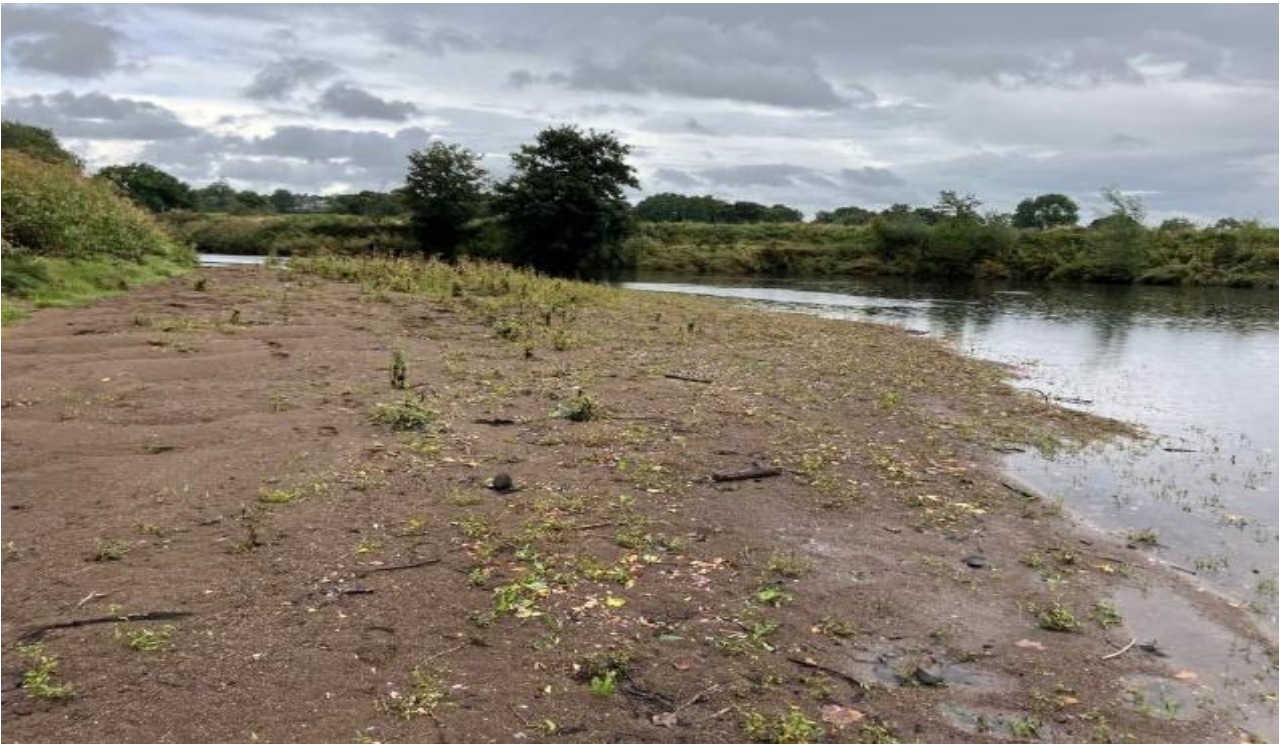
Two areas within the instream improvement works exhibited collections of “high and dry” gravel beds which would be otherwise suitable for salmonid spawning. Gravel was therefore regraded so that it lay below the water surface even on days of low flow, making it available to salmonids. Gravel in the areas immediately surrounding the once “high and dry” gravel deposits were also regraded, with a section of the gravel left to protect the existing bank from future erosion.

Figure 35: area of high and dry gravel was reggraded into the river to create spawning habitat for salmonids.

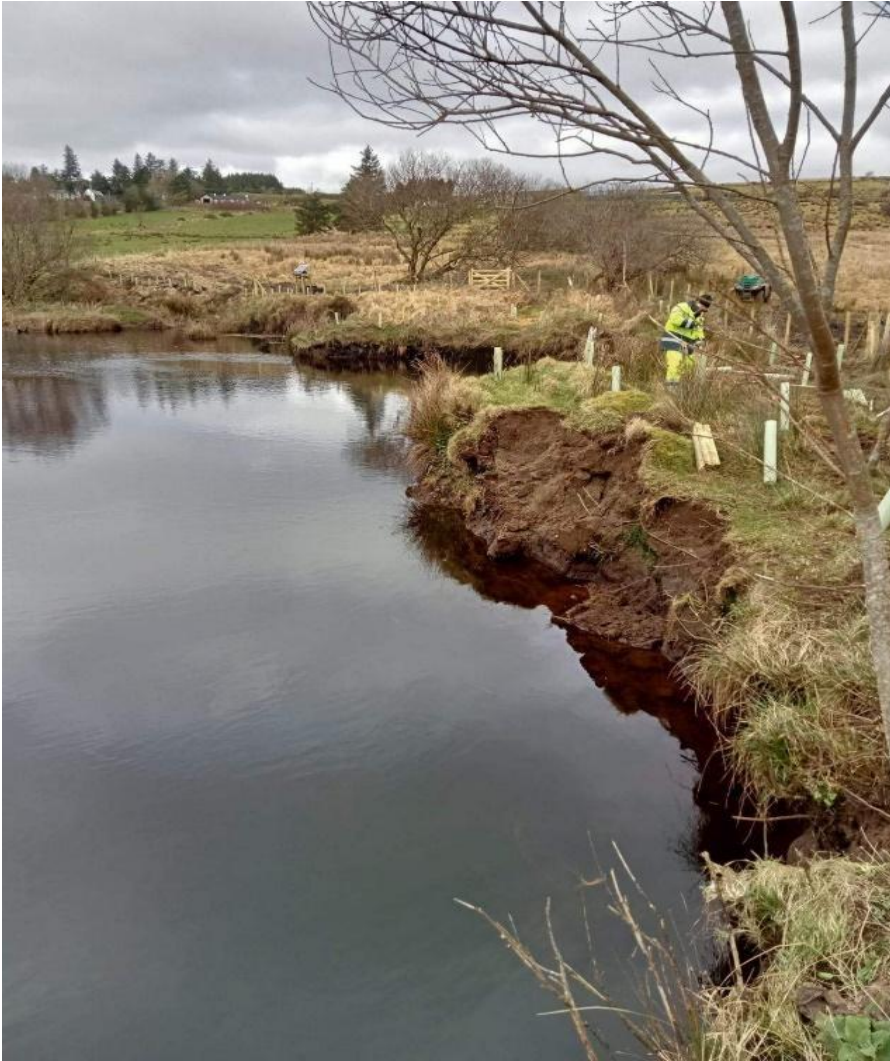
Figure 39: Planting of 900 native broadleaf trees along the Finn 001 stretch to provide adequate riparian margins and improve ecosystem diversity.

A mix of 900 native broadleaf trees composed of 25% Alder, 25% Willow, 25% Silver Birch and 25% Rowan were planted within the riparian margin created between the fencing and water's edge. As fencing eliminated direct livestock access to the river, 17 80 gallon twin reservoir drinking troughs filled by seven solar powered pumps with associated screens, filters and pipes were installed to supply offline drinking water to livestock.

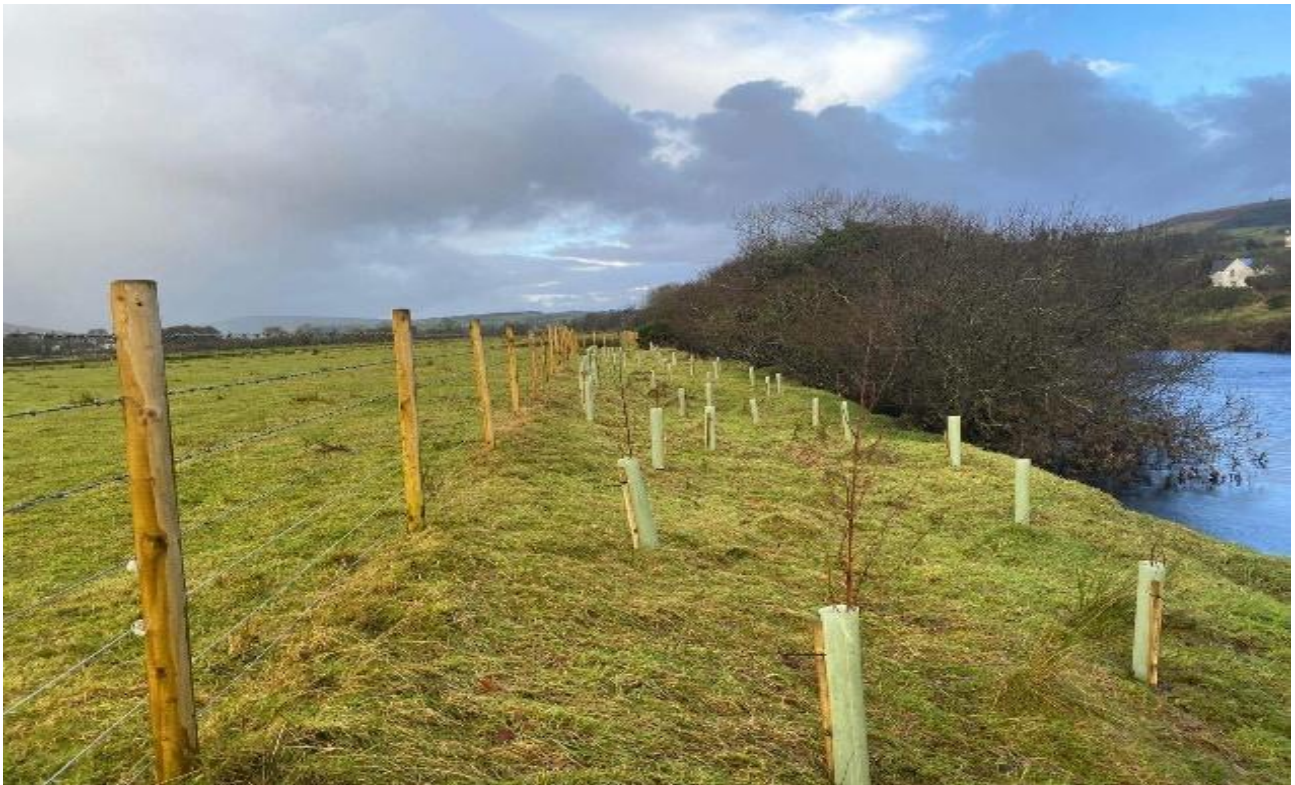
Figure 43: planting of the 700 native broadleaf trees along the Rough Burn Riparian margins.

In total 700 trees composed of a mix of 25% Alder, 25% Willow, 25% Silver Birch & 25% Rowan were planted to form a riparian margins along the stretch of the Rough Burn works, with 1,730 m of fencing, including posts, and strainers where appropriate, installed at varying distances of 3–20 m from the bank of the river to prevent livestock poaching.

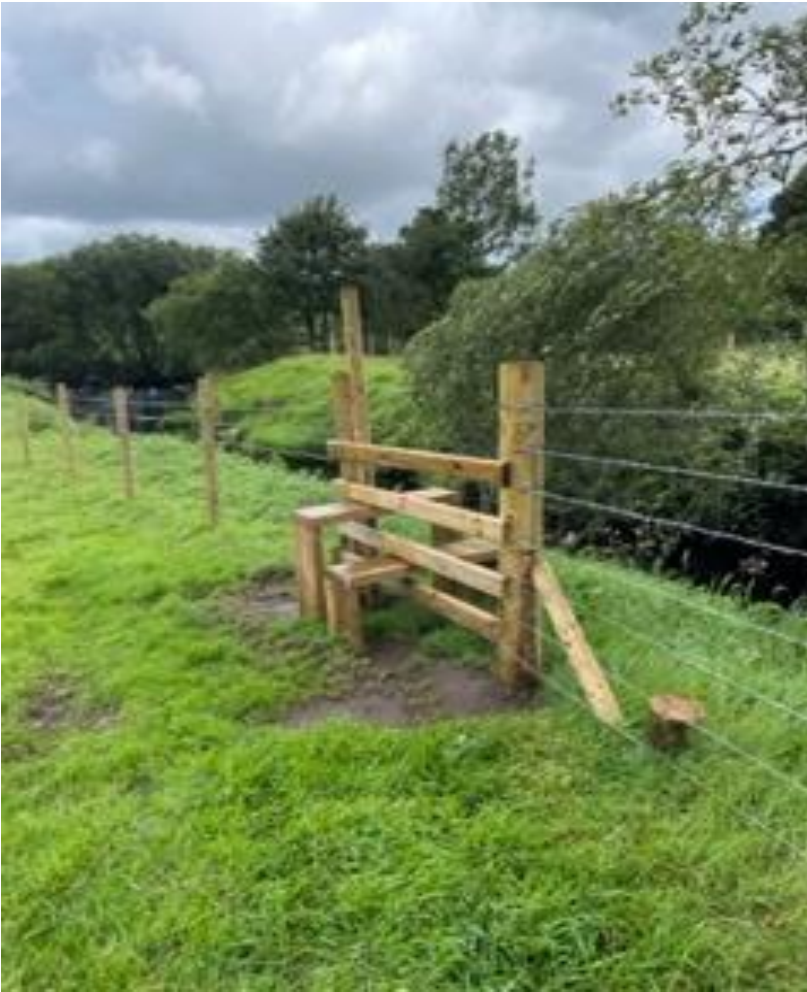
Figure 44: one of the 9 stiles installed along the Rough Burn restoration works for landowner and angler access.

As fencing eliminated direct livestock access to the river, installation of 14 x 80 gallon twin reservoir drinking troughs filled on demand by 5 solar powered pumps provided an offline source of drinking water. 10 unigates, 9 stiles and 12 ft gates (below the confluence of the rough burn with main River Finn) were also installed for access to the riparian margin.

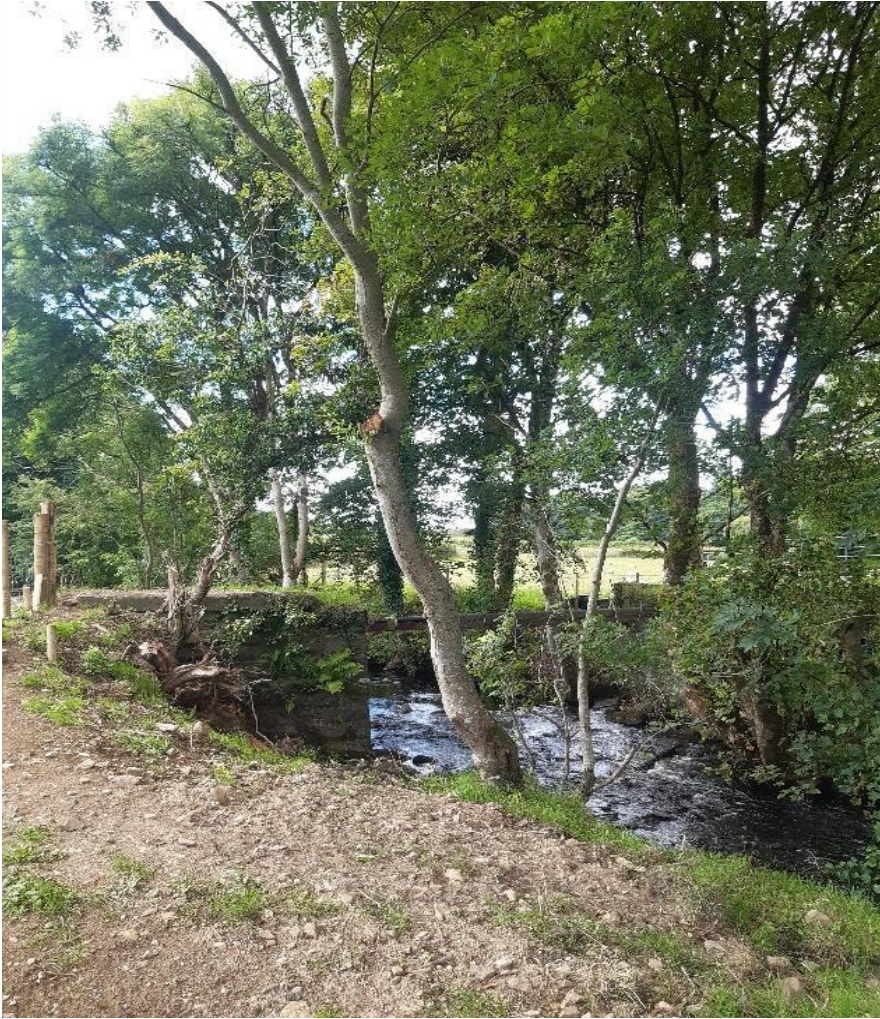
Figure 45: area of brush trimming implemented to increase light penetration into the Rough Burn.

Bush trimming of overhanging canopy was also required at several locations along the main stream to allow for increased sunlight penetration to the river's surface.

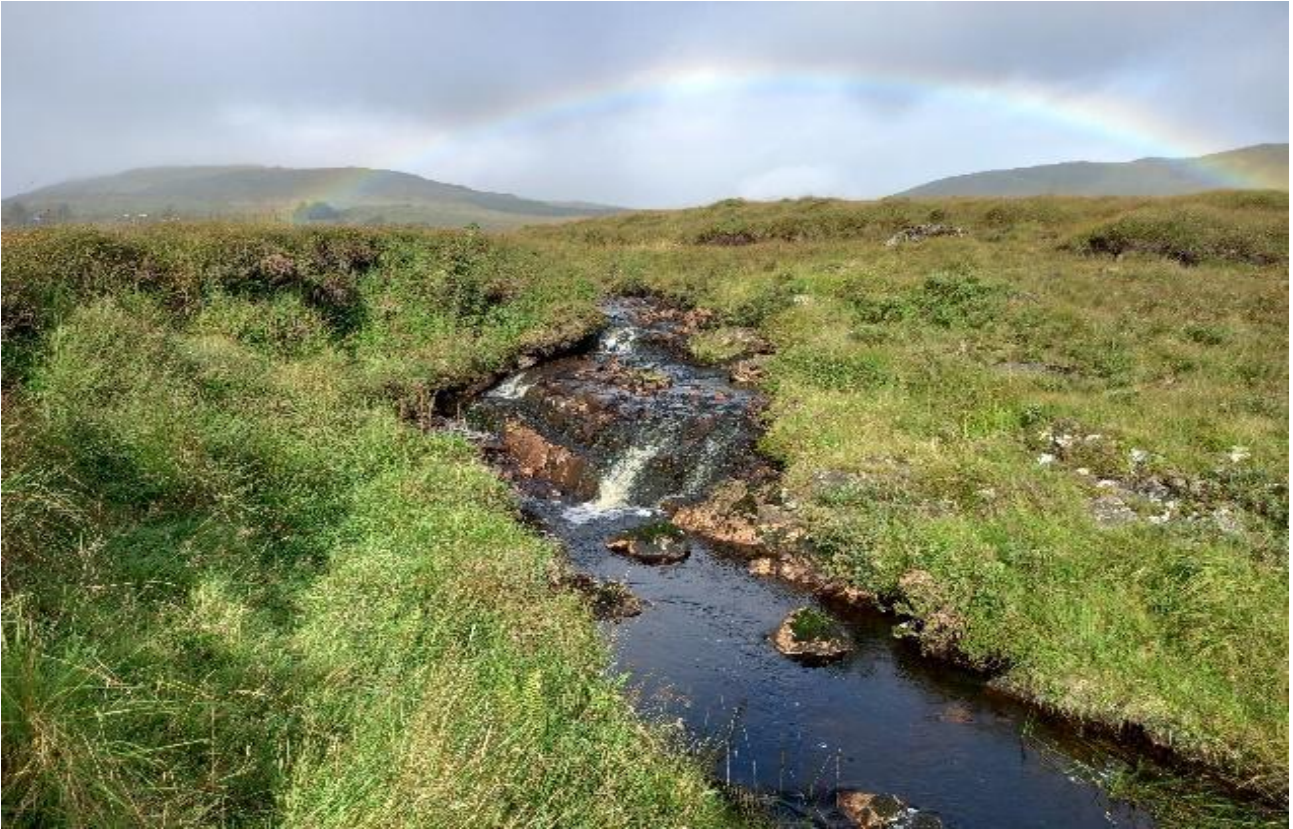
This site had a mixture of natural upland vegetation, unimproved grassland and conifer plantations present along the stretch. While riparian margins between conifer plantation and river range from 10 –25 m, RHAT scores were primarily impacted by the presence of conifer plantation as adjacent land use and the lack of native, broadleaf woody habitat, as well as the barrier to fish migration. Areas of the Reelin River lacked a riparian margin, with intermittent or no fencing along the stretch of works. In particular, improved grassland on the southern bank of the river had a very small riparian margin which could be optimised to the benefit of aquatic macroinvertebrates if enlarged and planted with native deciduous trees.

Figure 48: highlighting the lack of riparian margins along the Reelan River.

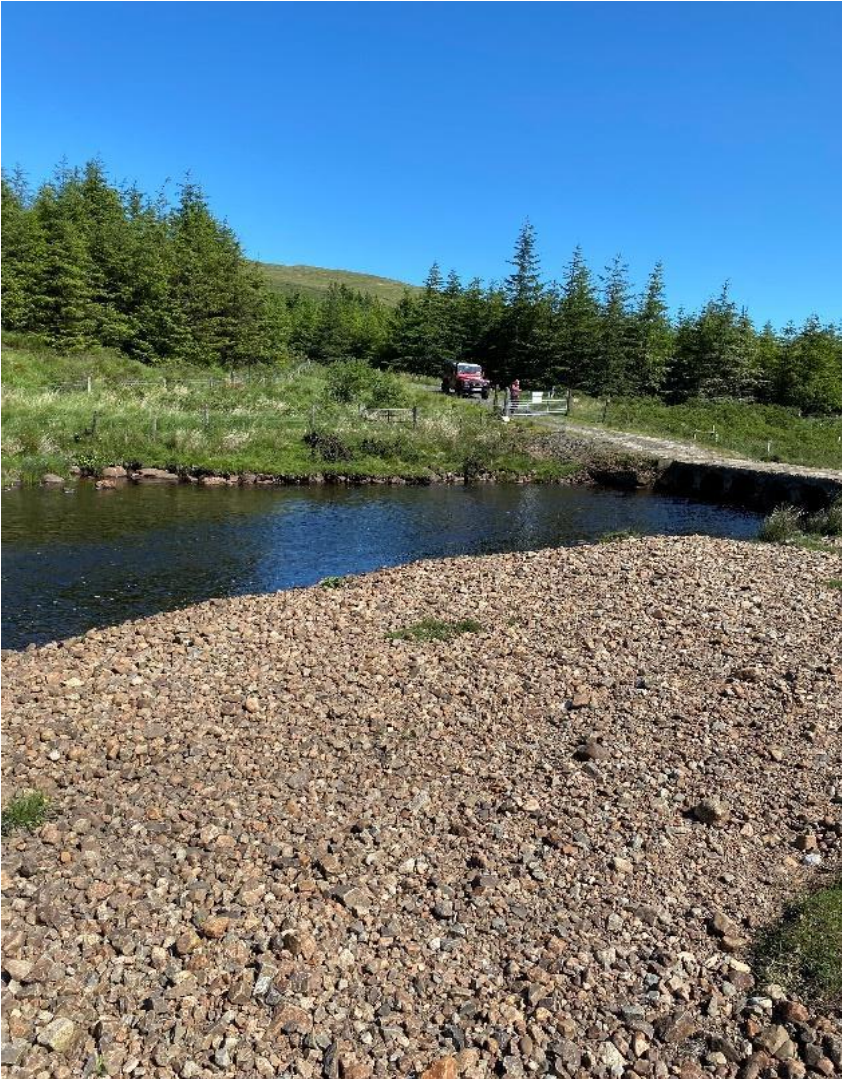
Instream there were several areas of “high and dry” gravel which needed to be made available for salmonid spawning, as well as areas of bank erosion and collapse which required pinning of wood. These soft engineering measures were also beneficial in providing food and refugia to macroinvertebrate and fish communities.

Figure 49: large area of high and dry gravel unreachable for spawning salmonids.

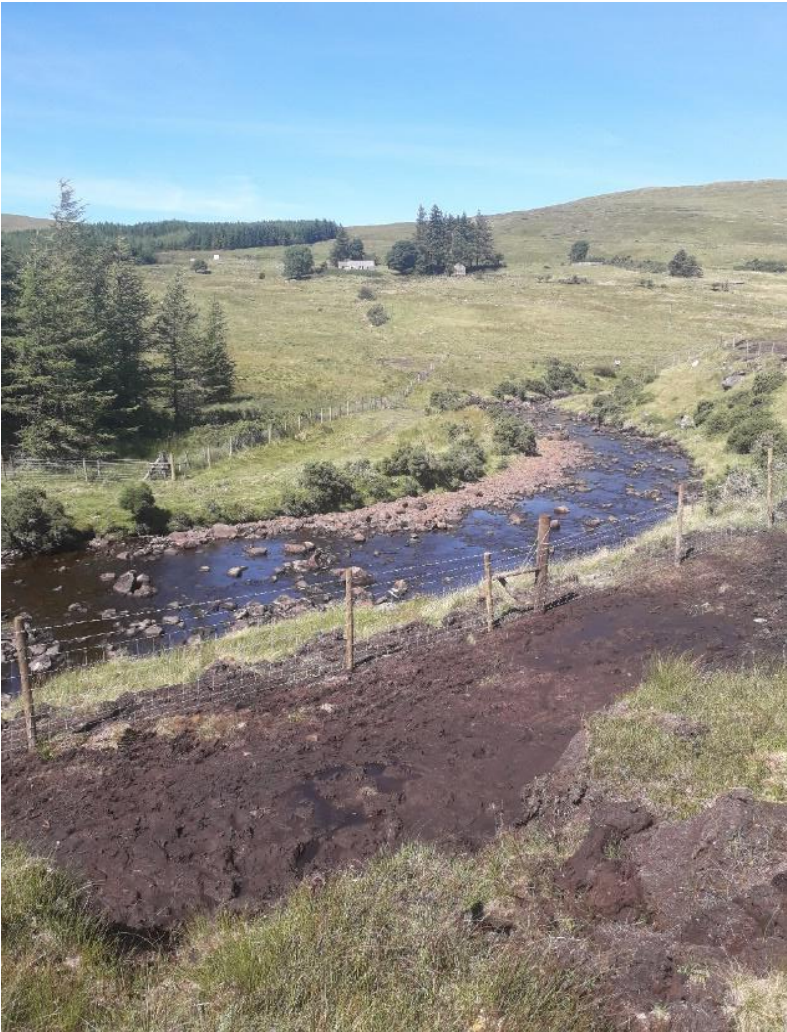
Figure 50: fencing implemented along the Reelan River.

Riparian improvement works along the River Reelan comprised of 5,110 m of both new and replacement fencing, along with planting of 7,613 native trees composed of 25% Alder, 25% Willow, 25% Silver Birch & 25% Rowan to create a 5 m riparian margin in areas which previously lacked an adequate riparian margin. Posts, splitters and strainers were installed continuously along the length of fencing for stability, particularly during times of high flow and flood conditions, along with five stiles and 8 unigates for access to the riparian margin.
