CatchmentCARE River Restoration Works Report

MARCH 2023

Community Actions for Resilient Ecosystems

A project supported by the European Union's INTERREG VA Programme, managed by the Special EU Programmes Body (SEUPB).

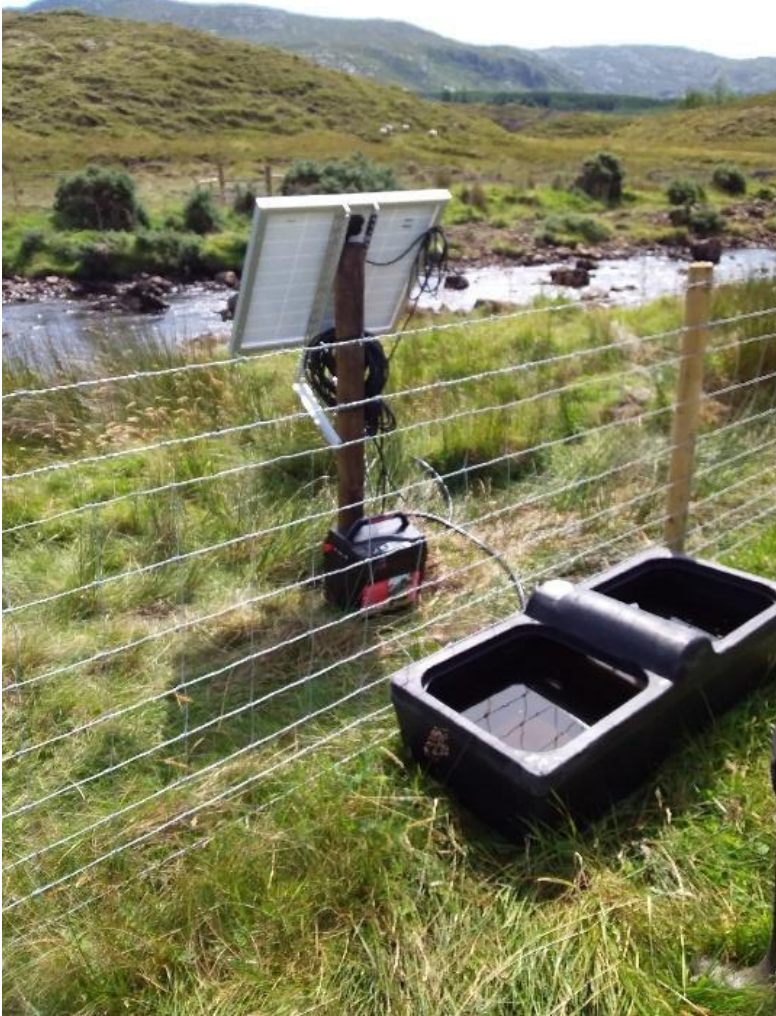
Figure 51: Solar powered pump and trough installed for livestock welfare.

As fencing eliminated direct livestock access to the river for drinking water, landowners were provided with 12 solar power pasture pumps (11 low spec, one high spec) and associated screens, filters and pipes to fill a total of 56 x 80 gallon twin reservoir drinking troughs.

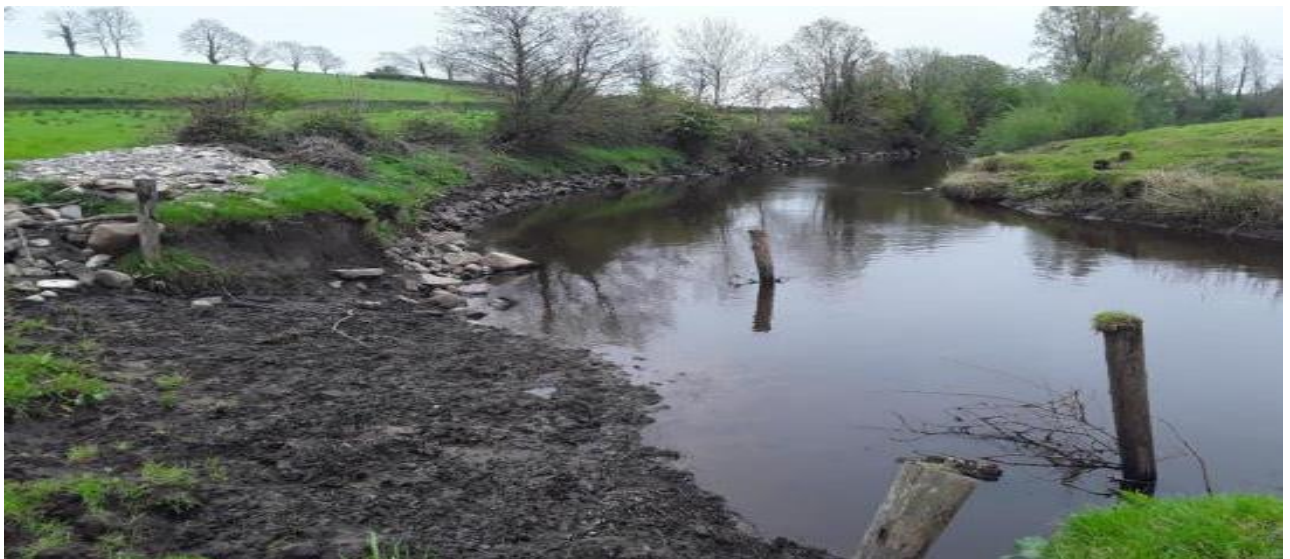
Figure 56: Cattle Poaching with large amounts of sediments with bank toe reinforcement.

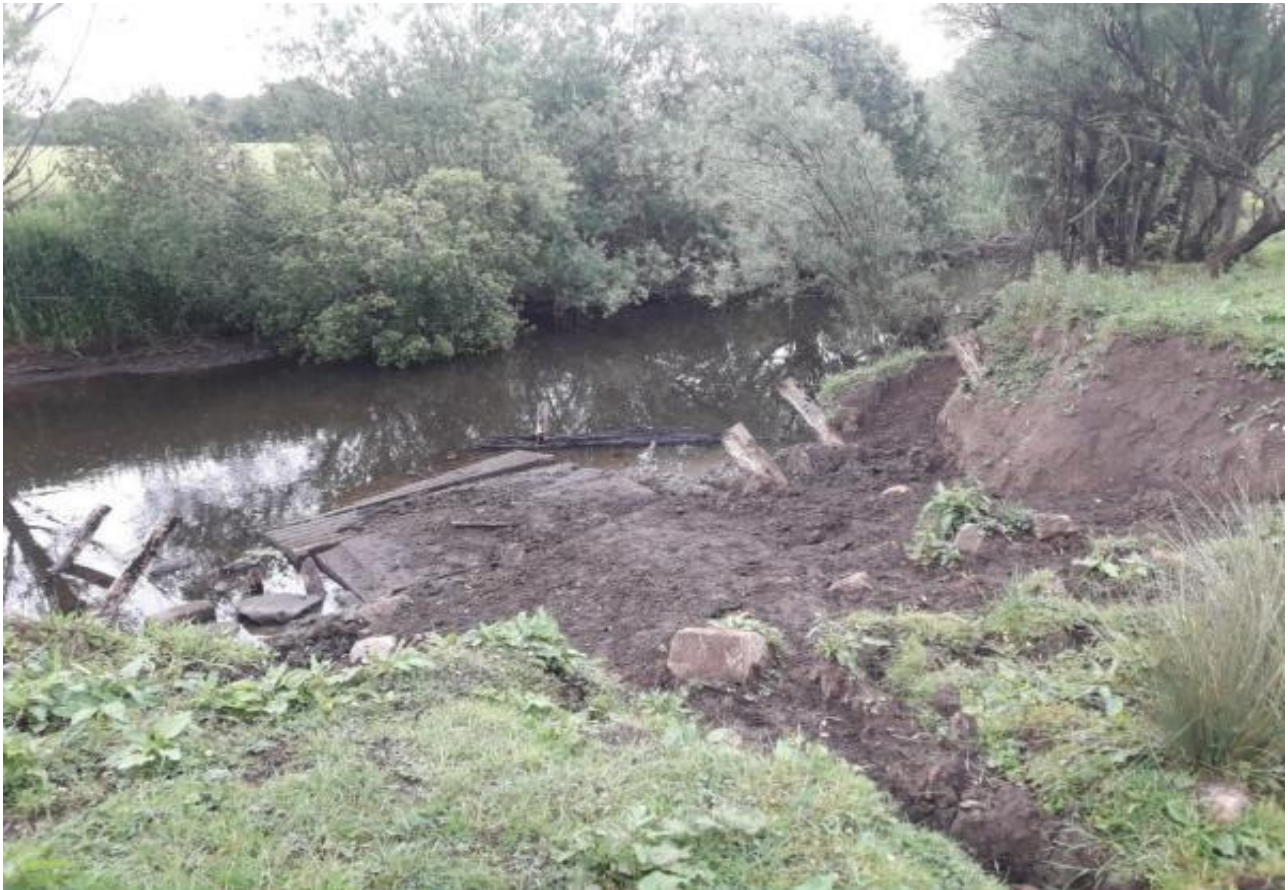
Figure 57: Area poached by cattle.

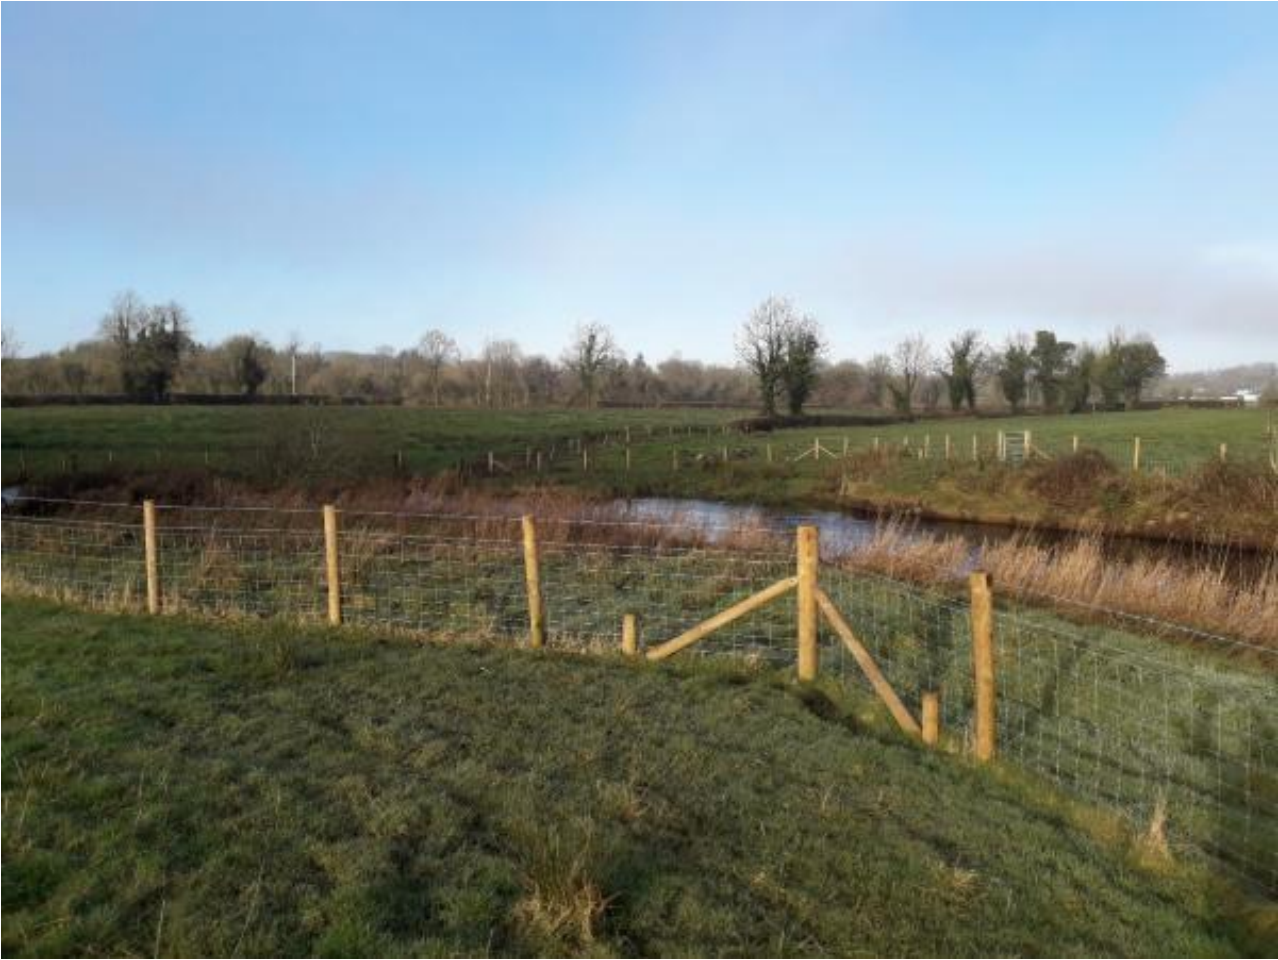
Figure 60: an example of the fencing installed along the Arney River.

- A total of 4,000 m of fencing has been installed along a river stretch of 2.7 km. Fencing consists of both sheep proof and stock proof which is comprised of 5 rows of barbed wire.

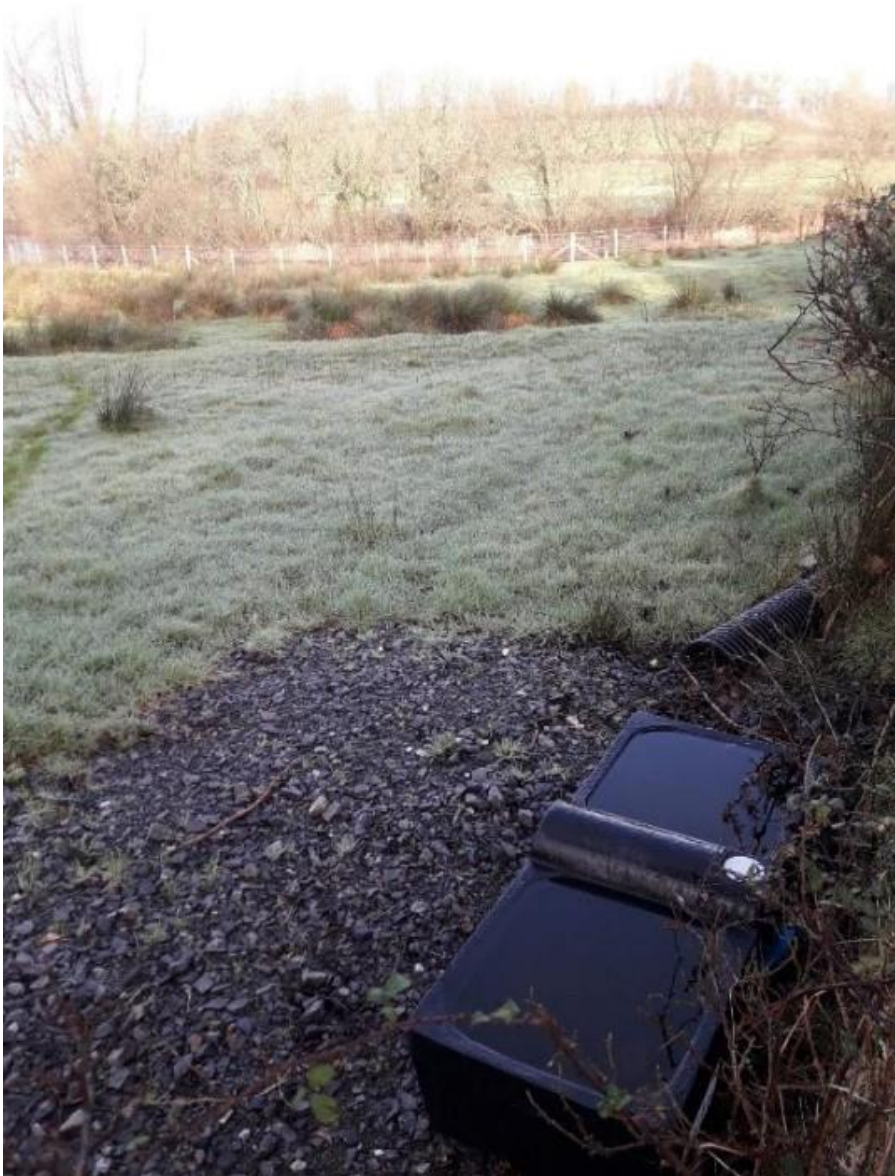
Figure 61: Livestock Trough with hard core to reduce soil erosion.

- 8 galvanised field gates have been installed for access to the river. The gates provide access to retrieve livestock (welfare gate), to allow any potential river maintenance by DfI Rivers and as a recreational access for canoes, anglers etc.
- 3 stiles have been installed for angler and recreational access to river.
- 28 livestock drinkers have been installed as alternative drinker sources for livestock. Drinking troughs are placed away from the river to reduce soil erosion close to the channel.

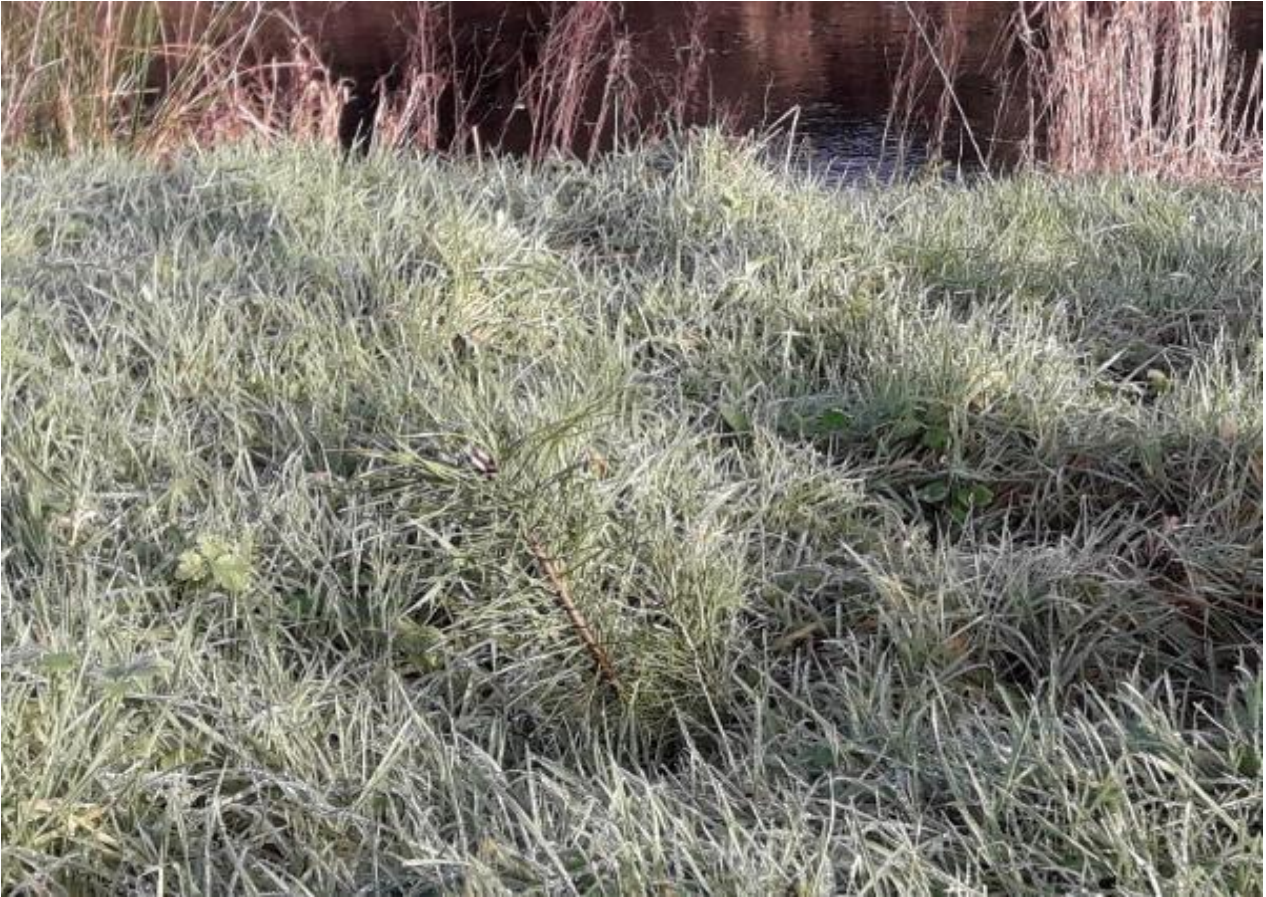
Figure 62: Planting of native broadleaf saplings along riparian zone.

- 500 tree saplings have been planted along the river corridor. The planting consists of 60 cm saplings composed of Oak, Alder, Guelder Rose, Spindle, Hazel, Crab Apple, Scots Pine, Rowan, Holly. 1 kg of wildflower seed mix was sown along banks of river to encourage pollinator species.

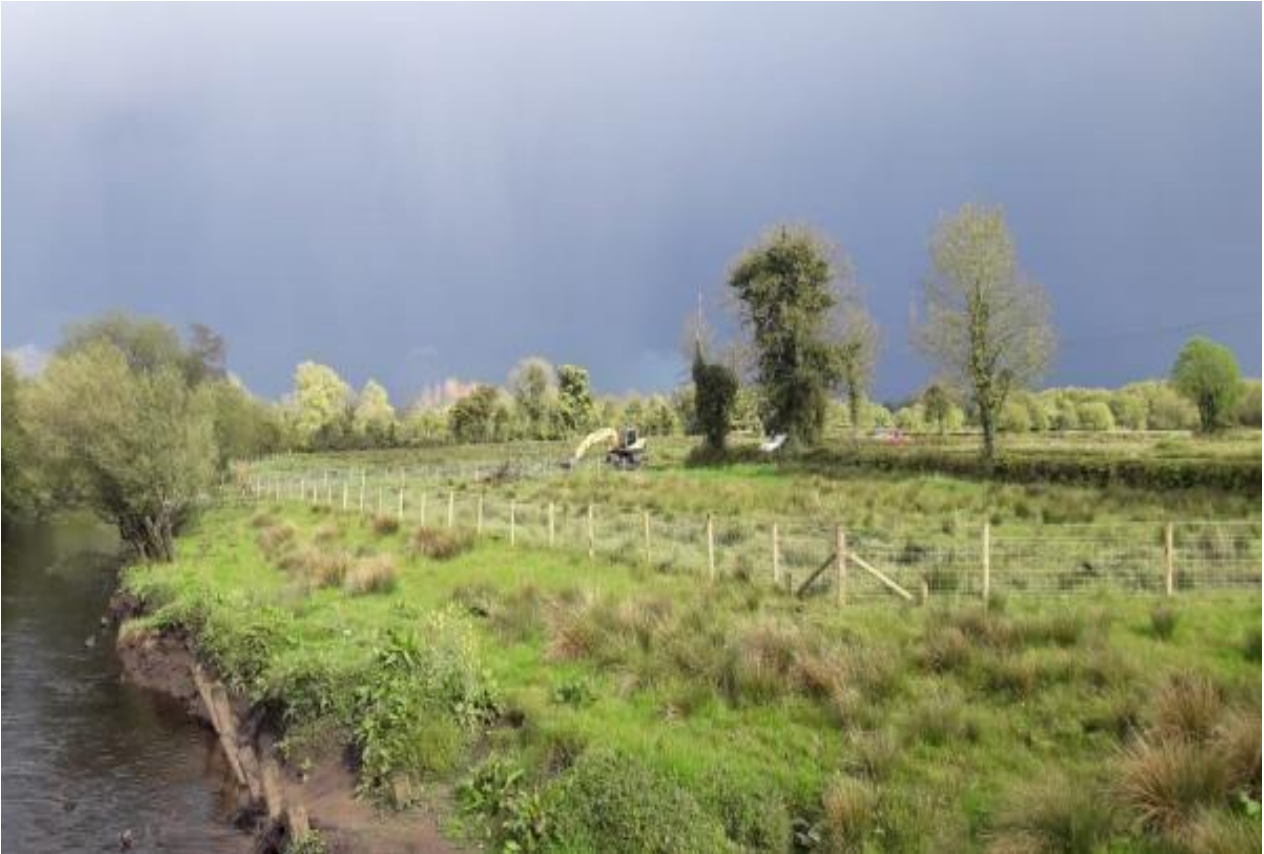
Figure 63: One Year after Fencing, cattle access to the river is now restricted, reducing pressure on the banks.

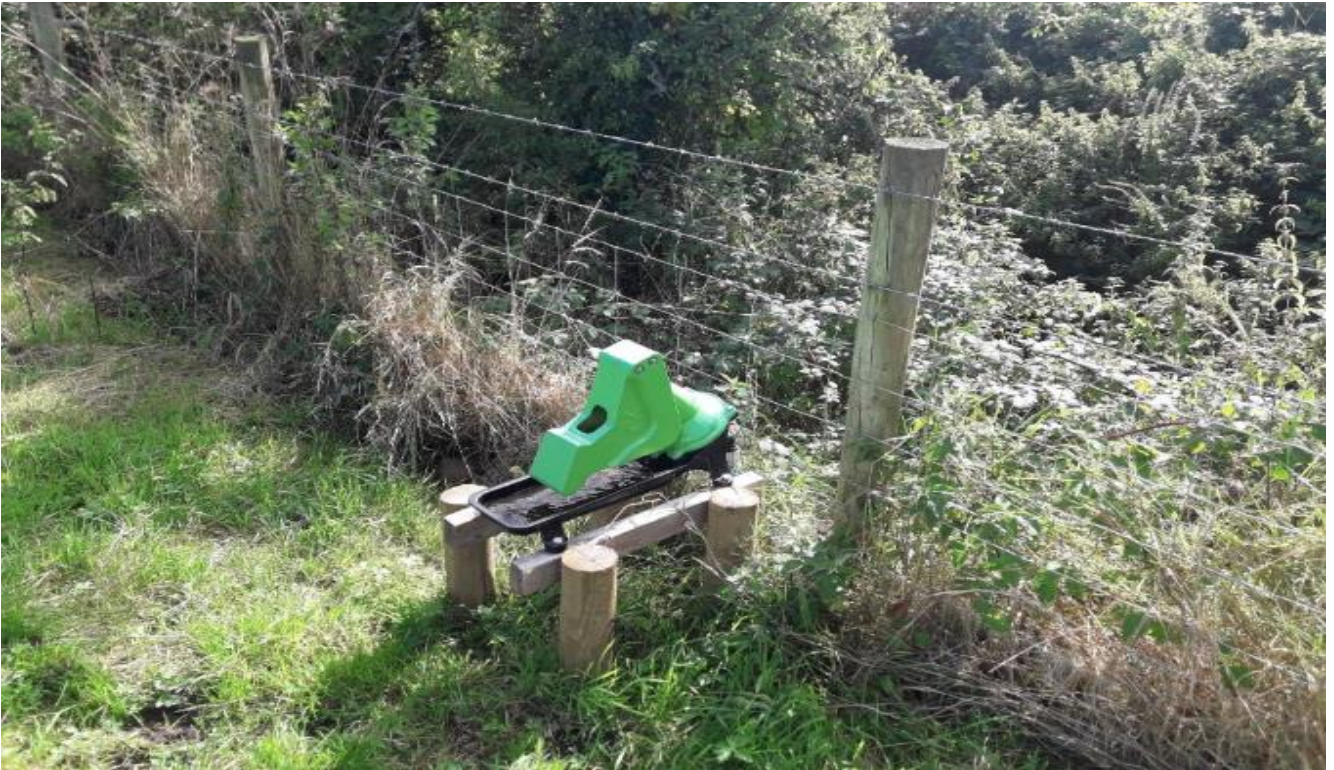
Figure 69: Pasture Pump providing alternative water source for livestock.

- 31 livestock drinkers have been installed as alternative drinker sources for livestock, including 3 pasture pumps and 4 solar pumps. Drinking troughs are placed away from the river to reduce soil erosion close to the channel.

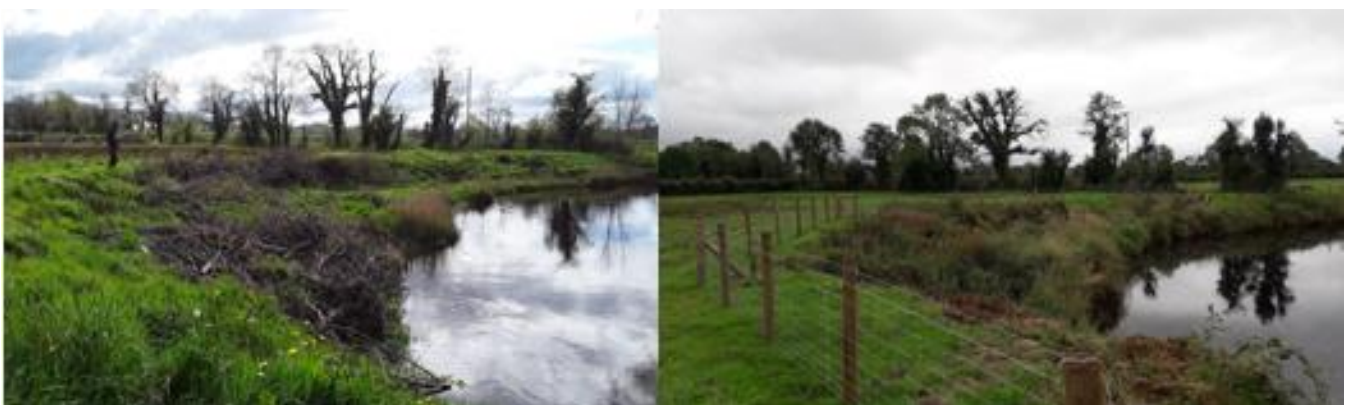
Figure 70: Installation of fencing before and after works.

- A total of 7,500 m of fencing has been installed along a river stretch of 5.4 km. Fencing consists of both sheep proof and stock proof which is comprised of 5 rows of barbed wire.
- 27 galvanised field gates have been installed for access to the river. The gates provide access to retrieve livestock (welfare gate), to allow any potential river maintenance by DfI Rivers and as a recreational access for canoes, anglers etc.
- 8 stiles have been installed for angler and recreational access to river.
- A discrete patch of invasive Japanese knotweed (*Fallopia japonica*) was identified in the area and were targeted with two applications of herbicide to prevent regrowth.

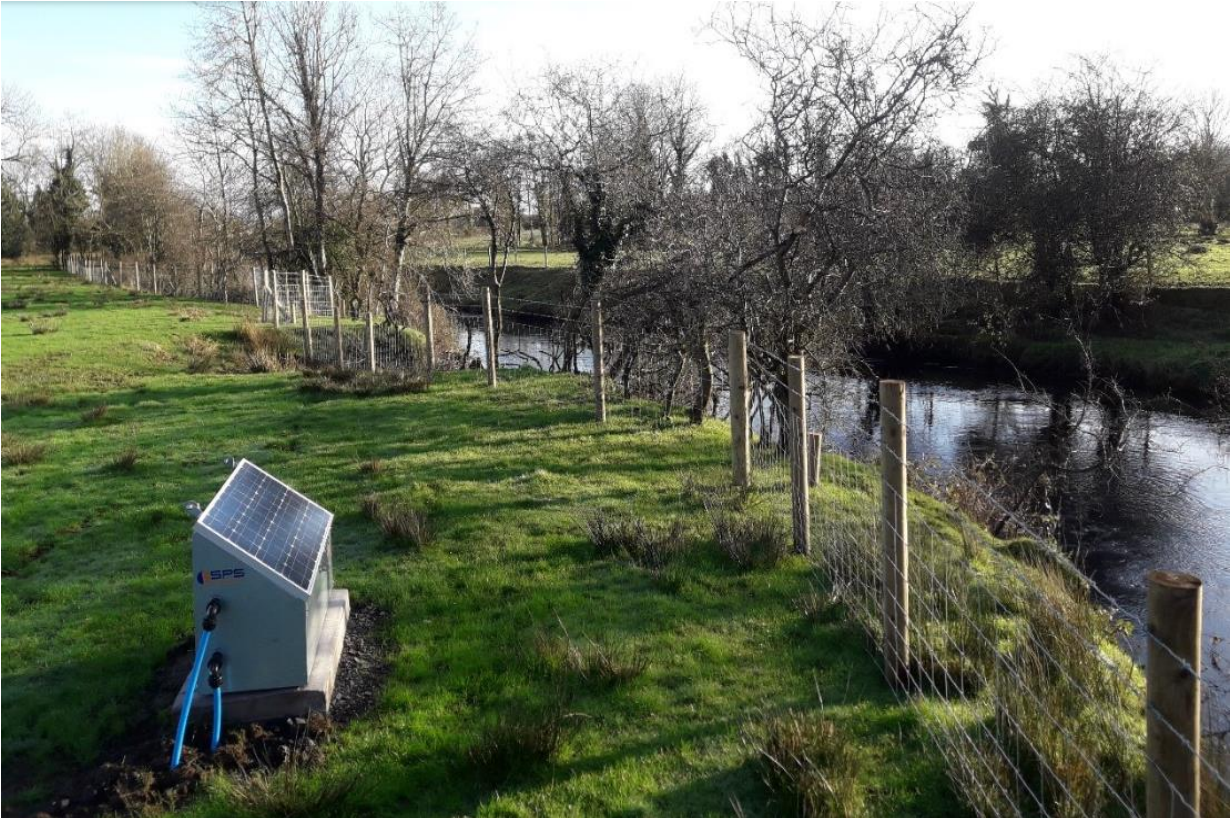
Figure 71: solar pump alternative water source for livestock.

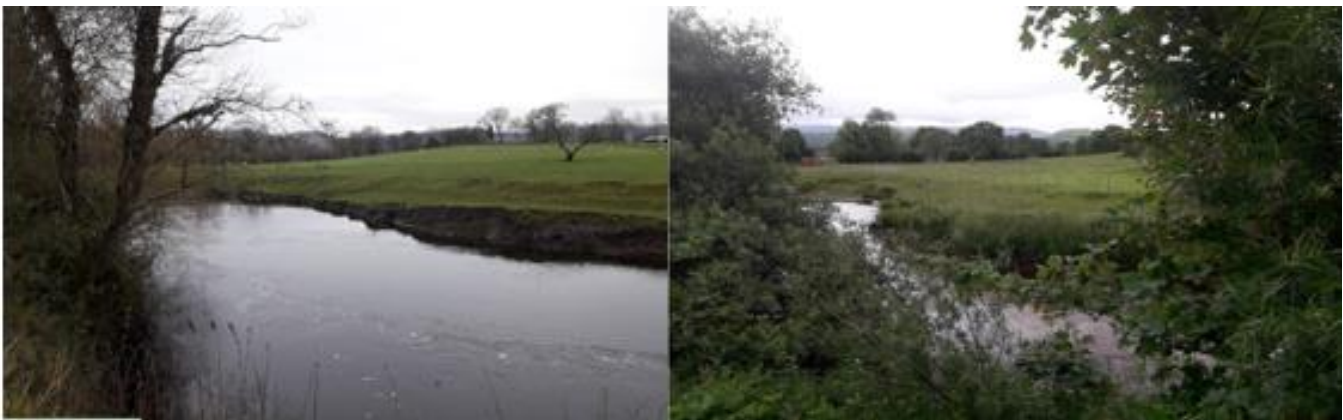
Figure 72: Before and after Riparian planting.

- 500 tree saplings have been planted along the river corridor. The planting consists of 60 cm saplings composed of Oak, Alder, Guelder Rose, Spindle, Hazel, Crab Apple, Scots Pine, Rowan, Holly.

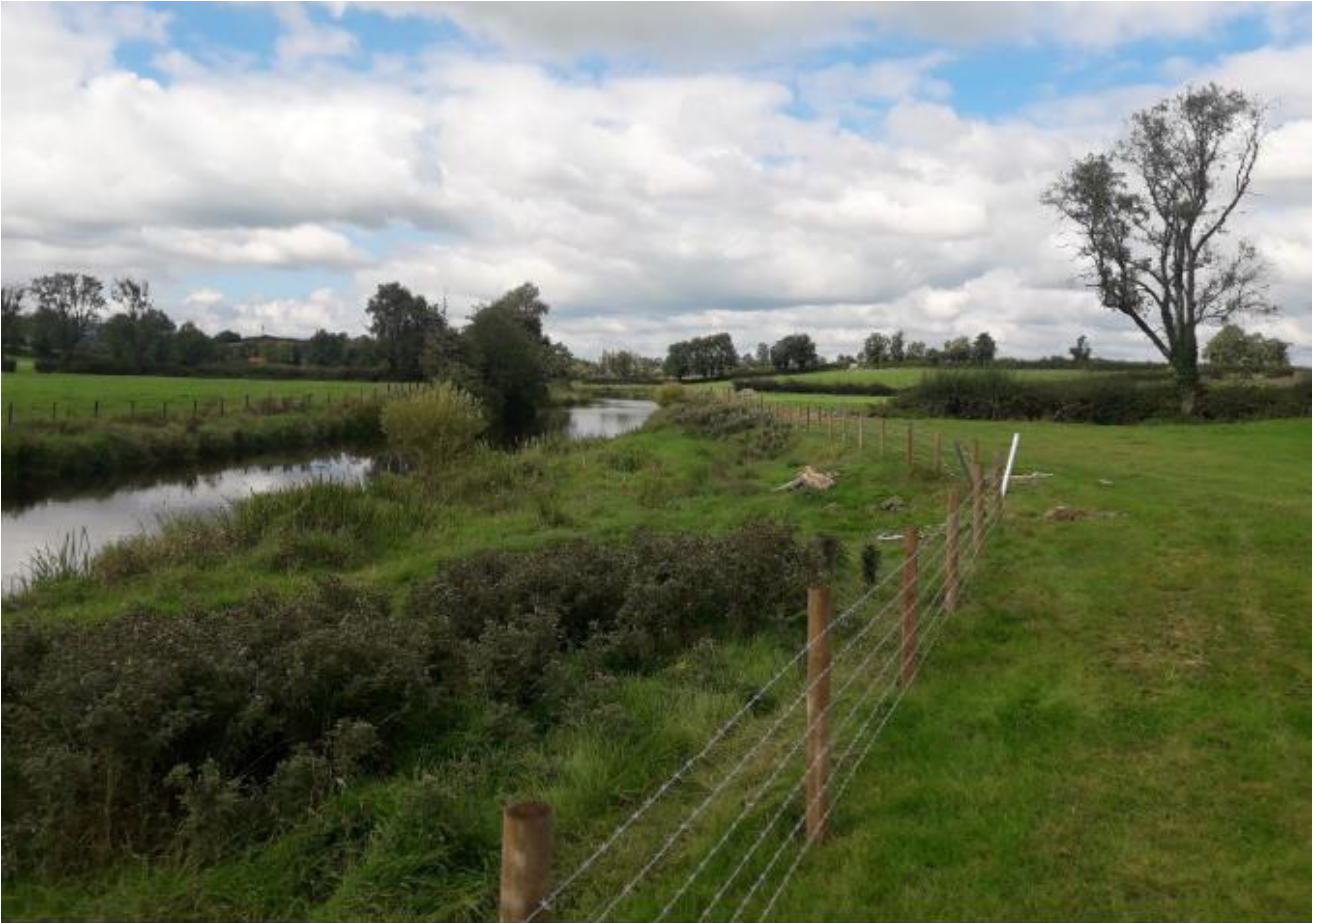
Figure 78: fencing installed to encourage vegetation growth on the banks.

Preventing access by grazing animals is a low cost method that can provide significant improvements in riparian vegetation, bank stability and overall river health and channel morphology. Fencing that completely excludes livestock prevents the introduction of additional nutrients and pathogens and allows the native vegetation rebuild the riparian buffer, without the pressures of grazing. The natural recovery of the river and its channel can be assisted via the planning and reintroduction of native flora.

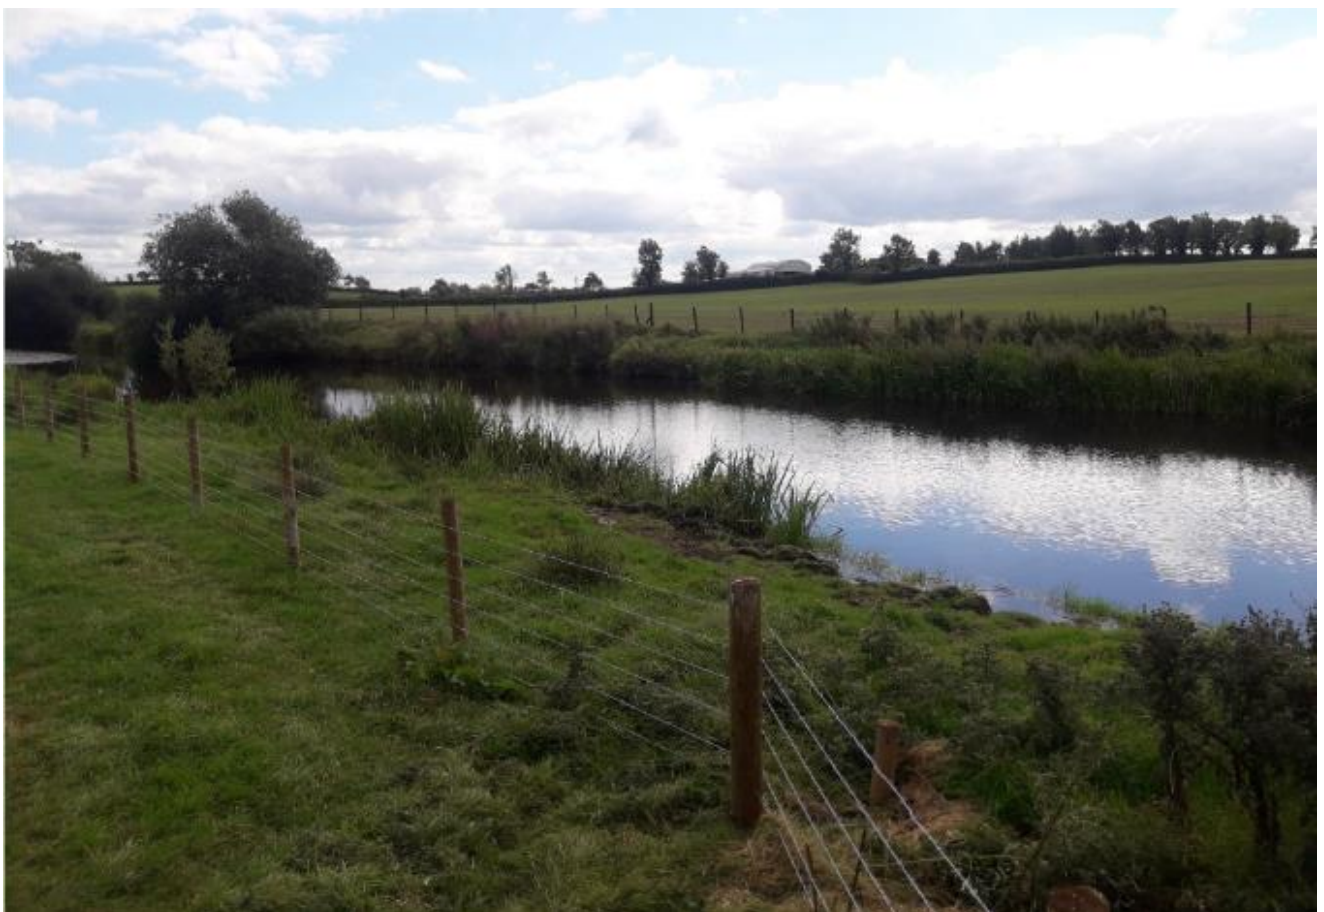
Figure 79: Livestock access point fenced to prevent ingress to the river.

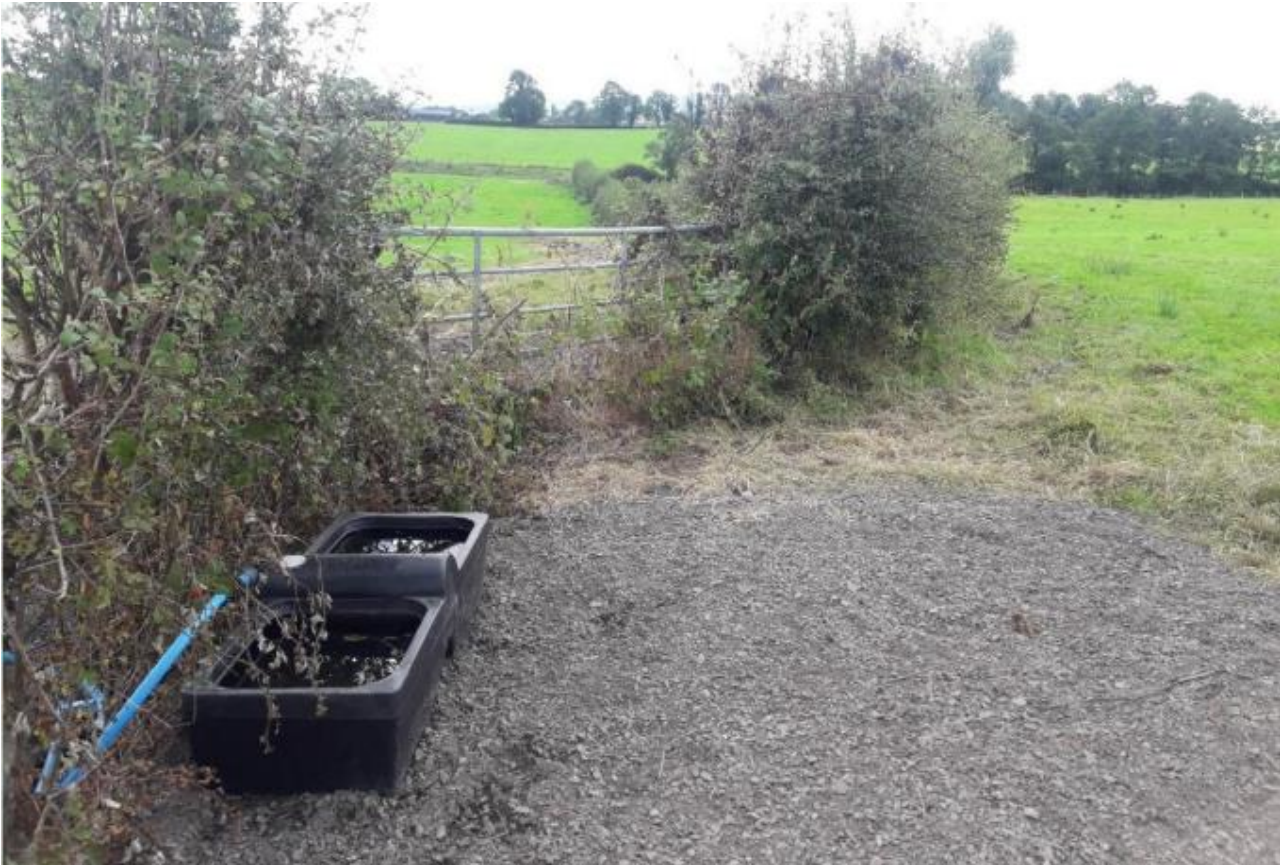
Figure 80: Livestock drinker with hard core installed away from the river to reduce soil exposure and to provide an alternative drinking solution for cattle.

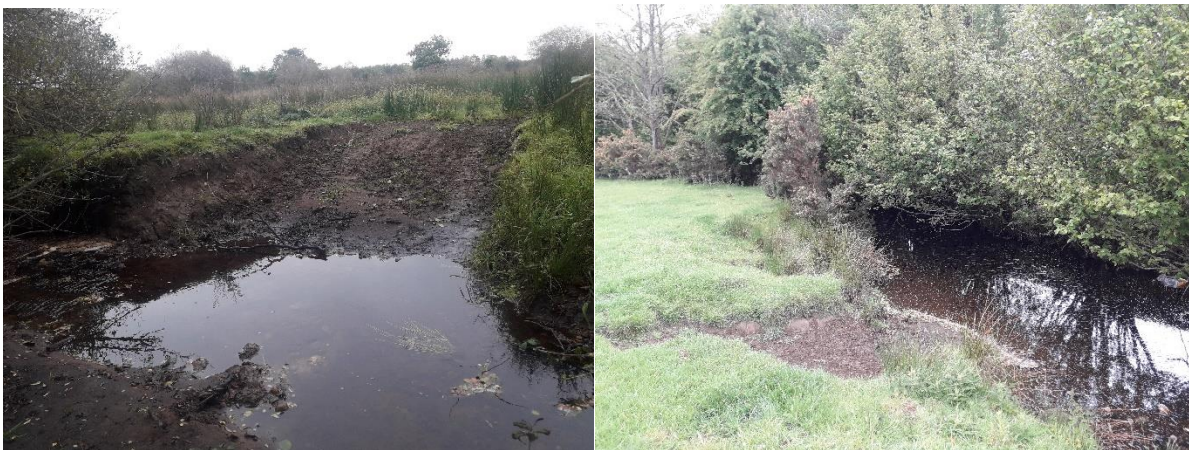
Agriculture practices and impacts have been identified as a pressure on this watercourse. Site walkovers have identified evidence of livestock entering the river at numerous locations causing further erosion of banks and input of excess sediment into the river. Diverse riparian vegetation has been removed from sections of the channels in recent years resulting in a lack of sufficient riparian cover.

Figure 83. Livestock access points.

There are several measures to reduce the agricultural pressures on the river. Measures include fencing along the river and providing alternative drinking sources for livestock.

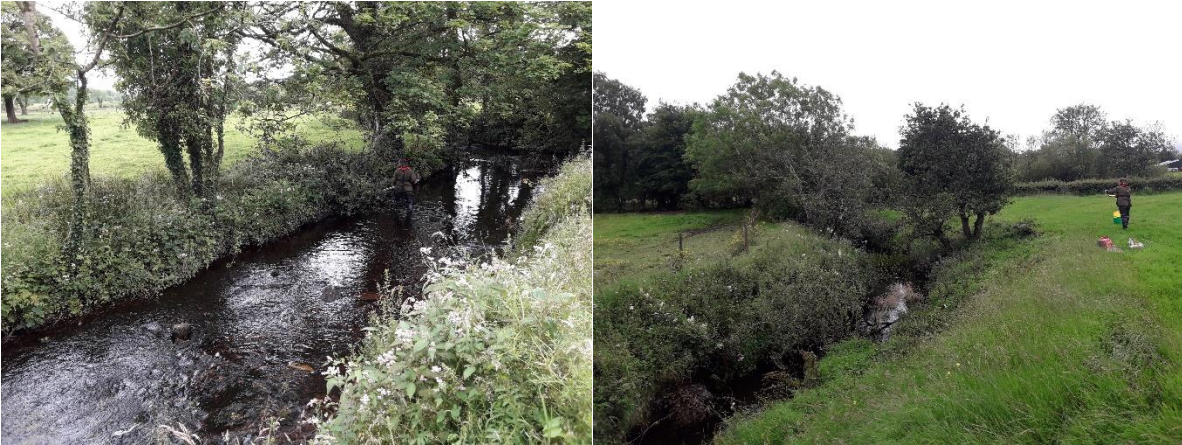
A section at the lower end of the Roo river has been historically altered (deepened) for construction of the railway line. The majority of the channels upstream have not been significantly altered. However, land practices are impacting the channel.

Figure 84. Natural channel morphology (left) and altered over-deepened channel with steep banks (right) 200 m downstream.

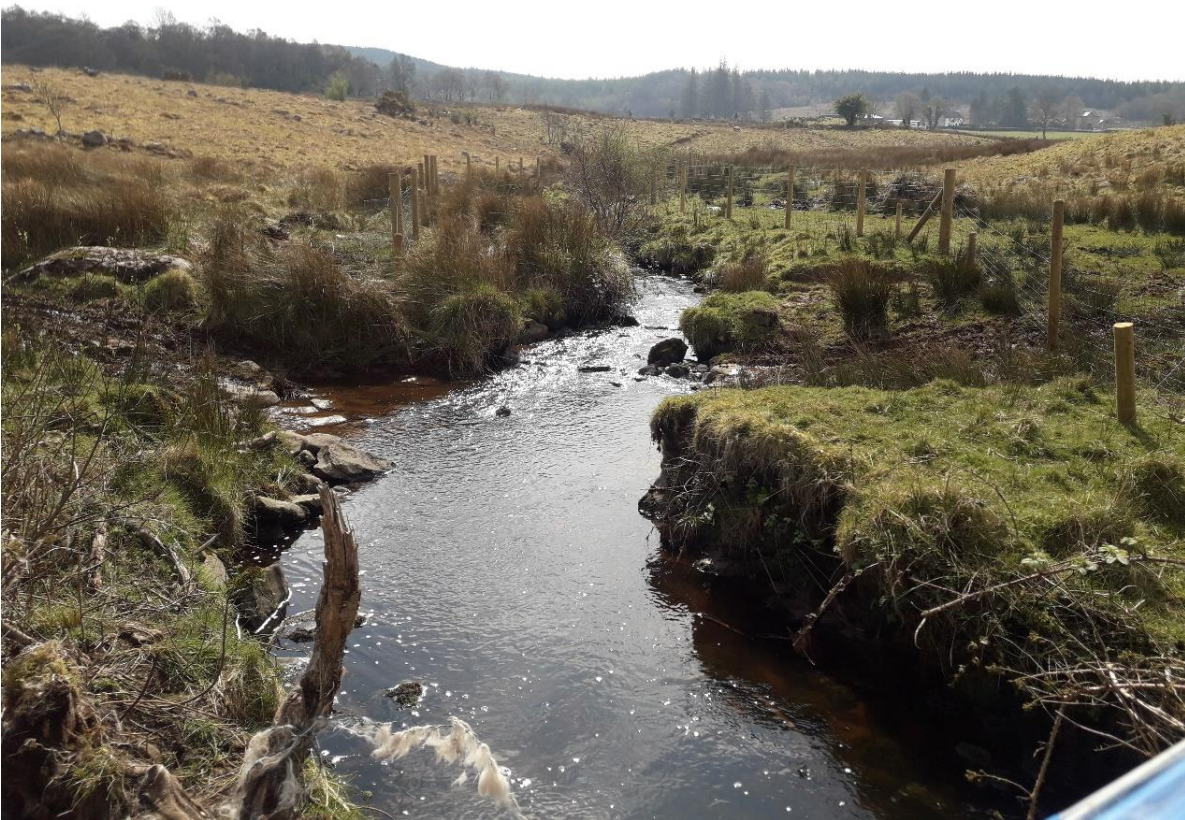
Figure 86. After Year 1.

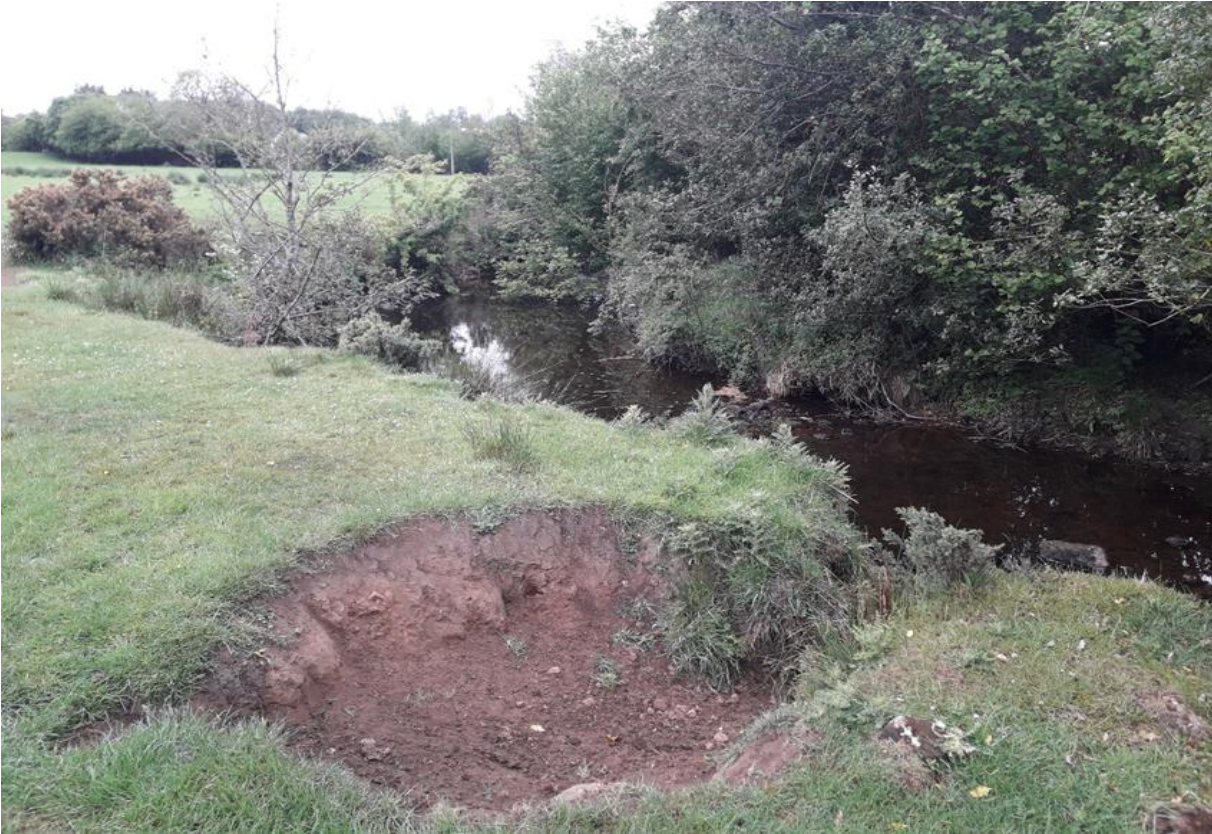
Figure 87. Before. Livestock ingress to channel.

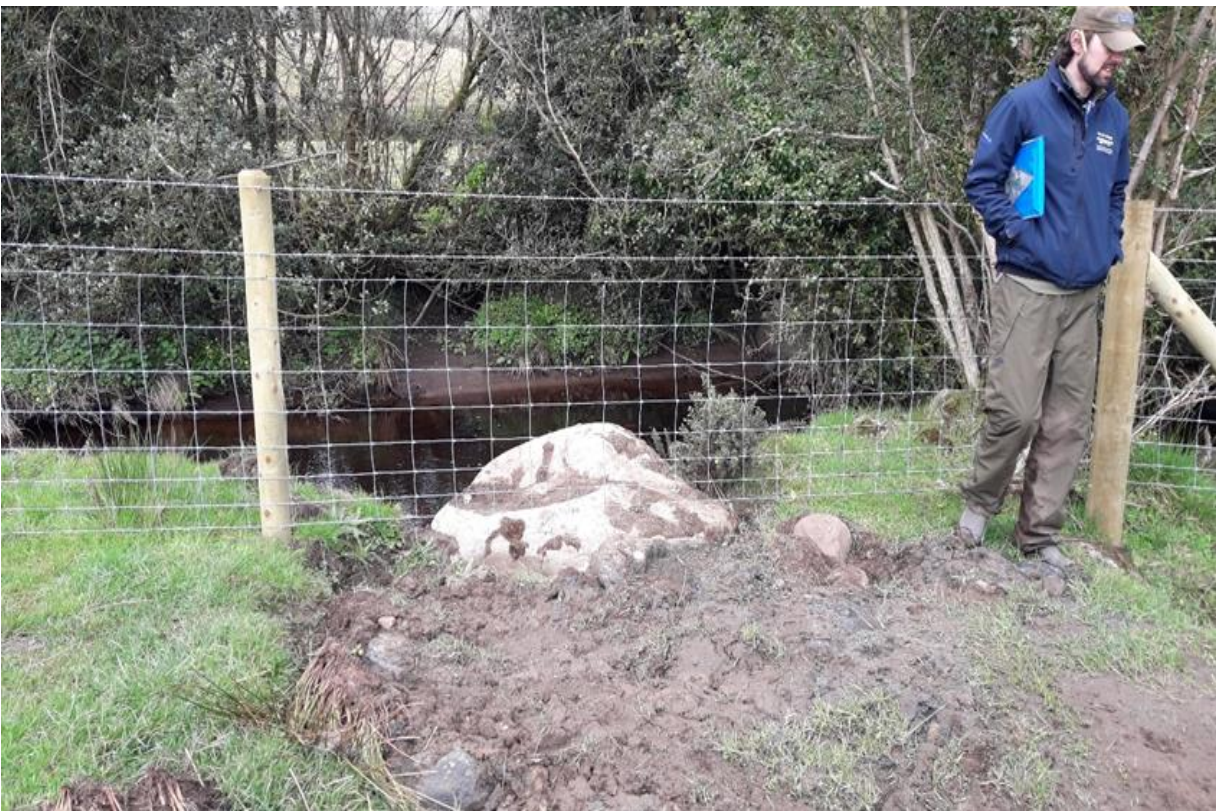
Figure 88. After. Year 1

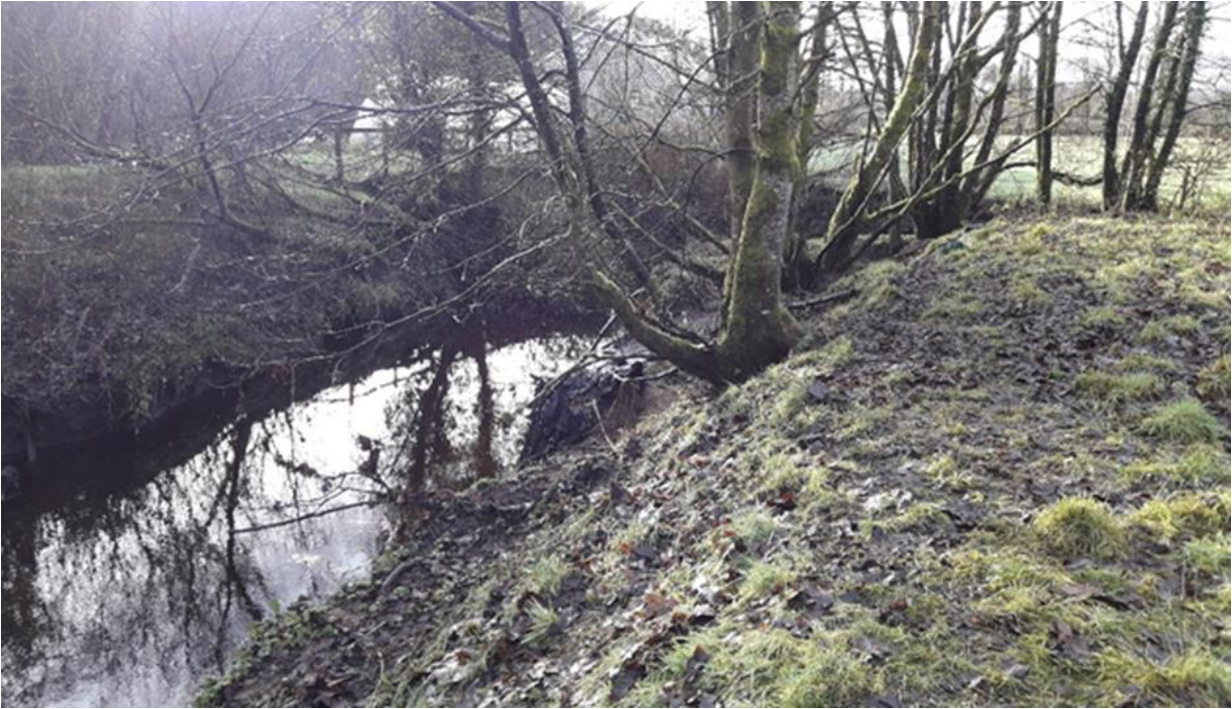
Figure 89. Before. Livestock ingress to channel, excess sediment input.

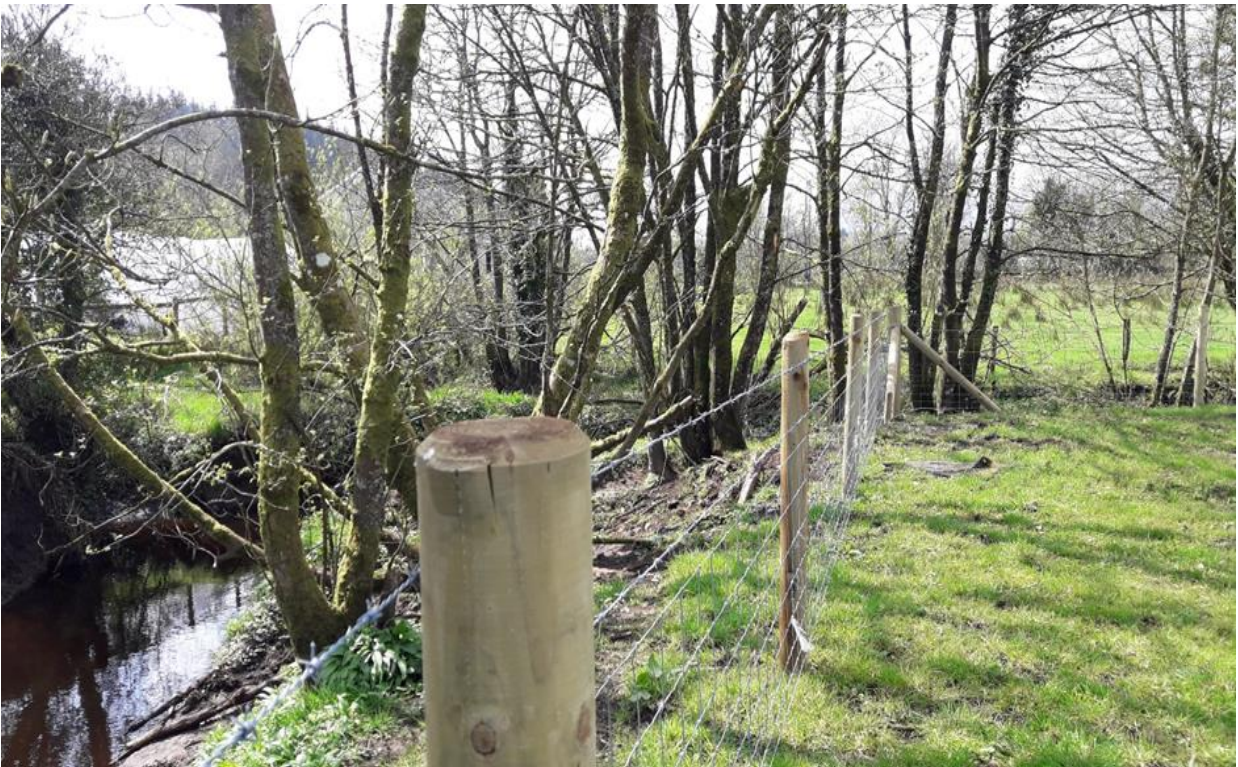
Figure 90. After. Year 1

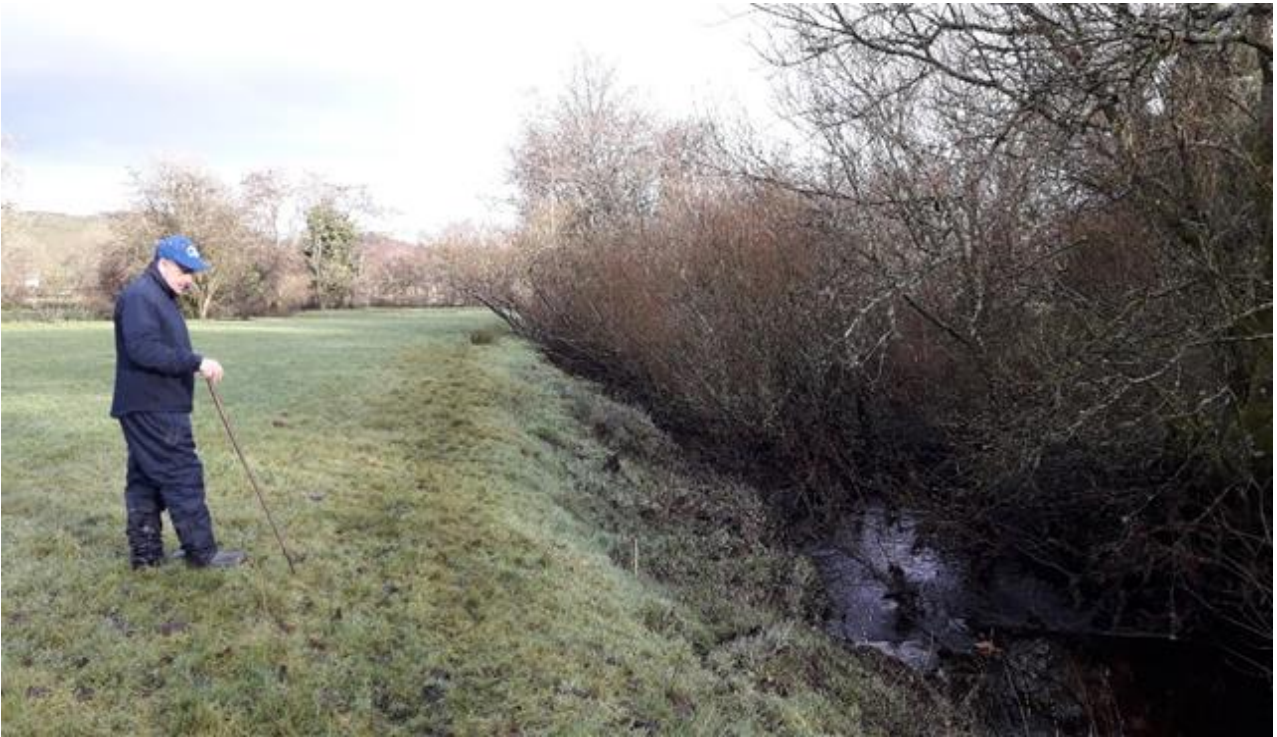
Figure 91. Before. Lack of fencing

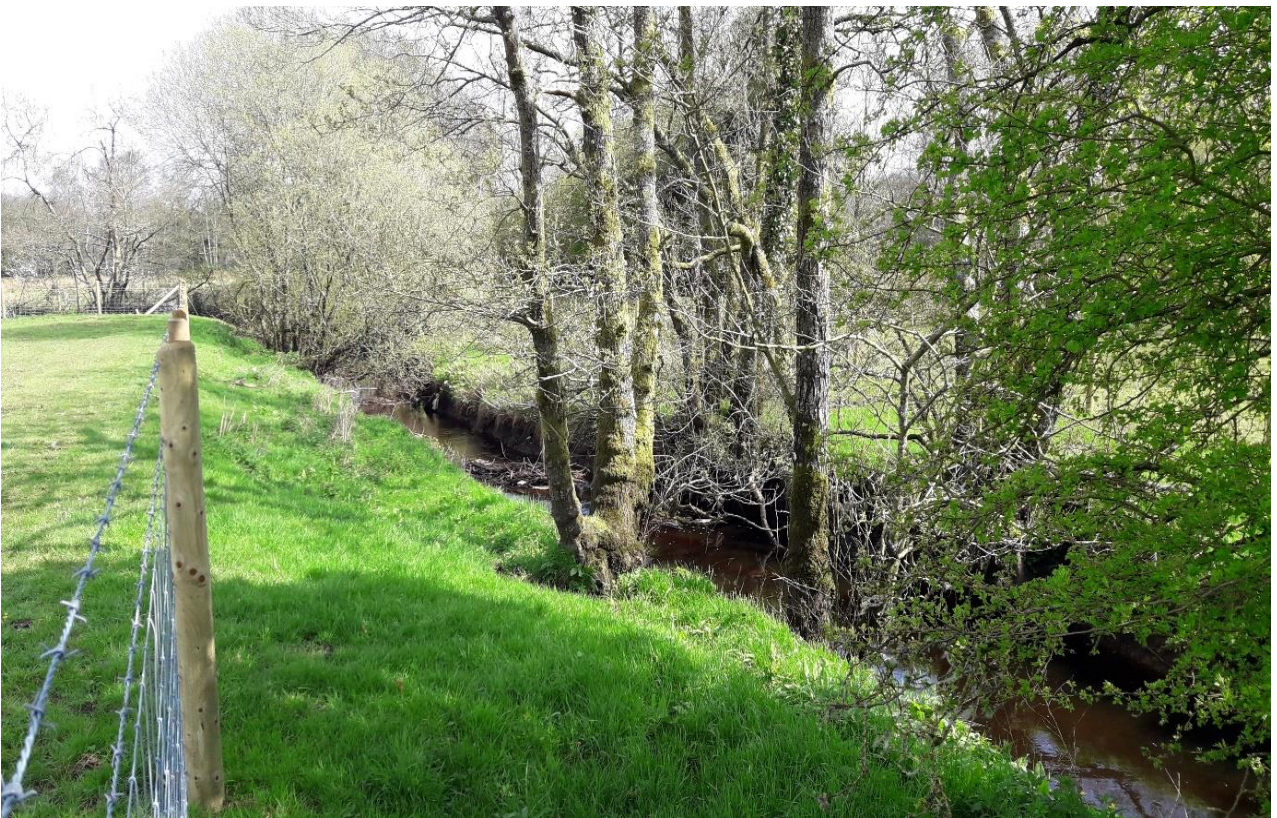
Figure 92. After year 1.
