CatchmentCARE River Restoration Works Report

MARCH 2023

Community Actions for Resilient Ecosystems

A project supported by the European Union's INTERREG VA Programme, managed by the Special EU Programmes Body (SEUPB).

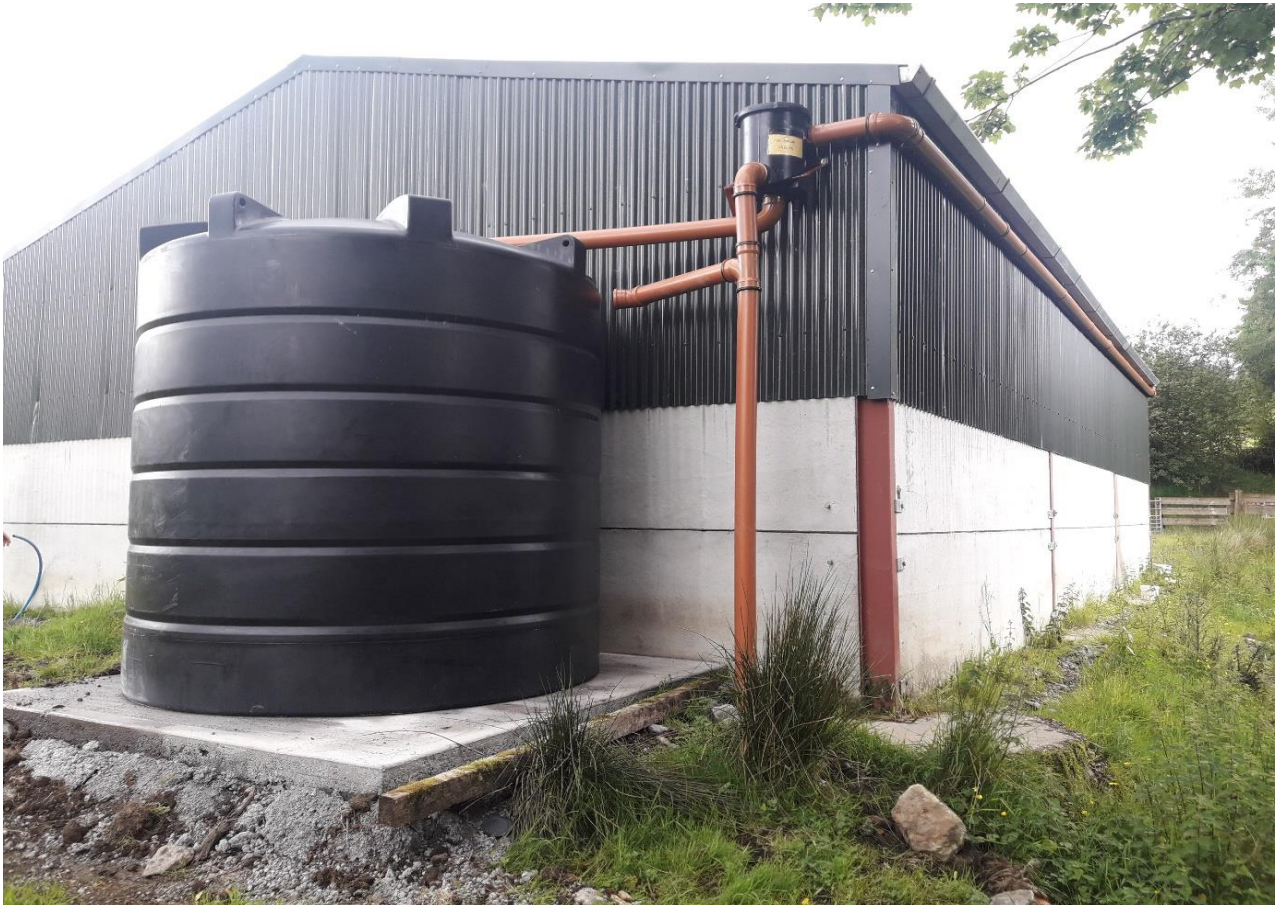
Figure 93. Installation of rainwater harvesting system.

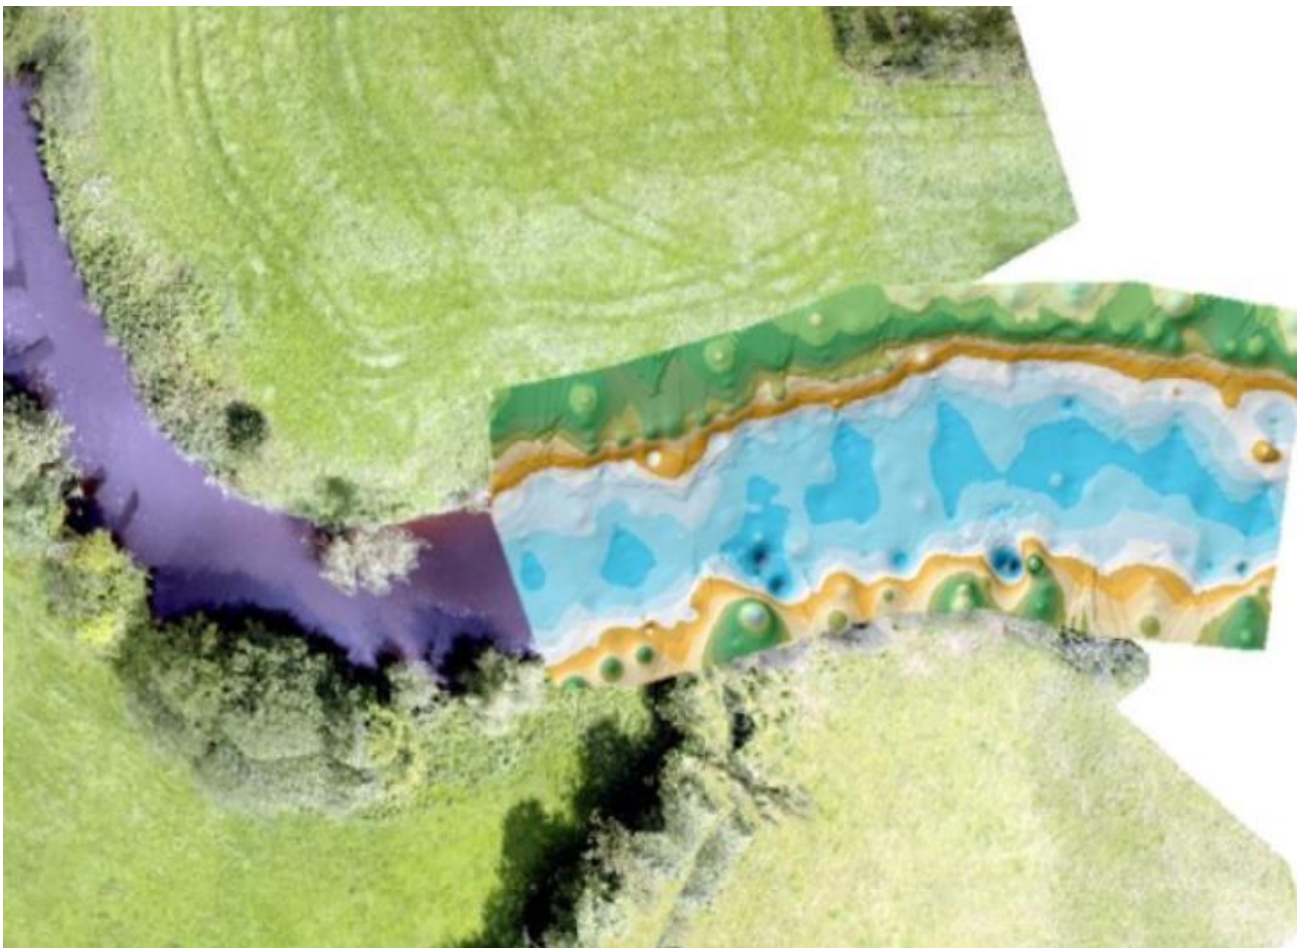
Figure 101: Instream morphology of Site 2 in 2021.

The bank condition and morphology were also monitored (Figure 101). In 2020 we can see this bank is slumping and the farmer was worried about erosion. In 2022, the vegetation is well established as livestock is no longer grazing this area. Willow has self-seeded this area and is starting to stabilize the banks with they're roots.

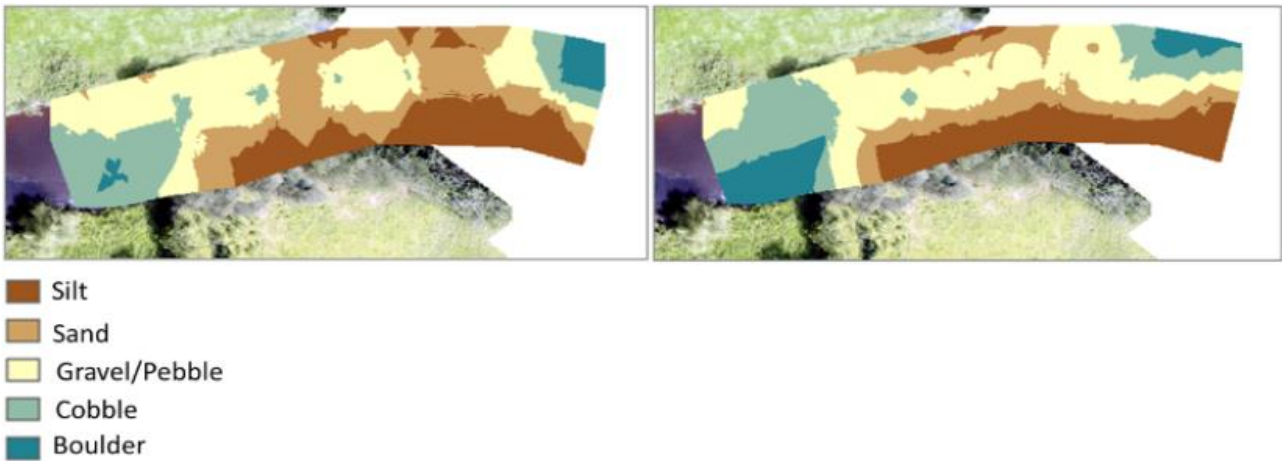
Figure 102: Substrate of silt of site 2 in 2021 (left) and 2022 (right).

Figure 102 shows substrate distribution throughout the section of the channel in 2021 and 2022. Note how it has changed in one year.

There was a cattle poaching area on the right bank (southern bank). Cattle were walking in the river and as a result there was excess fine sediment across channel. In 2022, the poaching area has been fenced. Fine sediment is being pushed to the river margins exposing more gravel pebble in river channel. A reduction of excess fine sediment within the channel should have a positive effect on water quality.

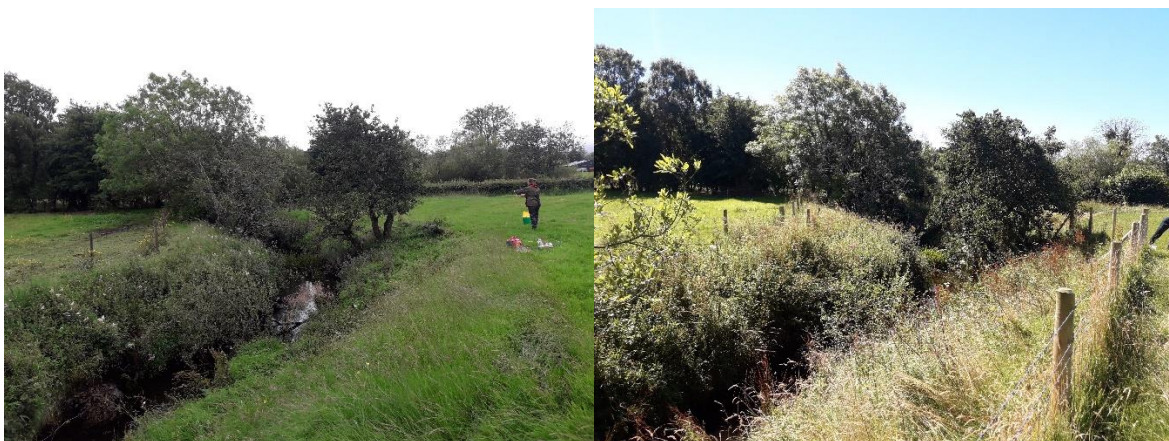
Hydromorphology was also assessed using a BACI approach. Eight attribute scores were collected for each RHAT survey. The difference in attribute score between control pre, control post, treatment pre and treatment post were examined. RHAT survey results show an increase in score from 2020 to 2022 in the impact site (Table 2). However, there was no increase in score at the control site (Table 3). Attributes that increased were ‘Channel Vegetation’ and ‘Channel Form and Flow Types’, due to increase diversity in flow types as a result of measures and allowing natural river process to take place. ‘Bank structure & Stability’ and ‘Bank Vegetation’ also increased due to livestock exclusion measures and increased vegetation growth (Figure 108-Figure 110).

Figure 108. Bank vegetation before and after measures.

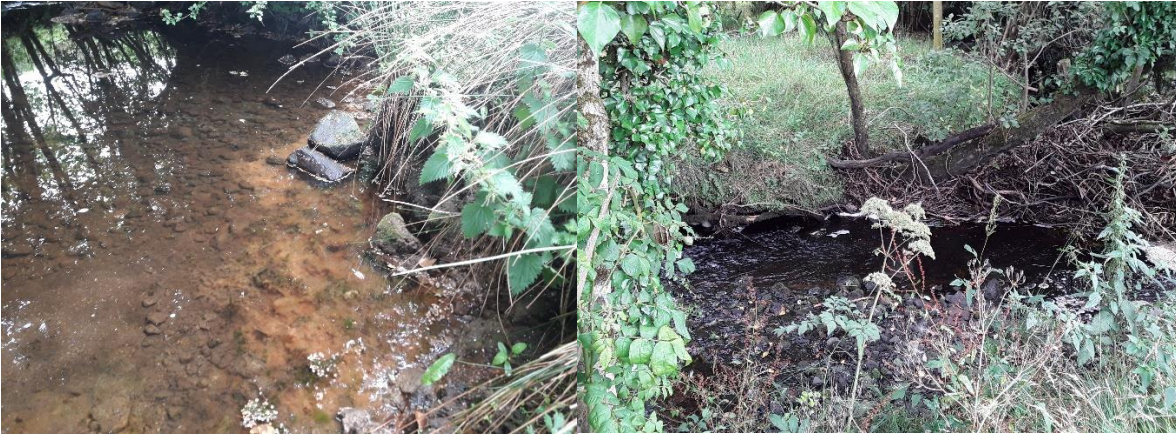
Figure 109. Substrate condition before and after measures.

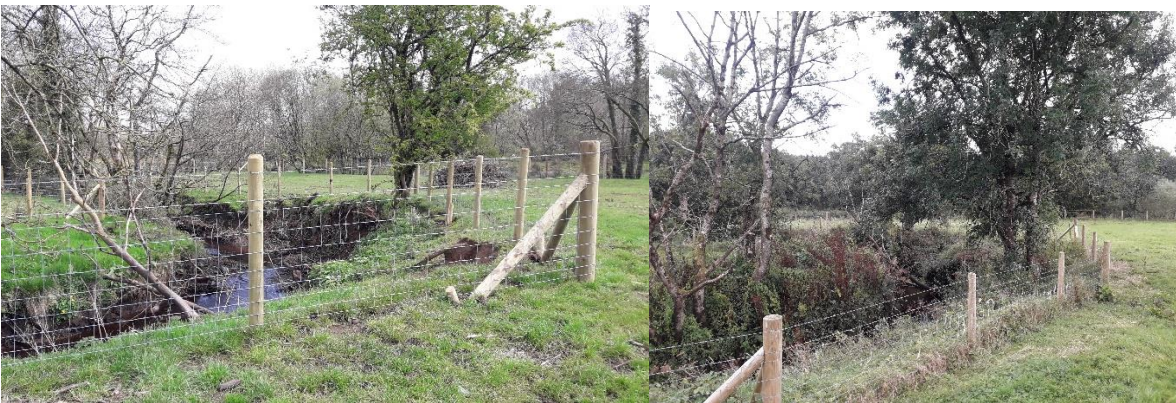
Figure 110. Bank structure & Stability during installation of measures and after measures have taken effect.

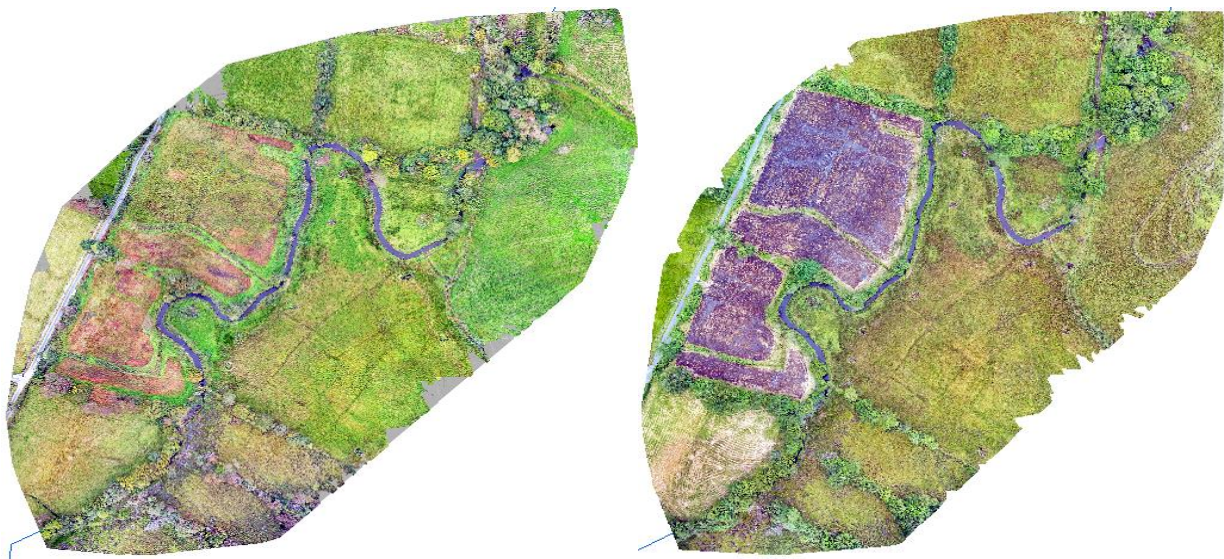
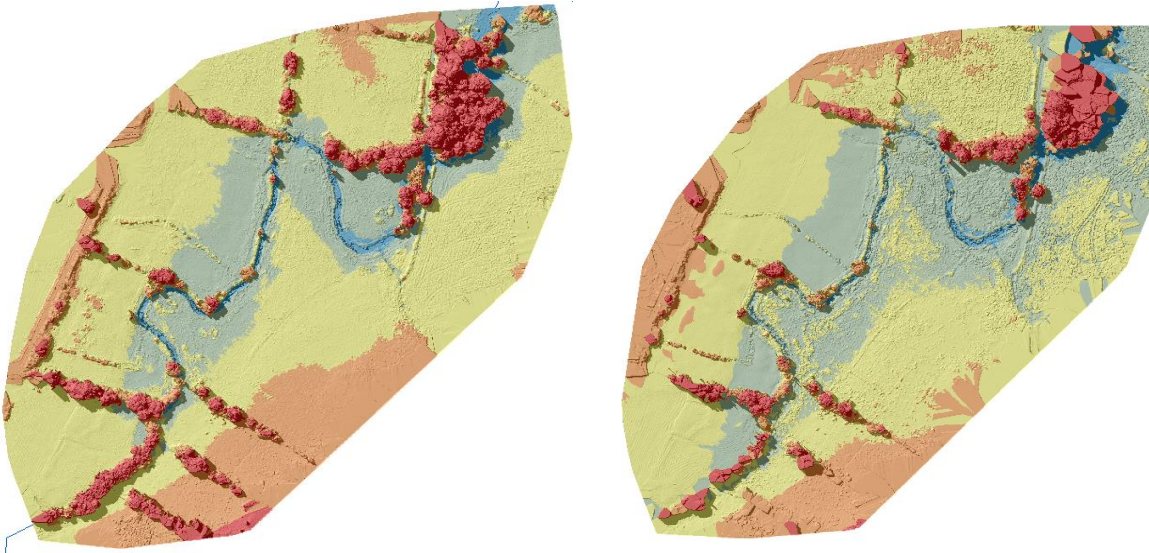
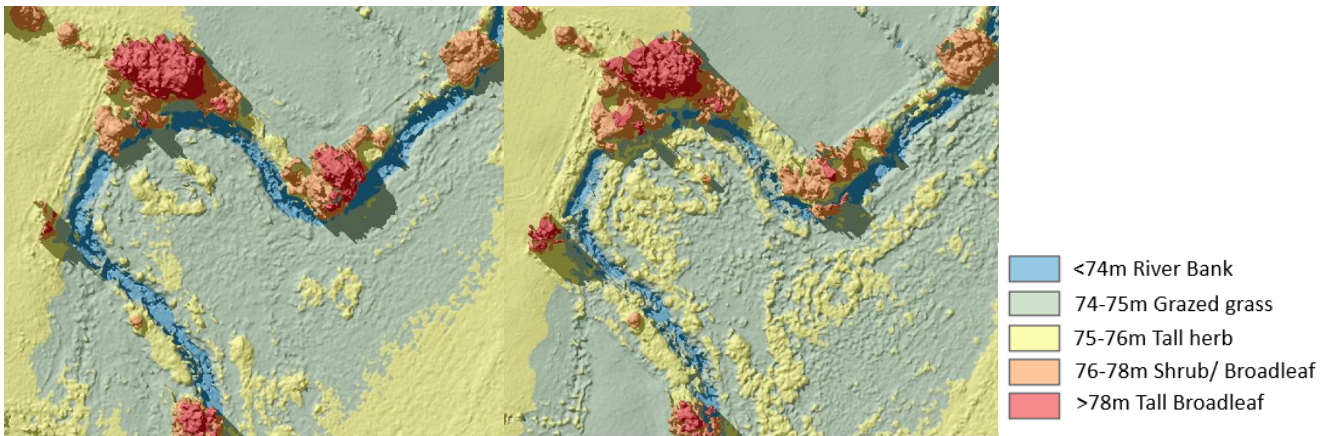
Figure 112. Orthomosaic of site 4 in 2021 (left) & 2022 (right).

Site 4 has reduced riparian cover, shown with DSM in Figure 112-Figure 114. The spikes in high temperature is likely due to the reduced riparian cover and shallower mean depth of river in this section. The stream where Site 11 is located rises from Barran spring and joins the main Roo channel. It also has been subject to tree removal in the past and has reduced riparian cover. The lower temperatures are a result of the cold spring water feeding the stream. Overall, varying temperature records throughout the waterbody indicate a patchy riparian cover where higher temperatures are as a result of areas with reduced riparian cover. It is predicted to see a reduction in temperature spikes with more vegetation growth, making it more habitable for biota.

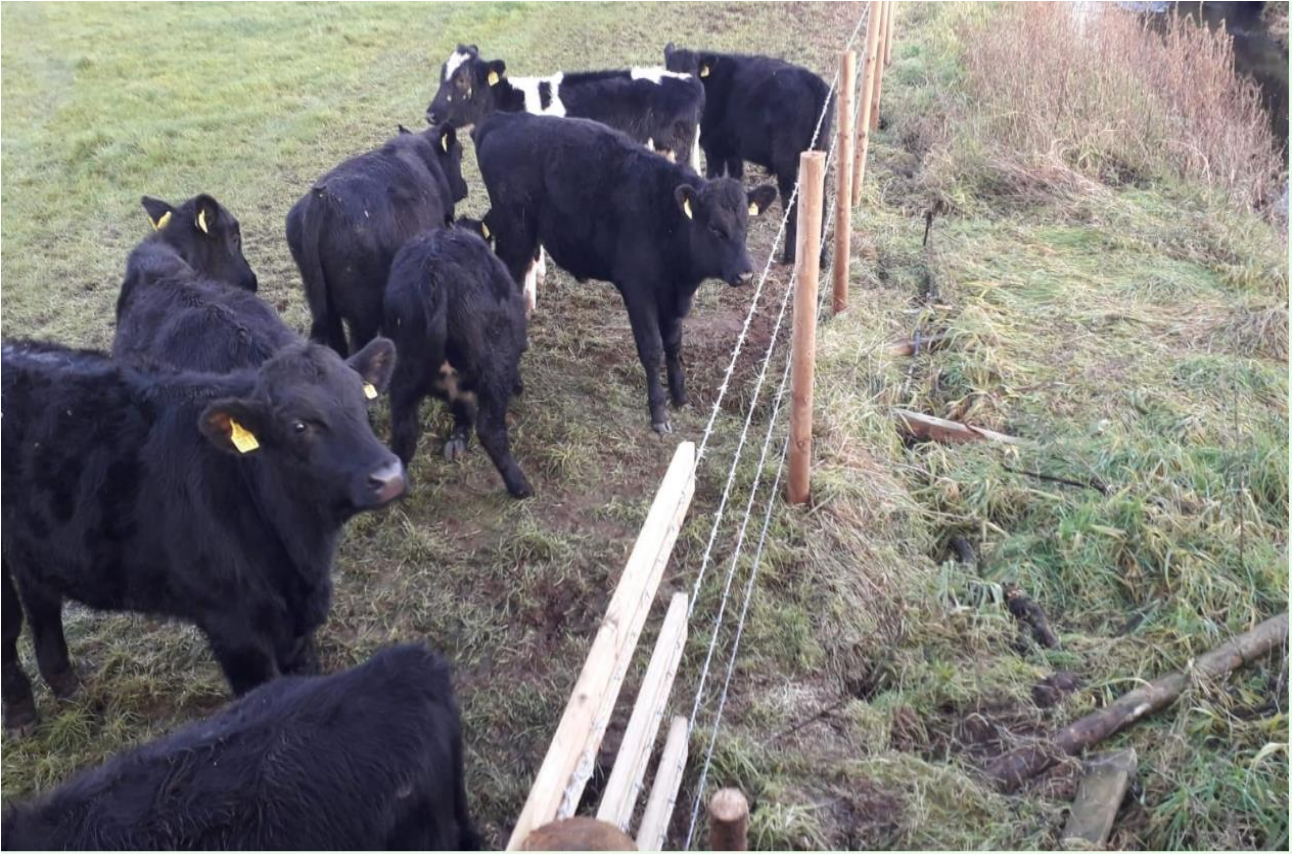
Figure 122: fencing installed to prevent livestock from accessing the river.

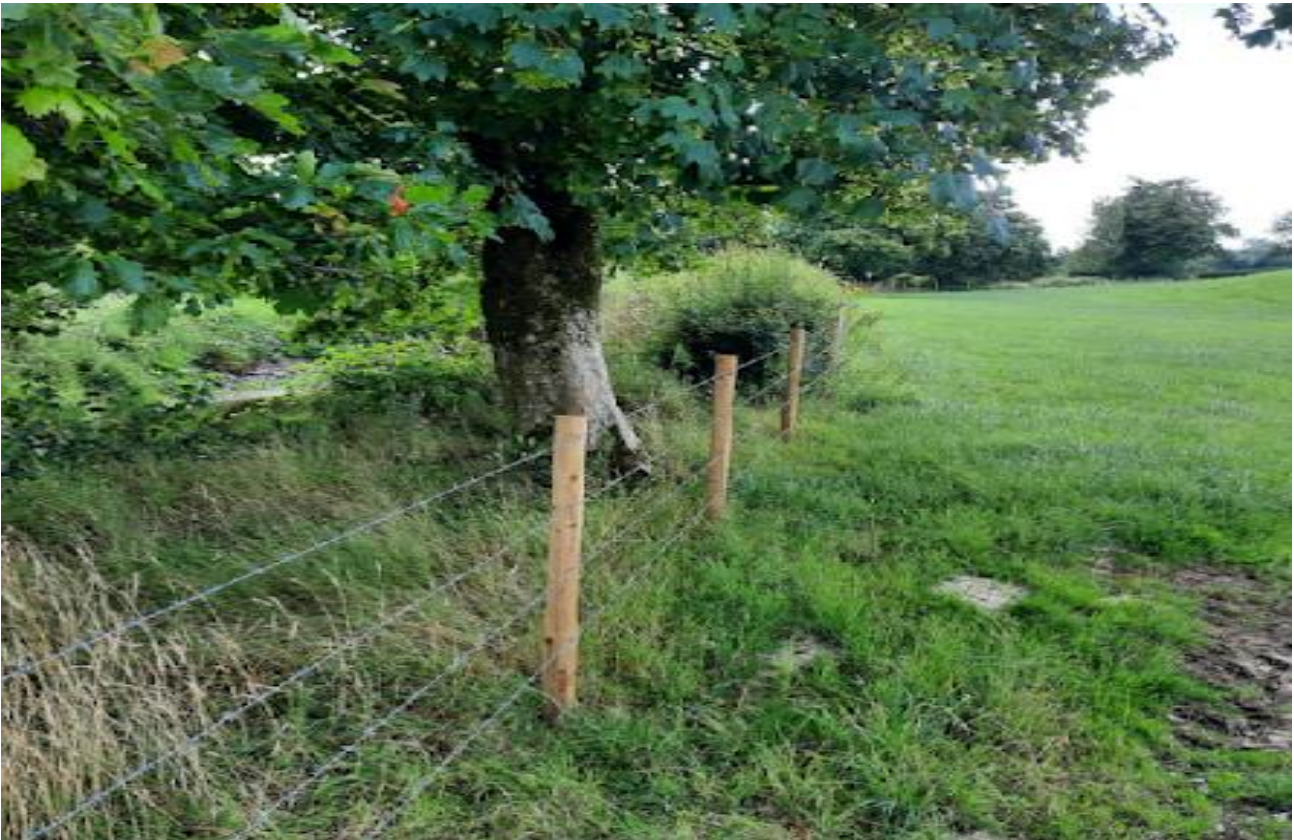
Figure 124: Fencing Installed

- Installation of livestock fencing (4 row of barbed wire) over 4.6 km of riverbank.

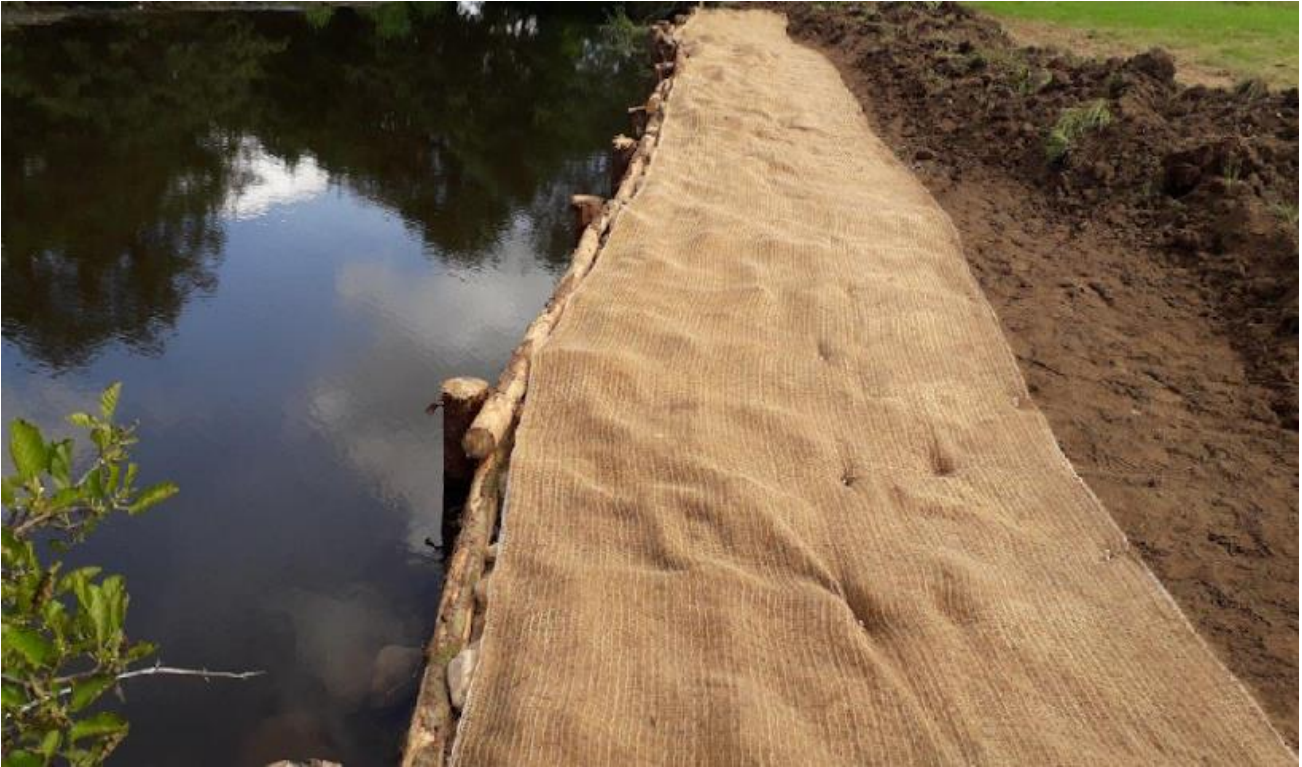
Figure 125: Coir Matting Installed

- A range of deep water revetment measures were introduced along 4.5km of river at 3 sites – these included ‘toe revetment’ using cobbled stone, ‘log walls’ and ‘coir matting’.

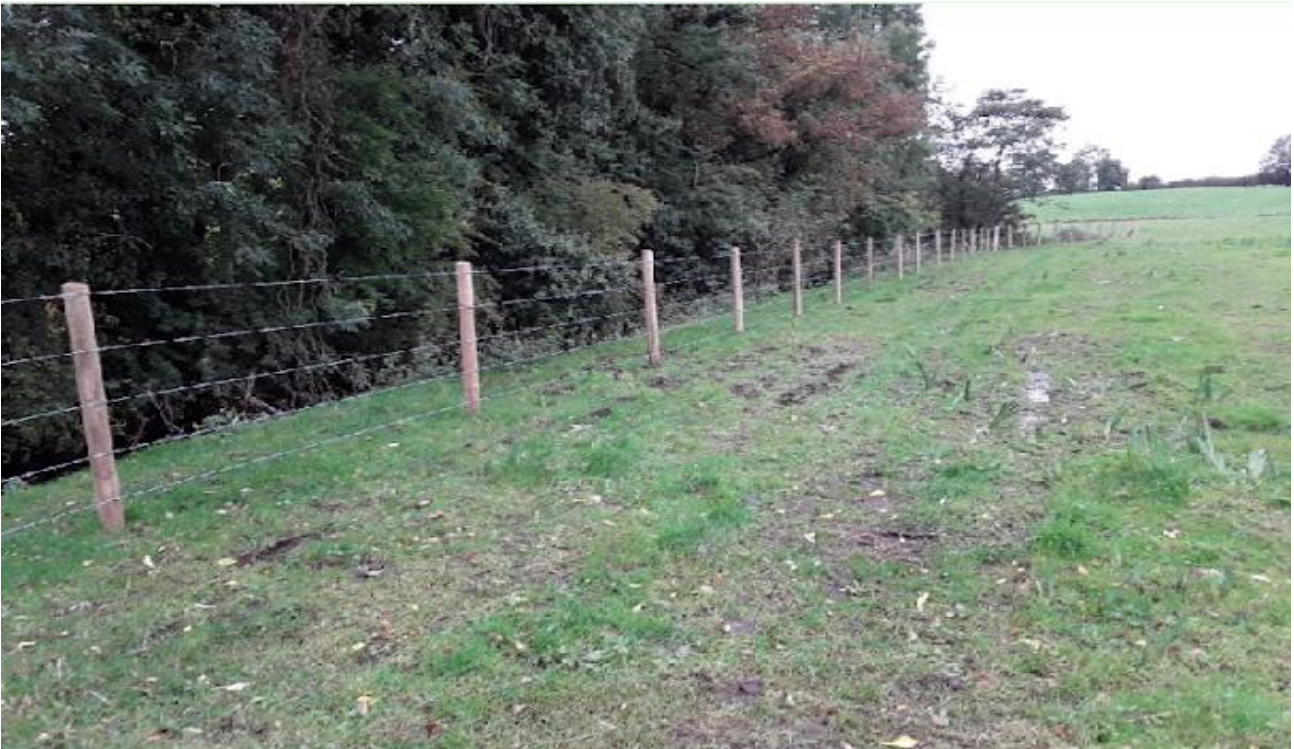
Figure 127: Fencing Installed

- Installation of livestock fencing (5 rows of barbed wire) over 2.2 km of riverbank.

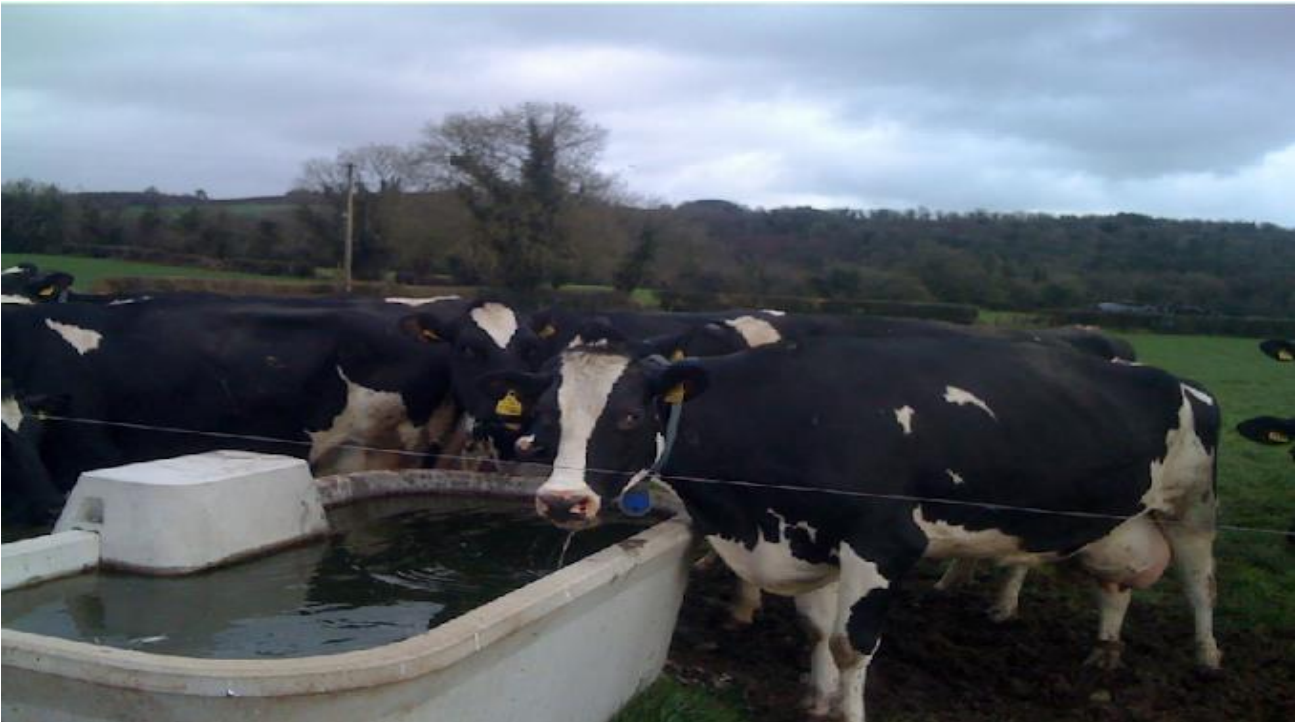
Figure 129: Cattle drinkers installed as part of the remediation works

- Installation of livestock fencing (4 rows of barbed wire) over 430 metres of riverbank.
- Installation of 2 stiles for access to the river for anglers, landowners and other stakeholders such as NIEA staff to facilitate water testing.
- Installation of Two 4 gallon livestock drinkers (concrete) and 9 x 45 gallon livestock drinkers (Plastic) plus 880 m Of 25 mm pipe work (buried 400 mm).

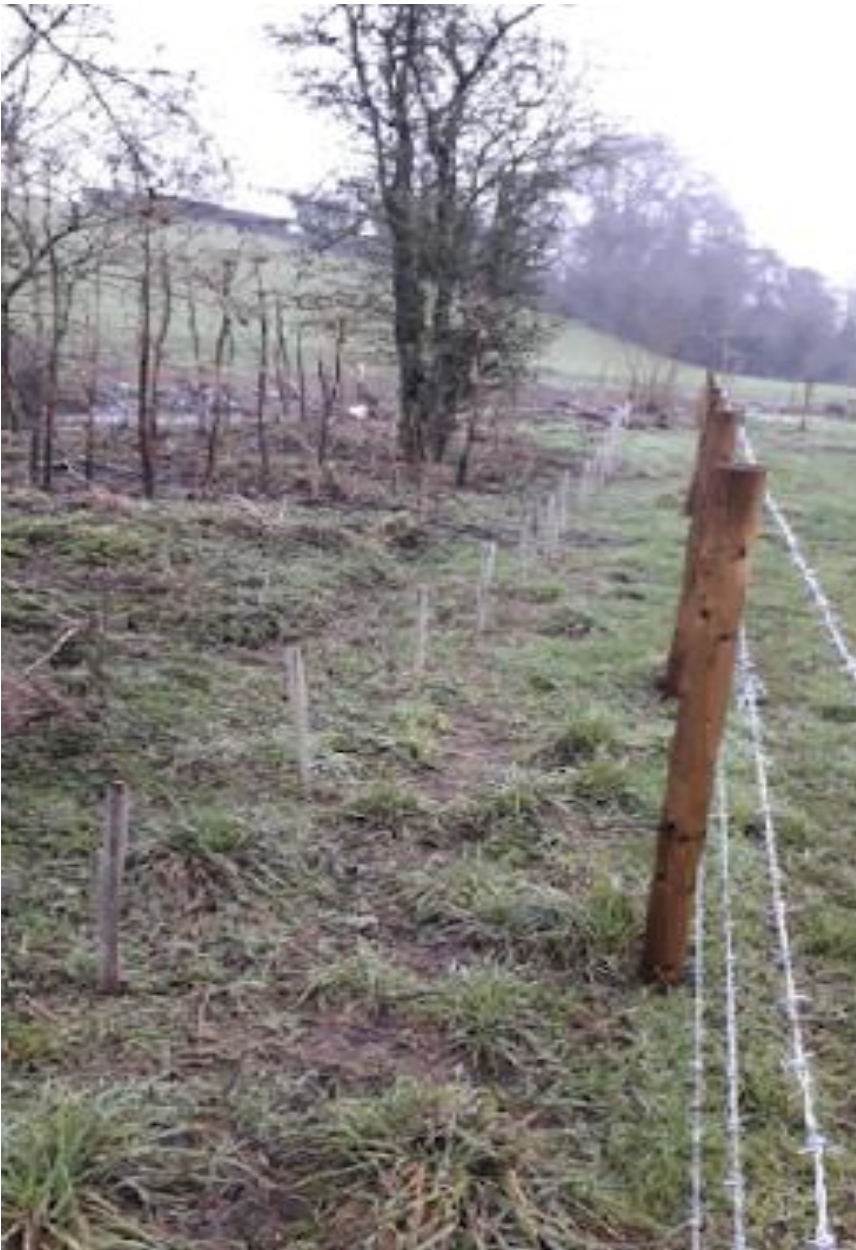
Figure 131: Trees planted

- Installation of 6 galvanised steel gates to allow access to individual fields
- Removal of 51 trees (Dead Alders) and overhanging branches in the watercourse over 3.2 km
- Planting of 1,500 native tree saplings (2-5 year old). A mix of native hardwood species was planted (Whitethorn, Crab Apple, Downey Birch, Silver Birch, Scots Pine, Spindle, Oak, Blackthorn Cherry, Rowan, Guelder Rose, Hazel, Sycamore, and Horse Chestnut). Tree protectors and stakes were included.

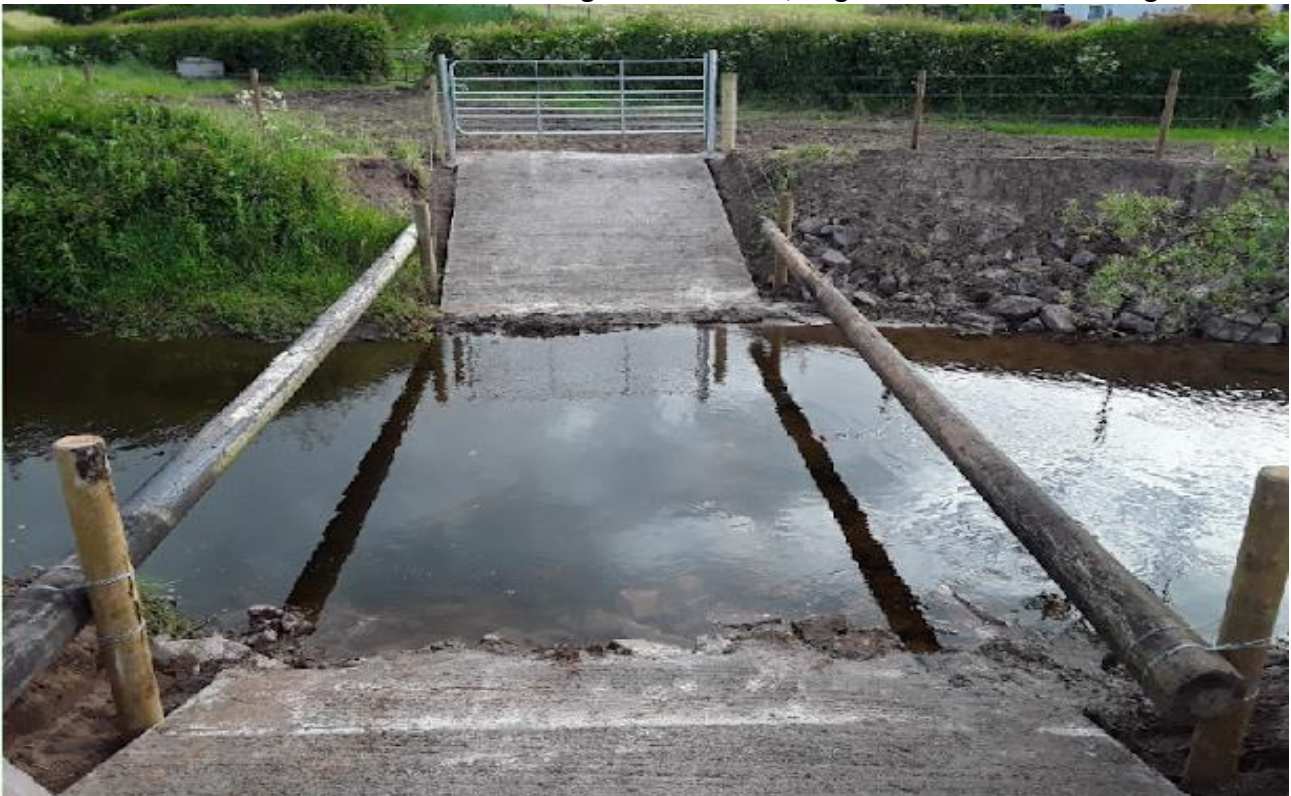
Figure 133: River crossing installed

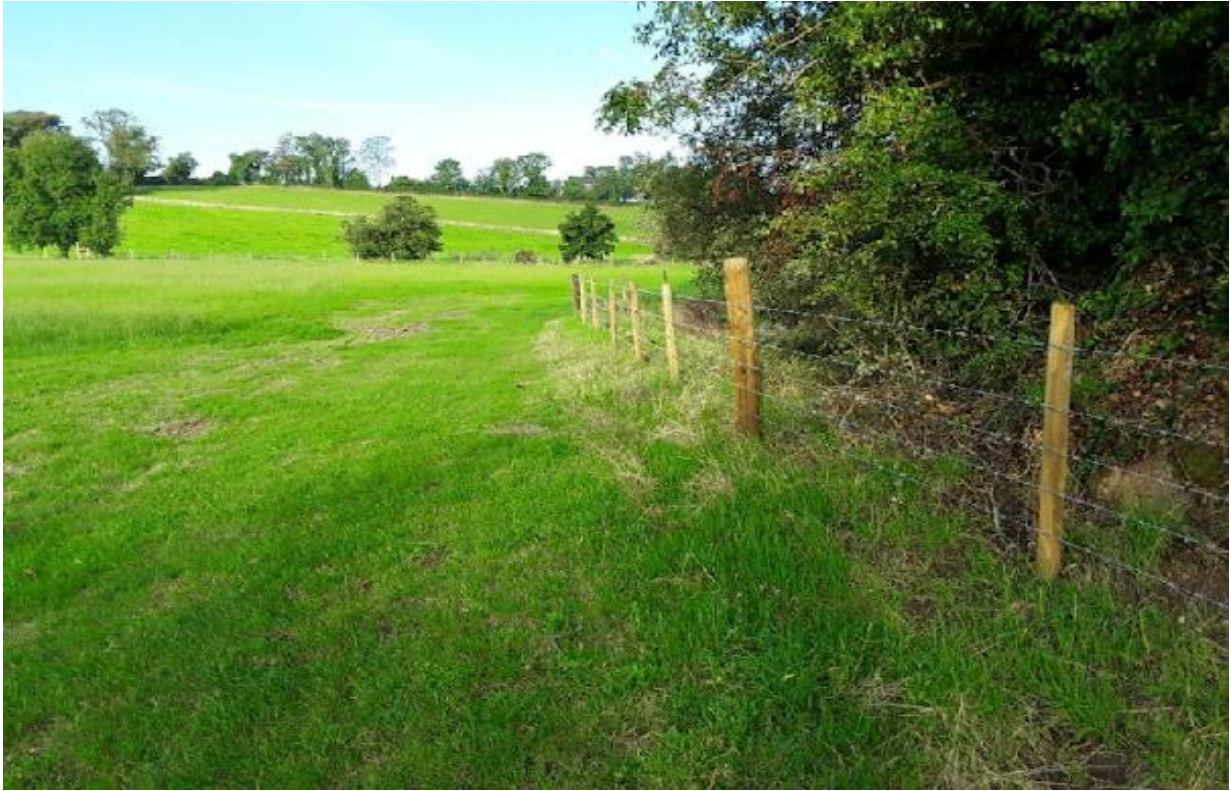
Figure 135: Fencing installed

- Installation of livestock fencing sheep proof fencing (3 rows of barbed wire and sheep proof wire) over 4 km of river bank.

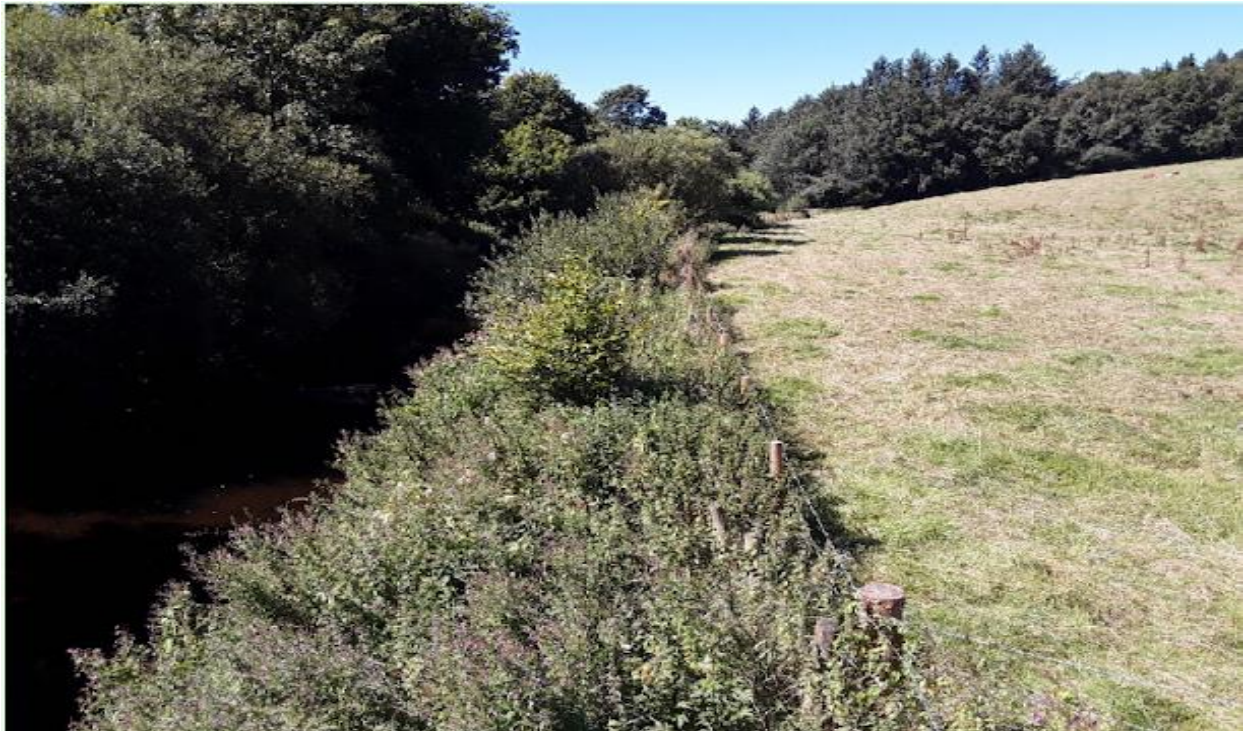
Figure 136: Riparian margin implemented

- Installation of 26 livestock drinkers
- Planting of 4,000 native tree saplings (2-5 years old). A mix of native hardwood species was planted (Whitethorn, Crab Apple, Downey Birch, Silver Birch, Scots Pine, Spindle, Oak, Blackthorn Cherry, Rowan, Guelder Rose, Hazel, Sycamore, and Horse Chestnut). Tree protectors and stakes were included.

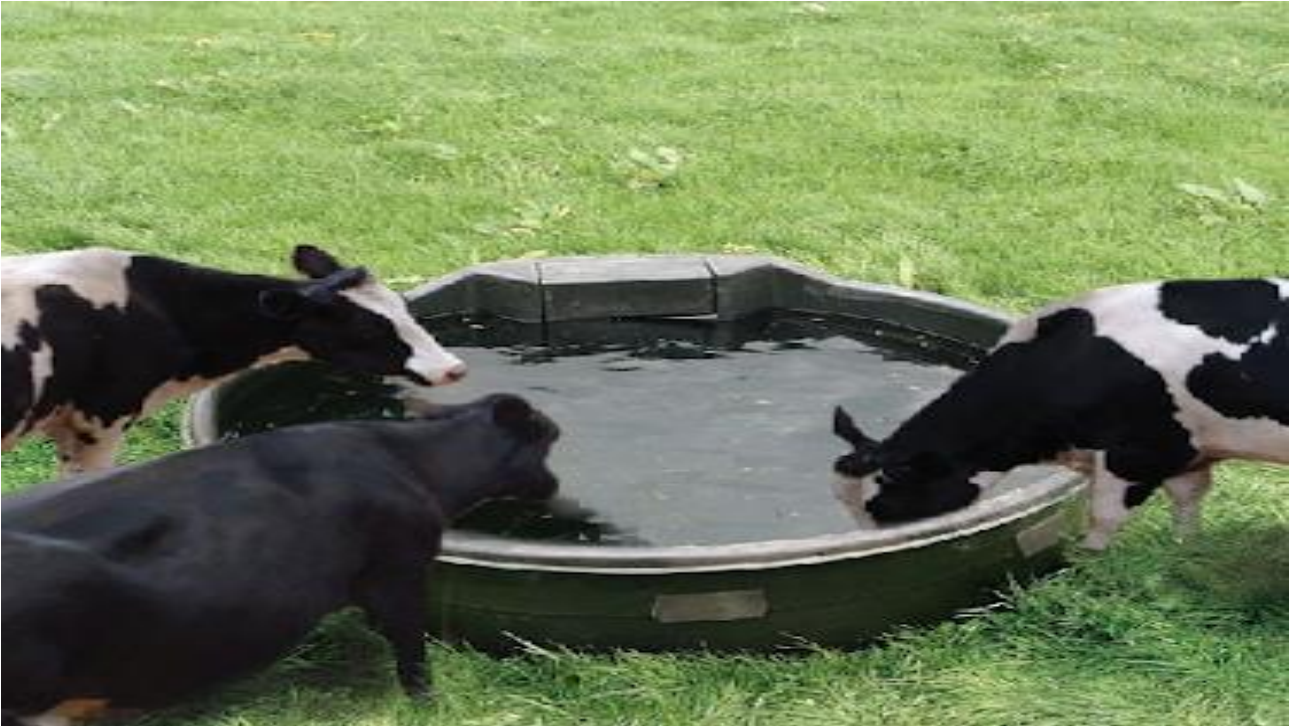
Figure 139: Cattle drinkers installed

- Installation of livestock fencing (4 row of barbed wire) over 2.1 km of riverbank
- Installation of 3 stiles for access to river for anglers, landowners and other stakeholders such as NIEA staff to facilitate water testing
- Installation of 3 livestock drinkers and associated pipework to provide water for cattle and sheep over 2.1 km of farmland.

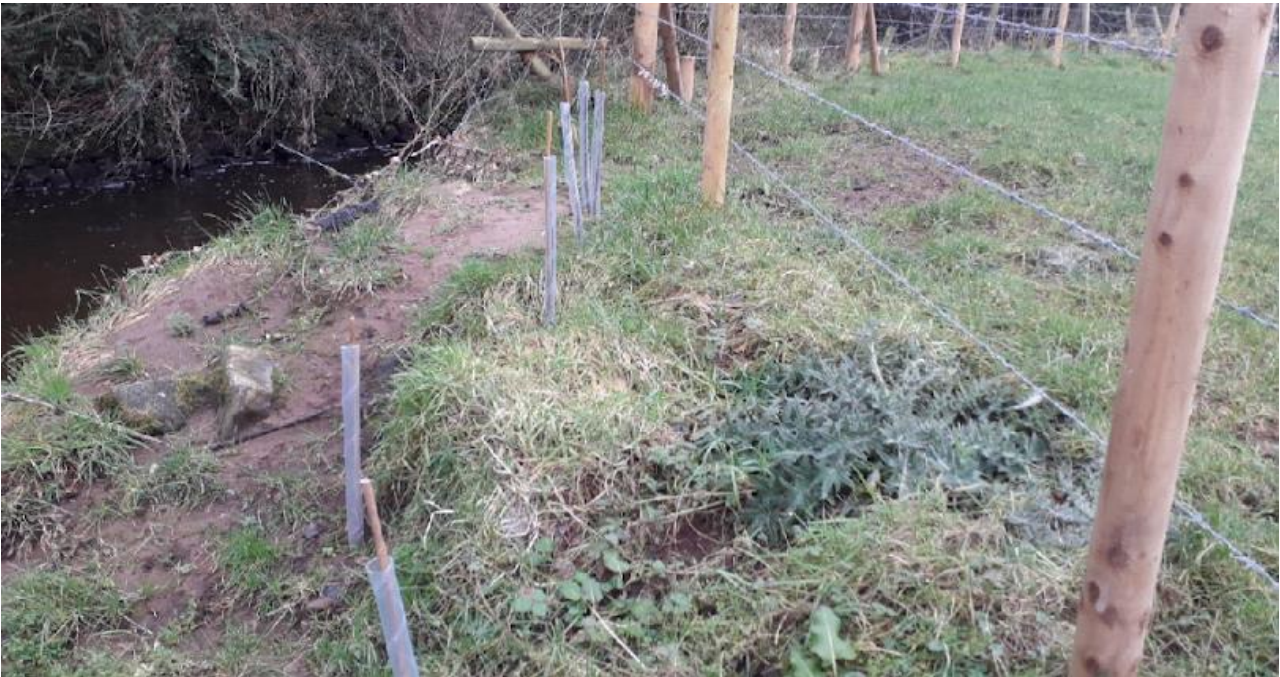
Figure 142: Planting and fence implemented

- Installation of 12 stiles
- Installation of 2* 14 ft long steel gates
- Installation of livestock electric fencing (2 row of high tension) over 2 km of riverbank
- Planting of x 950 native samplings (Whitethorn, Crab Apple, Downey Birch, Silver Birch, Scots Pine, Spindle, Oak, Blackthorn Cherry, Rowan, Guelder Rose, Hazel, Sycamore, and Horse Chestnut).

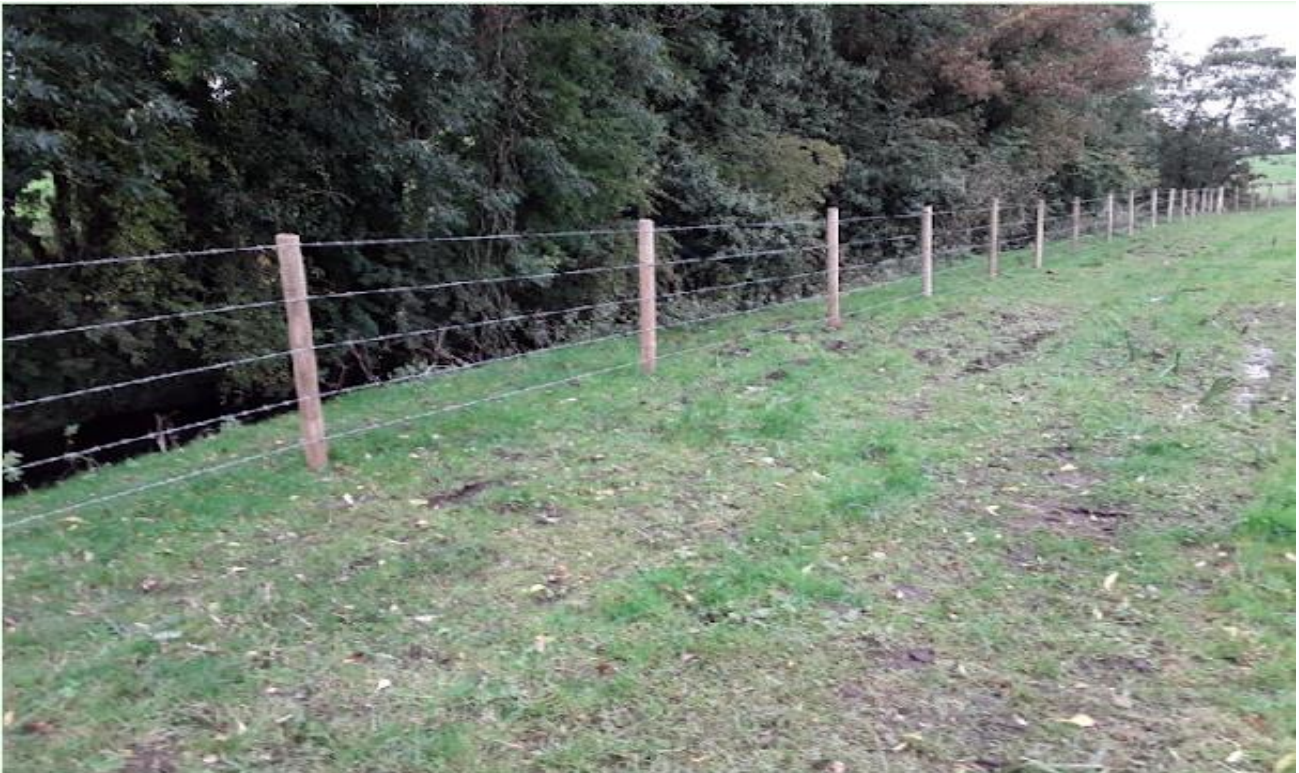
Figure 145: Fencing installed to prevent livestock access to river

- Installation of livestock fencing (5 rows of barbed wire) over 2.7 km of riverbank.

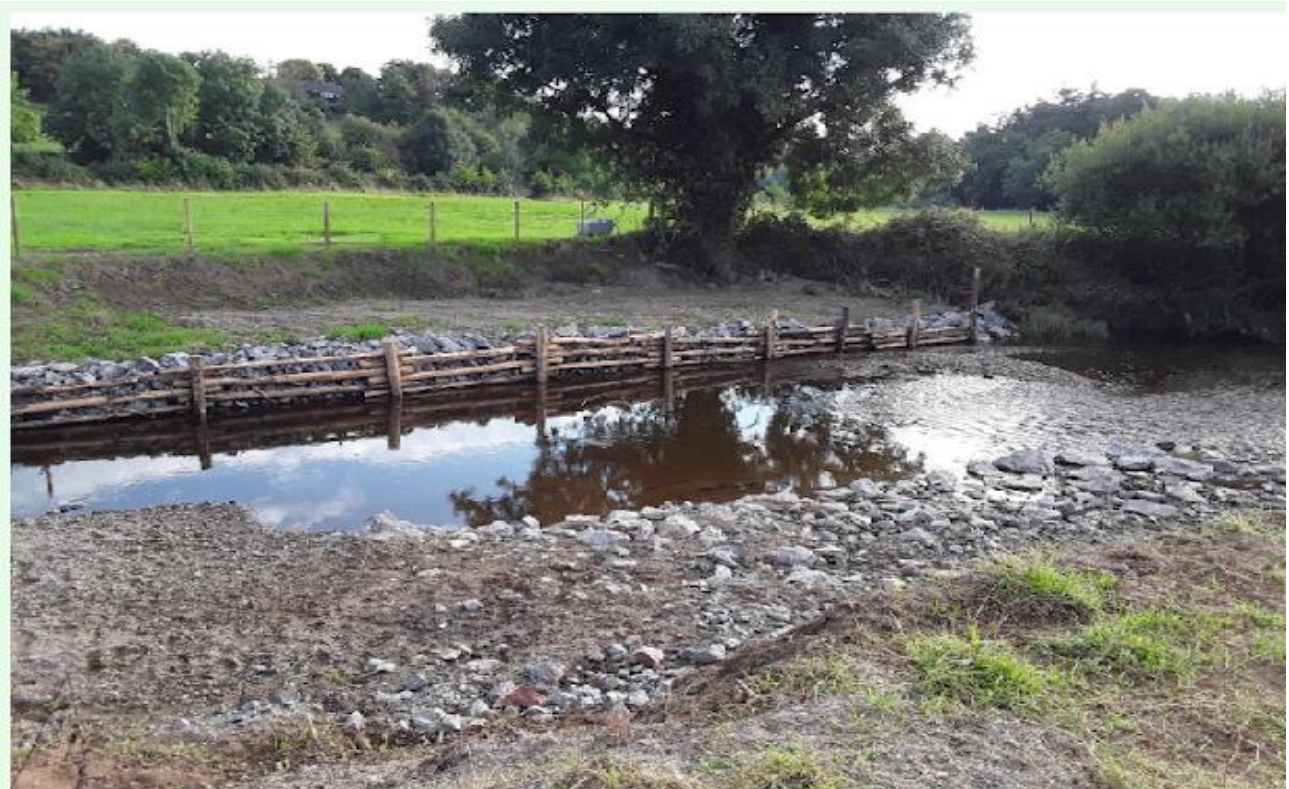
Figure 146: Log wall implemented

- Installation of 10 stiles for access to river for anglers, landowners and other stakeholders such as NIEA staff to facilitate water testing
- Planting of 1,500 native tree saplings (2-5 year old). A mix of native hardwood species was planted (Whitethorn, Crab Apple, Downey Birch, Silver Birch, Scots Pine, Spindle, Oak, Blackthorn Cherry, Rowan, Guelder Rose, Hazel, Sycamore, Horse Chestnut). Tree protectors and stakes were included.
- Supply and installation of livestock drinkers x8
- A range of deep water revetment measures were introduced along 430m of river – these included ‘toe revetment’ using cobbled stone, ‘log walls’ and ‘coir matting’

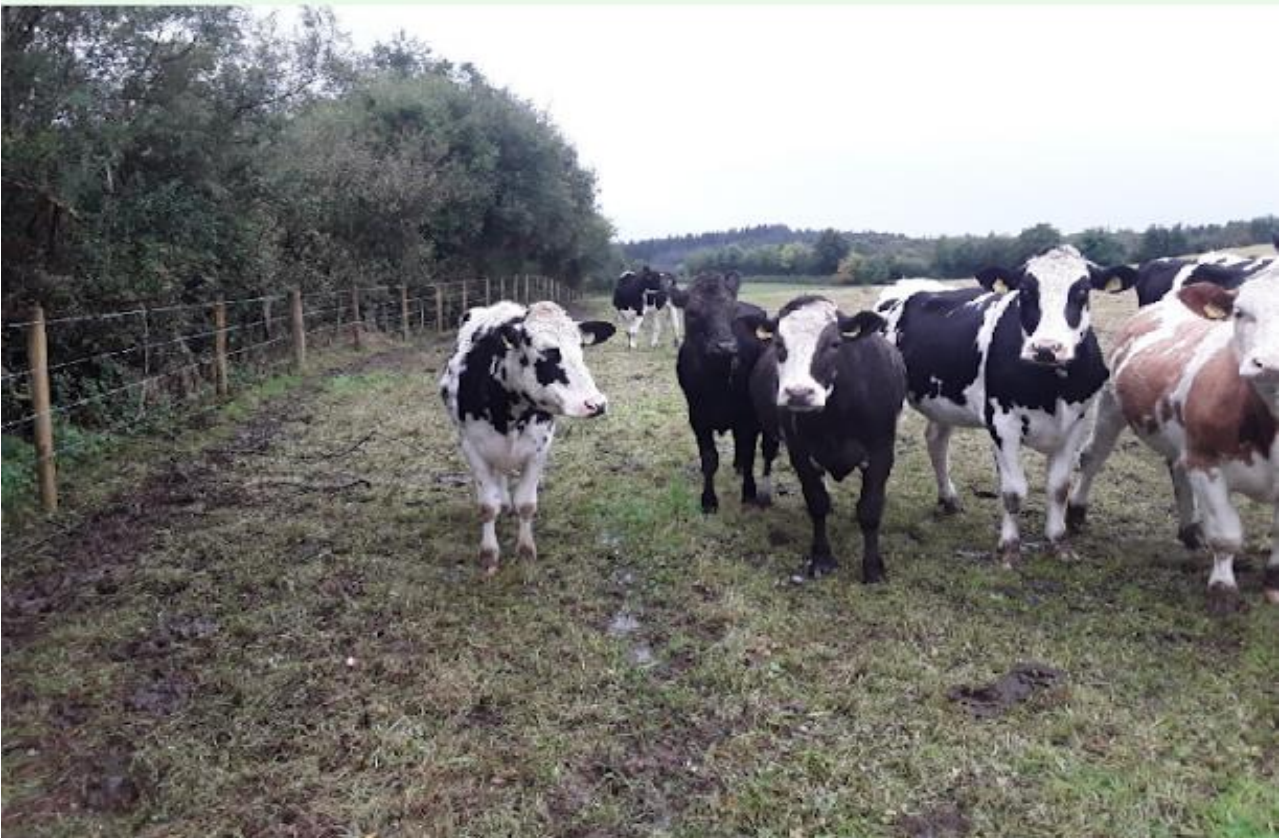
Figure 147: Fencing to prevent cattle poaching on banks

- Installation of livestock fencing (5 rows of barbed wire) over 1.8 km of riverbank.
