CatchmentCARE River Restoration Works Report

MARCH 2023

Community Actions for Resilient Ecosystems

A project supported by the European Union's INTERREG VA Programme, managed by the Special EU Programmes Body (SEUPB).

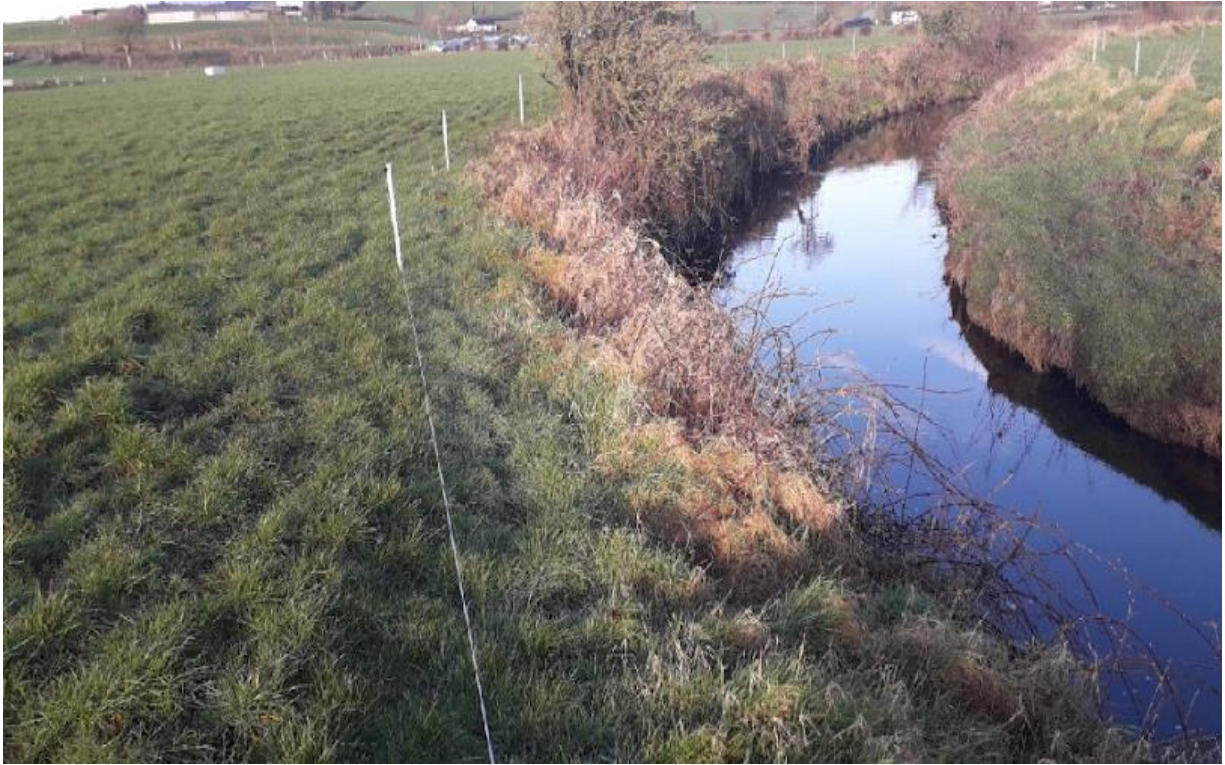
Figure 149: Electric fencing installed

- Installation of livestock fencing (4 row of barbed wire) over 2 km of riverbank
- Installation of livestock fencing (2 row of electric fence) over 1.2 km of riverbank.

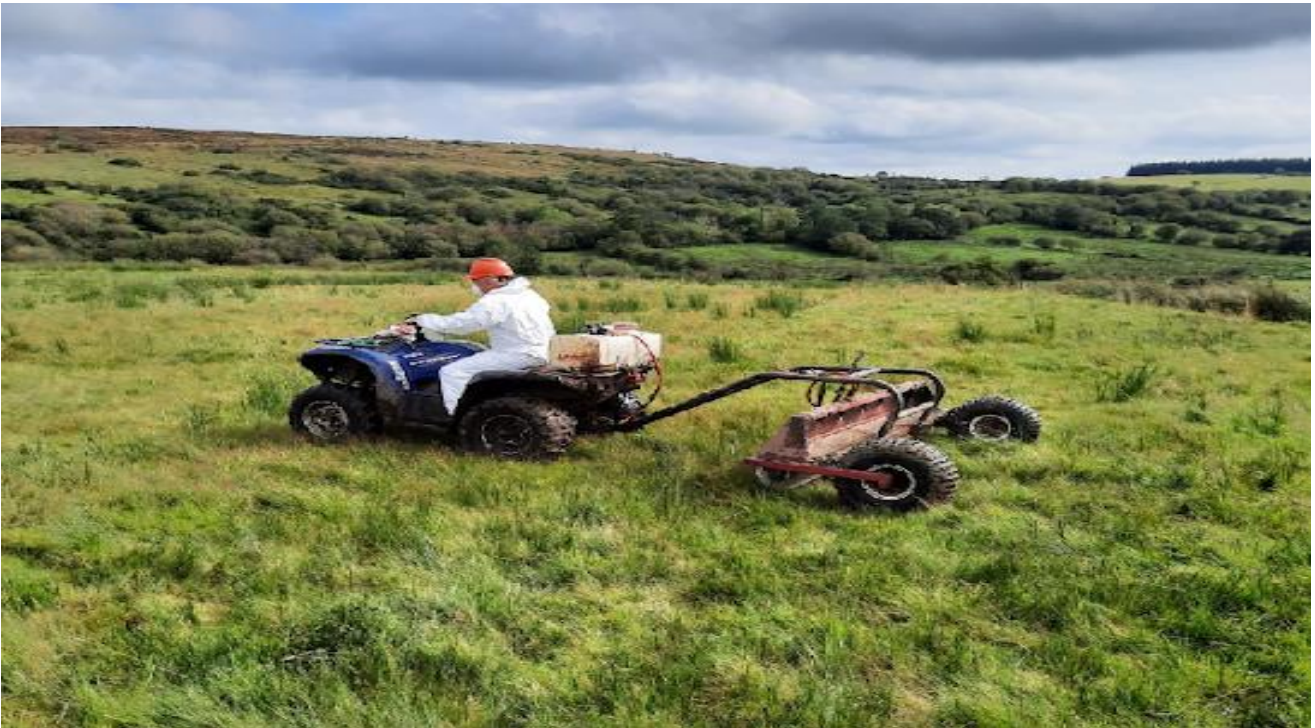
Figure 151: Weed wiping of rushes

As part of the works in this area, CatchmentCARE also funded a local farmer's project through Phases 1 & 2 of the Community Incentive Scheme (CIS). The two projects worked with 80 local farmers in the border region (north and south) aimed to remove / control rushes at selected farms in a way that will help prevent MCPA leaching into local watercourses. An extensive training programme for local farmers was included as well as the development of targeted and detailed farm nutrient management plans for those taking part in the project.

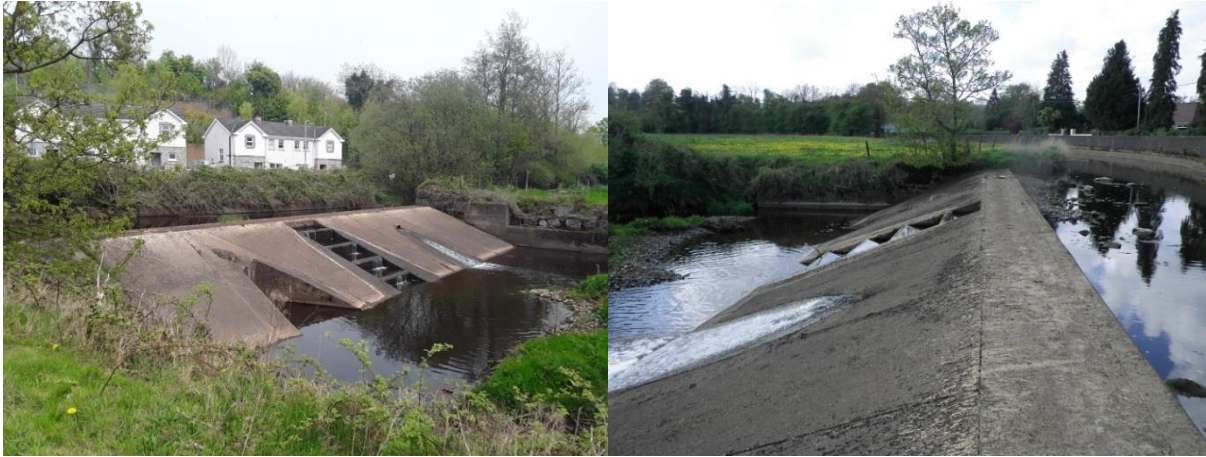
Figure 152. Emyvale weir.

During the prioritisation workpackage Emyvale Weir was identified as a barrier to fish migration (Figure x). The weir at Emyvale (Emyvale Weir hereafter) is currently directing a significant proportion of the Mountain Water River to Emy Lough. The diverted water (Emy Lough Channel hereafter) does not return to the Mountain Water river but rather flows directly into the Ulster Blackwater river at Figanny/Ballynahone. This diversion creates a significant impact on hydromorphological conditions in the Mountain Water River downstream of Emyvale as there are insufficient water volumes to sustain natural environmental flow regimes. Environmental flow describes the quantity, quality and timing of water flows required to sustain freshwater and estuarine ecosystems and the human livelihoods and well-being that depend on these ecosystems (Arthington, 2012).

River in the village of Emyvale in County Monaghan. The report outlines the different options that are available to reduce the impact of the weir on the Mountain Water River. It is hoped that this report will allow other agencies to progress with barrier mitigation at this site in the future. This report is available on request from Inland Fisheries Ireland.
